CONCRETE PAVEMENT JOINT DIAGNOSTICS USING ULTRASONIC TOMOGRAPHY

Paper submitted 1 August 2011 in consideration for
Transportation Research Board 91st Annual Meeting,
22-26 January 2012

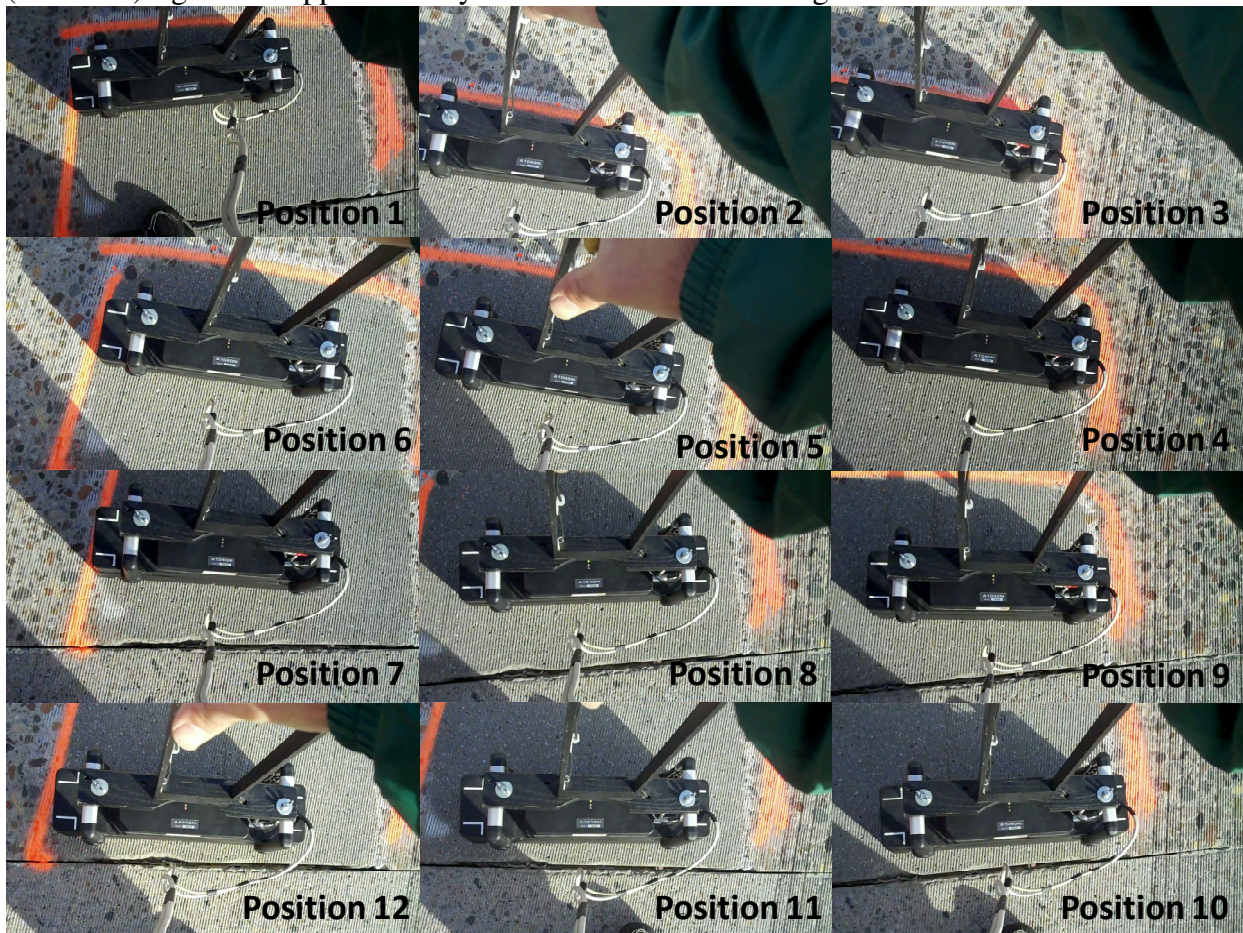
Figure 5. Twelve MIRA scan locations taken at the example partial depth repair.

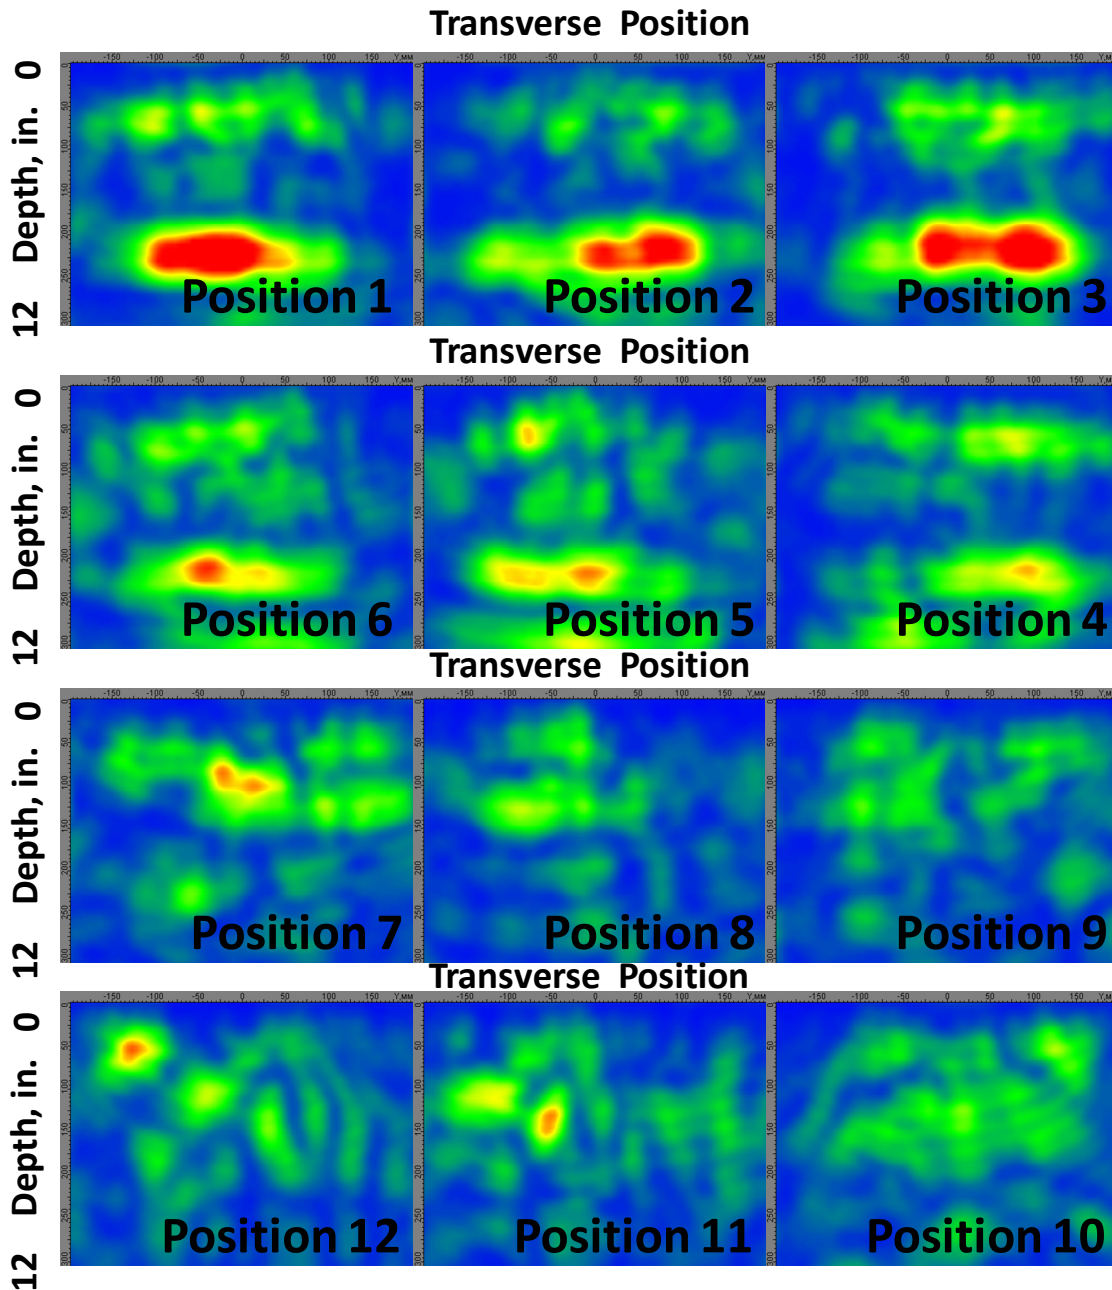
Each of these scans resulted in real time SAFT B-scan results associated with the condition of the concrete below (shown in Figure 6). It can be observed from Figure 6 that a large majority of these scans experience shadowing (explained in the section above) of the backwall reflection at about 9 in. (~225 mm). This indicated the presence of a planar flaw such as debonding which was corroborated with the chaining information that this general vicinity was experiencing debonding.

Figure 6. SAFT B-scans associated with the 12 MIRA scan positions shown above (depth of each scan: 300 mm).

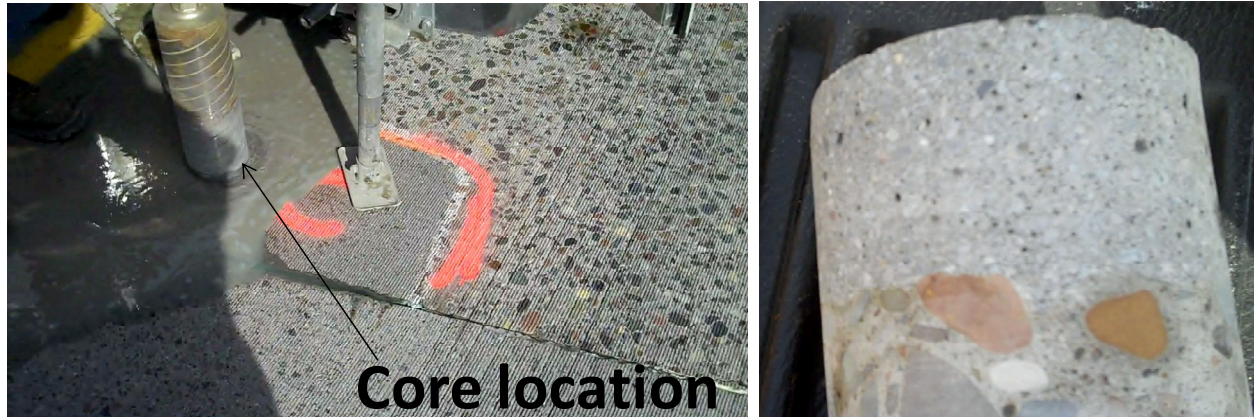
Therefore, a core was taken at a location within this partial depth repair (towards the fog line and away from the transverse joint) as shown in Figure 7. The core at this location showed a proper bond between the partial depth repair and the existing concrete upon inspection of the cross-section as shown in Figure 7 on the right.

Figure 7. Core location (left) and result showing properly bonded partial depth repair.

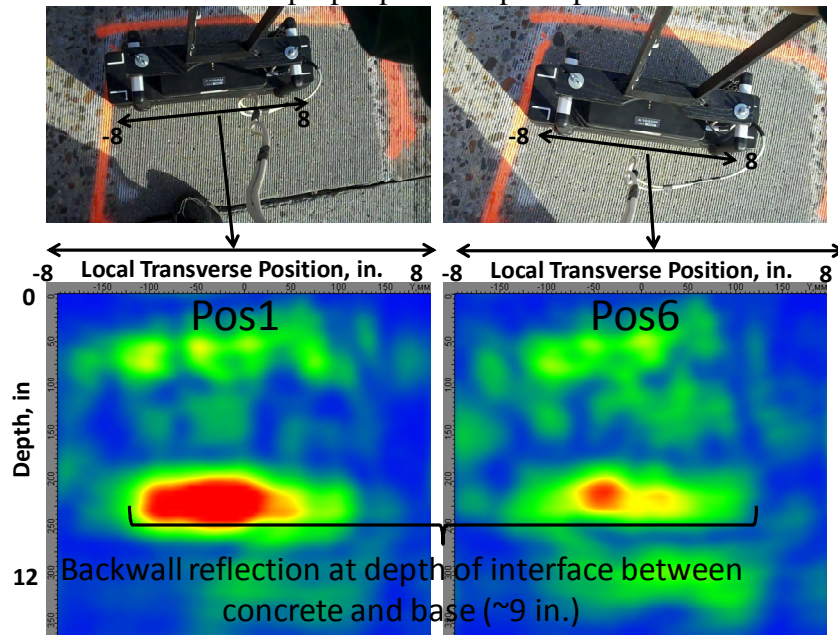
SAFT B-scans within the area deemed to be experiencing debonding were matched with their corresponding positions. Further inspection revealed that a few of the scans in this vicinity did in fact have a strong backwall reflection indicating a proper bond. These scans included the location where the core was taken (positions 1 and 6). Figure 8 shows the position 1 (left) and position 6 (right) scan locations and B-scans. It can be observed that these scans are similar to the example scan shown in Figure 3 which indicates a proper partial depth repair bond. The clear backwall reflection at the concrete and base interface gives the indication of a proper partial depth repair bond above.

Figure 8. SAFT B-scans in the location where the first core was taken with a strong backwall reflection indicating a proper bond between of the partial depth repair.

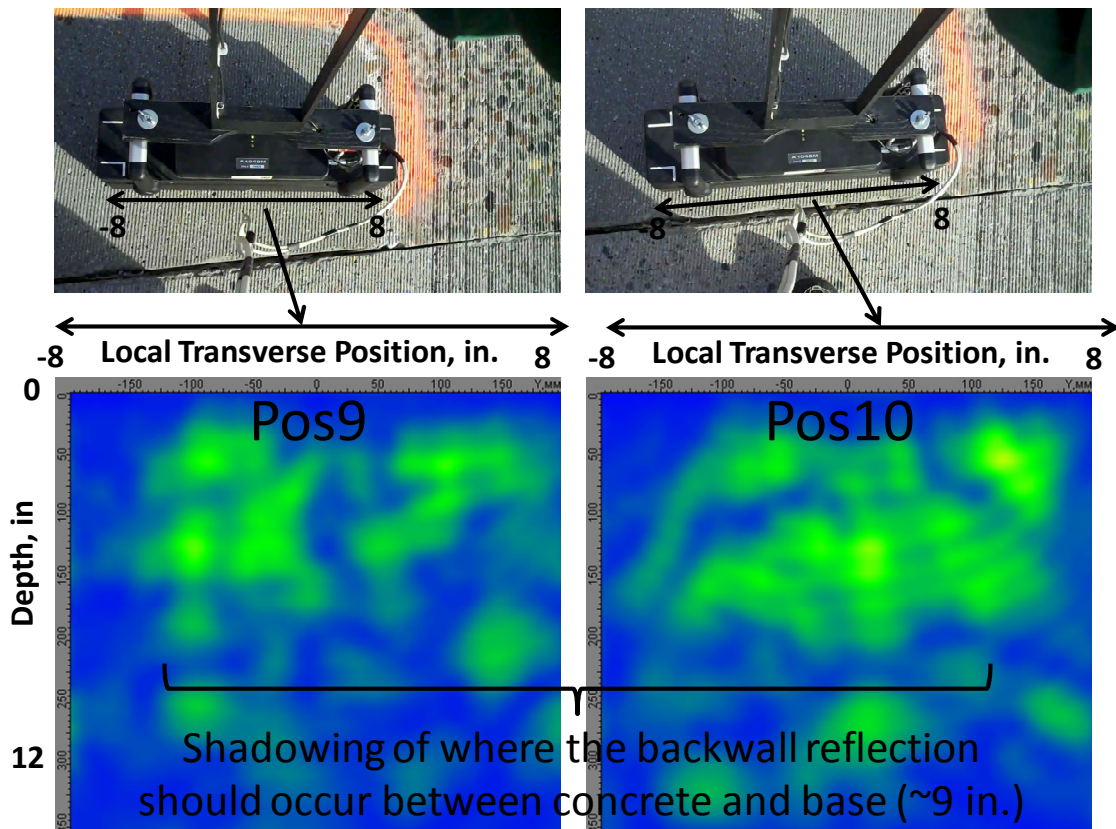
Locations where the backwall reflection experienced clear shadowing (positions 8, 9, 10, and 11) were inspected further with MIRA measurements to pinpoint a location where the core would verify the debonding within this general vicinity (positions 9 and 10). Figure 9 shows the position 9 (left) and position 10 (right) MIRA scan locations and associated B-scans. It can be observed that these SAFT B-scans are dissimilar to the type of SAFT B-scan that should be expected for a properly bonded partial depth repair. In these scans the backwall reflection at the depth of the interface between the existing concrete and base layer is not present. This is an indication that the unbounded condition at the partial depth repair interface obstructed the shear waves from through transmission to the depth of the concrete.

Figure 9. SAFT B-scan locations indicating a poor bond between the partial depth repair and existing concrete.

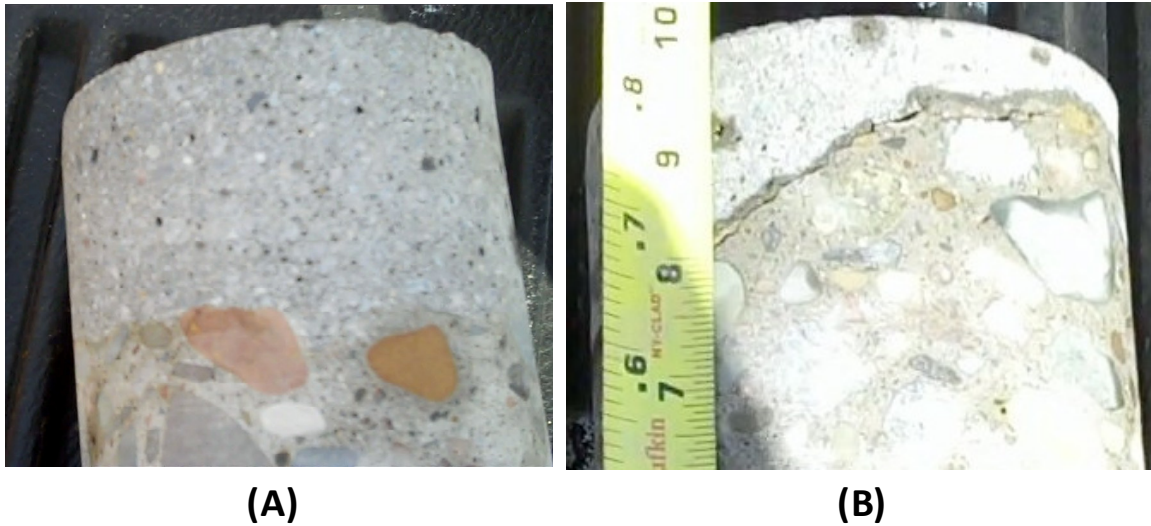
The core taken using this pinpointed location is shown in Figure 10 (B). It can be observed that the partial depth repair is de-bonded, especially when compared to the properly bonded location core (Figure 10A). This verified the non-destructive diagnosis of an improperly bonded partial depth repair.

Figure 10. Cores taken at the area (B) towards the centerline near the transverse joint indicating an improperly bonded partial depth repair in comparison to (A) the properly bonded repair.

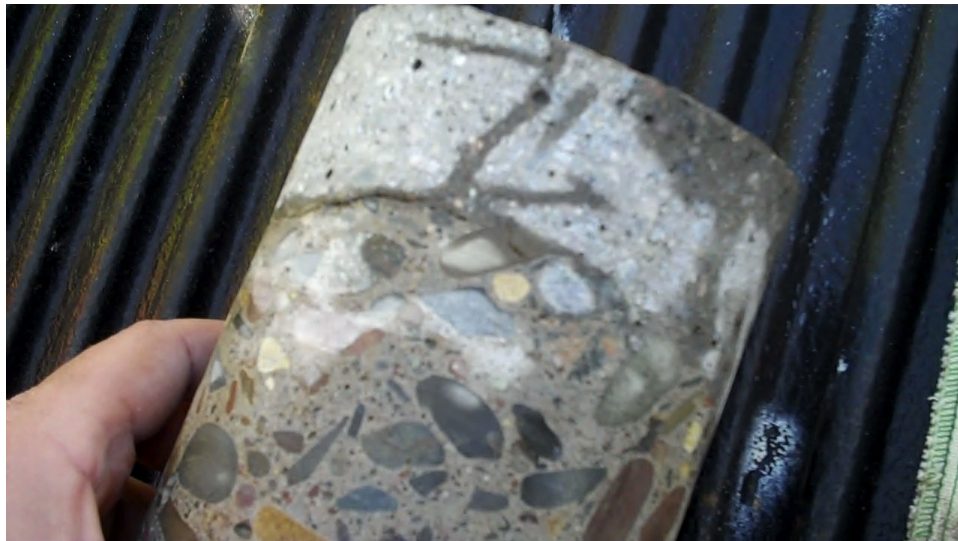
A similar process was used to pinpoint a debonded location in other joint locations where MIRA indicating debonding. Another core verifying debonding of the partial depth repair as indicated by MIRA pinpointing diagnosis is shown in Figure 11.

Figure 11. Core showing debonding of the partial depth repair.

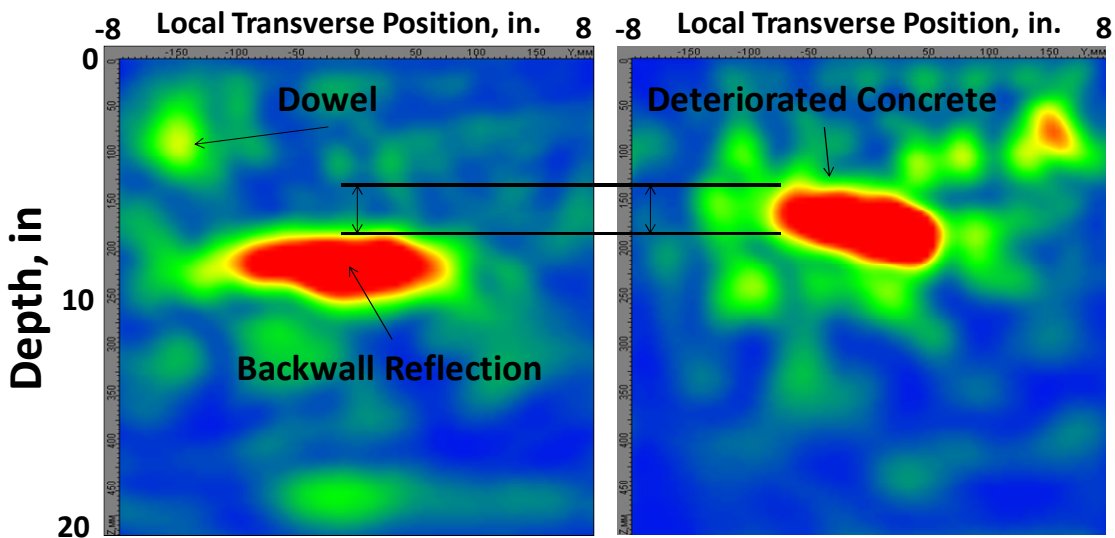
Multiple MIRA scans were taken at various transverse joints in an initial screening. Analysis of the SAFT B-scans at one joint location showed some locations that indicated potential flaws. More detailed testing along the joint with scans taken in 3 inch step sizes showed the extent of the potential damage at the joint. Analysis of the SAFT B-scans taken in the right wheel path general area showed similar results to that shown in Figure 4. An example SAFT B-scan at a right wheel path is shown on the left in Figure 12. In this, and other locations around the right wheel path, the high intensity of reflection areas corresponded to dowel locations and the depth of the concrete-base interface as should be expected for undamaged concrete. Analysis of the remaining portion of the joint indicated a much different subsurface condition. Subsequent measurements at the center of the joint as well as moving toward the centerline of the joint indicated damage. Instead of strictly reflections at the dowels and concrete thickness, there was an uneven reflection at a shallower depth that should not be expected. This shallow and uneven reflection indicated deterioration of the concrete at the interface with the base.

Figure 12. MIRA B-Scan locations in suspected sound (left SAFT B-scan) and deteriorating (right SAFT B-scan) conditions.

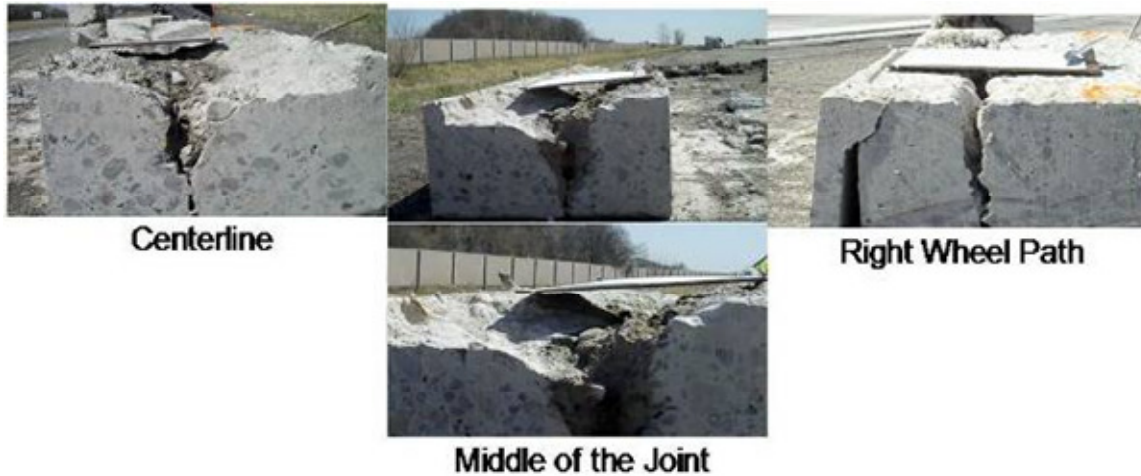
MnDOT personnel subsequently took a 12 ft by 3 ft full-depth concrete sample from along the transverse joint to verify the MIRA SAFT B-scan diagnosis. As shown in Figure 13, the sample was flipped so that the interface between the concrete and base is shown at the top. It can be observed that the underside of the concrete near the right wheel path is in relatively good condition as was diagnosed by MIRA. The underside of the concrete near the base in the samples at the middle of the joint and at the centerline show significant deterioration.

This verified the nondestructive diagnosis of deterioration using SAFT B-scans prior to the forensic verification.

Figure 13. Forensic sample sections used to verify the concrete condition on the underside at various locations near the transverse joint.
