DOCter Impact-Echo Testing cases

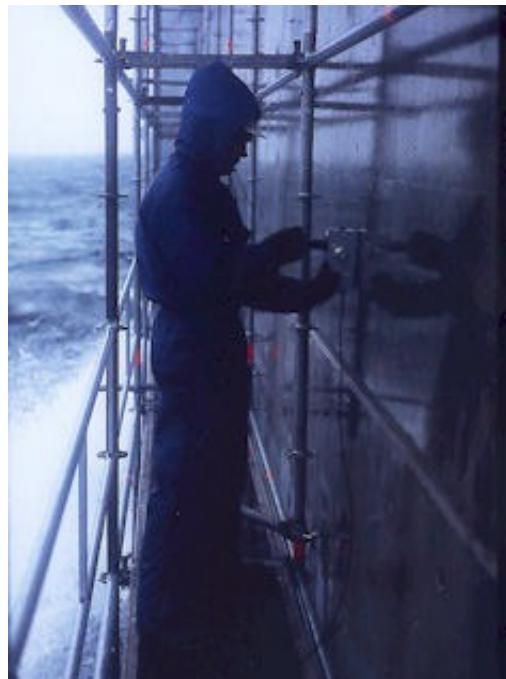
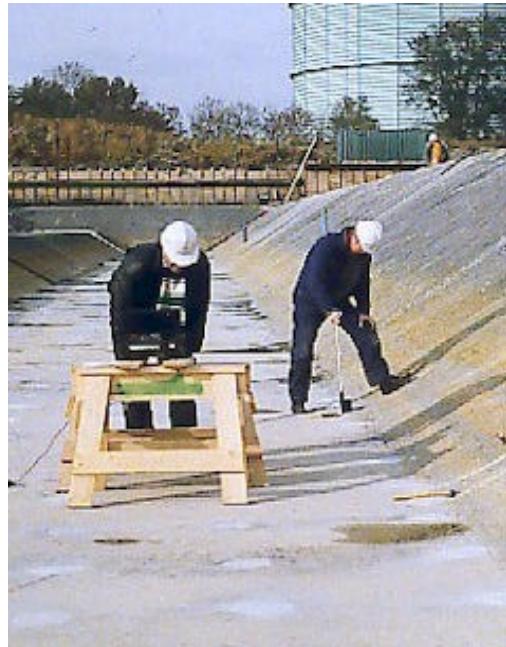
2. Voids below a sludge basin

Shortly after completion of a sewage plants sludge basin rain fell heavily for three weeks. The rain penetrated the surrounding soil, lifted the basin and partly washed away the sand bed material below the fiber reinforced concrete bottom plate. Before the basin could be taken into operation the voids below the bottom plate needed to be detected and injected.

Six major areas were detected as voided. Cores were drilled out for confirmation.

Injection with a pressurized mortar took place through the cored holes until the bottom plate was lifted 1 mm. Finally, the bottom plate was re-tested with impact-echo and no voids were detected. The sludge basin was put into service.

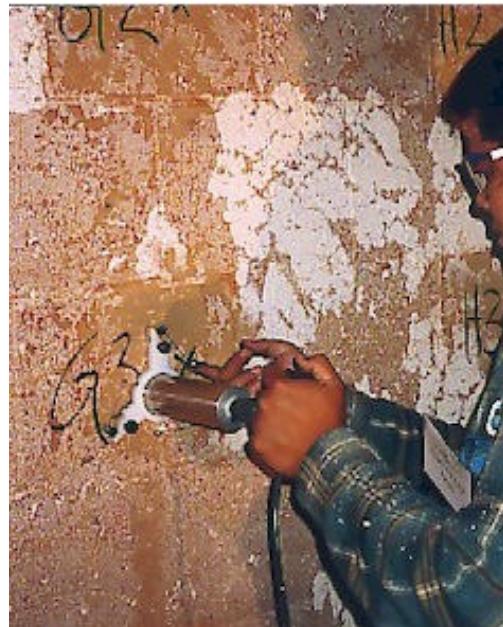
3. Debonding of tile lined concrete vessels

With the vessel in service impact-echo was used from the outside of the vessel to detect the debonding of the inside tiles.

Detected loose tiles on the inside were confirmed by coring. Similarly, areas found solid by impact-echo were cored and found to be solid.

An impact-echo testing program was set up for regular inspection of vessels in service, involving considerable savings to the owner of the paper mills compared to traditional testing.

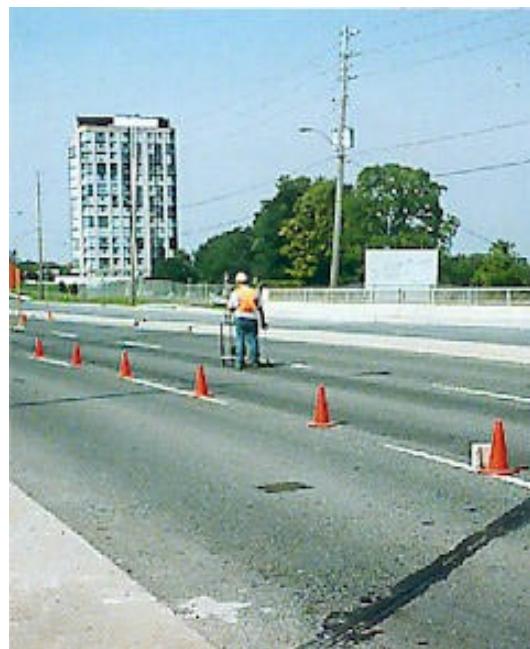
4. Delaminations of a highway bridge deck

The bridge deck of a highway bridge had been subjected to de-icing salts during the winter for 15 years. The deck, 30 meter long and 12 meter wide, had a 300 mm concrete slab with an 50-100 mm asphalt overlay and a bituminous membrane in between.

Impact-echo detected the areas where debonding of the membrane had taken place, and, in addition, zones with delaminations in the concrete slab caused by chloride induced corrosion at the top reinforcing steel as well as at the bottom steel. Testing was performed partly from the top surface and partly from the bottom of the slab.

A limited number of cores confirmed the impact-echo test results.

A repair program was undertaken involving installment of a new asphalt/membrane overlay after localized repair of the concrete slab in the corroding zones had taken place.

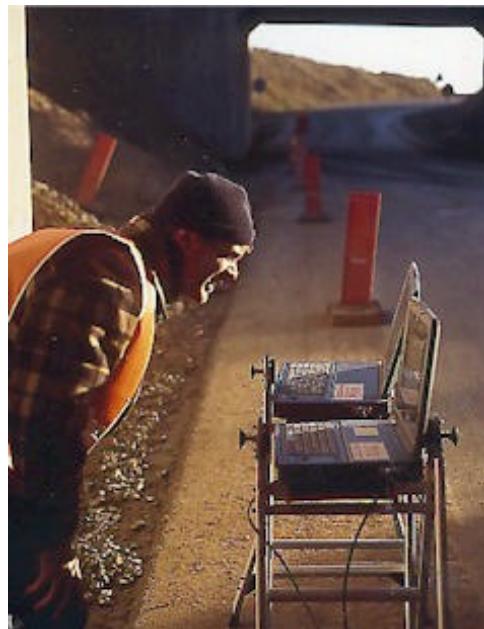
5. Honeycombing in bridge supporting walls

Two supporting walls, 60 meters long and 5 meters high, of a major highway bridge were cast with a high performance concrete. After removal of the formwork the surfaces revealed a number of honeycombs, which were repaired by the contractor.

The testing performed revealed two locations with honeycombs, otherwise the walls were evaluated as solid. The integrity of the walls was accepted by the owner.

In addition, impact-echo found an 8 mm bituminous membrane installed on one face of one of the walls against the earth-fill. This membrane was not indicated on the drawings. Installation had been made by the contractor to avoid water intrusion from the earth-fill.

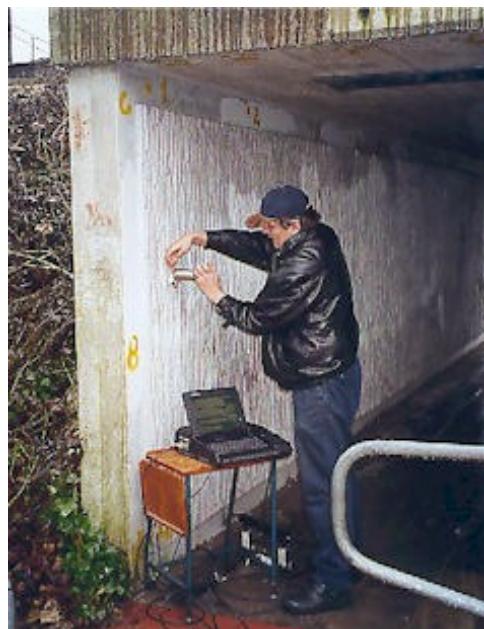
6. Cracking in two tunnels caused by ASR

Two 25 years old tunnels carrying railway tracks suffered from ASR (Alkali Silica Reactions). Prior to upgrading the tracks for high speed trains the extent of the cracking needed to be established, in particular to clarify if delaminations had occurred.

Impact-echo was performed. Three classes of signals were detected, solid concrete, concrete with multiple smaller cracks and one area close to a deck edge exhibiting a major reflection surface at a depth of 180 mm.

Coring revealed the reflection surface to be caused by a cast-in 40 mm in diameter rubber tube. The tube was not indicated on the drawings.

Coring also confirmed the solid concrete found to be solid and the concrete with multiple reflections to contain 5-30 mm long cracks, predominantly parallel to the surface.

An intended strengthening program was decided not to be carried out.

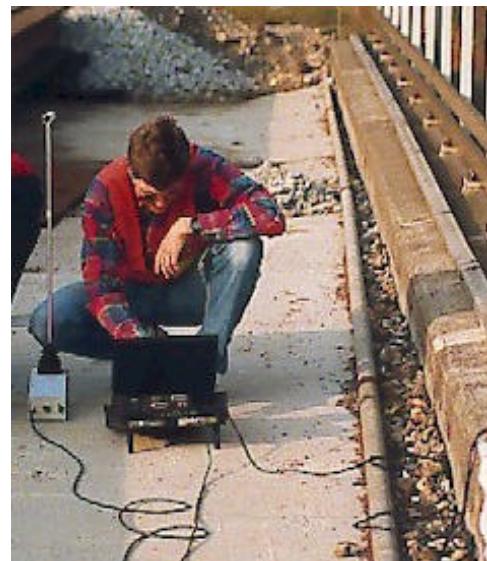
7. ASR delamination of a railroad bridge deck

A 1 meter thick reinforced concrete bridge deck 30 years old, carrying a rail track, suffered from ASR. The span of the deck was 25 meters.

A horizontal crack at mid-depth in the deck was detected across virtually the entire span.

The crack was confirmed by coring.

The bridge was judged unsafe and was demolished. During demolition the lower half part of the slab came down in its entire length.

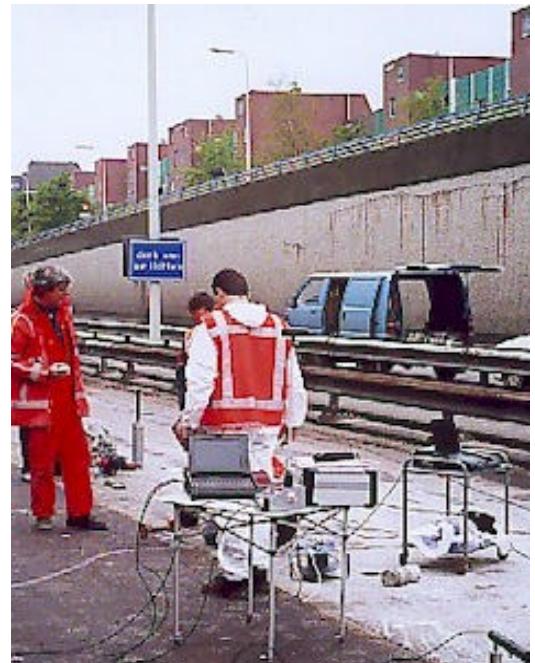
8. Delaminations near joints of highway slabs

The slabs close to 9 of the joints were evaluated as solid. Delaminations were indicated in the remaining slabs with depth indications between 111 mm to 589 mm.

Coring was performed, one on each side of the joints tested. The impact-echo findings proved to be 95% correct.

The delaminated slabs were repaired by removal of the concrete past the delaminations and casting of a new concrete well bonded to the concrete substrate.

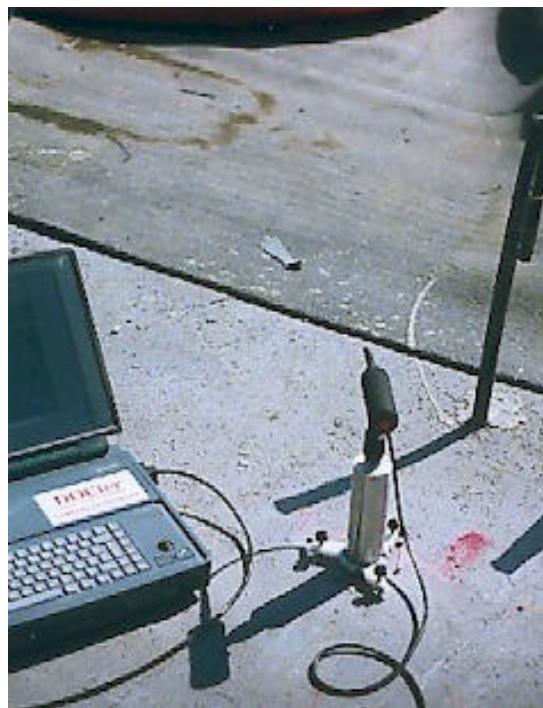
9. Voids in injected cable ducts

The impact-echo test signals were classified in three types of signals, fully injected ducts, partially injected ducts and empty ducts.

Thirty cable ducts were tested with impact-echo of which 21 were evaluated as solid. The remaining ducts, partially injected or empty, were re-injected with grout from the top tubes.

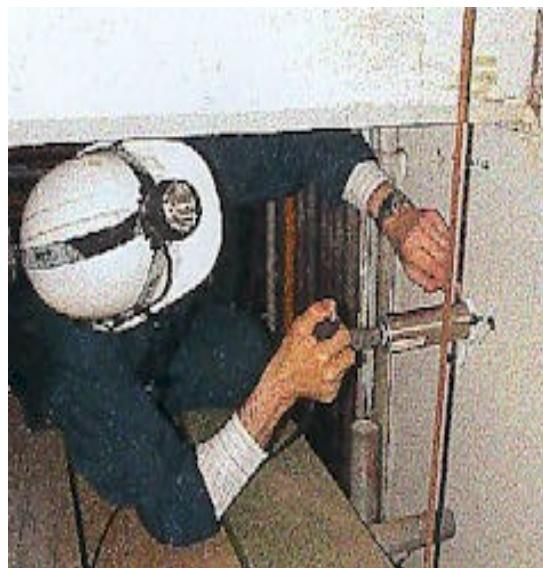
10. Steel liner corrosion in a containment wall

Corrosion of the liner cause an air gap and a reflection frequency of approximately 10 kHz for the 20 cm deep air gap. Similarly, if no corrosion has occurred, the impact-echo P-wave will be reflected at a frequency of 5 kHz from the steel liner.

The impact-echo testing mapped quickly the corroding areas of the liner. Coring confirmed the test results. The liner was repaired after removal of the 20 cm cover concrete in the corroded areas.

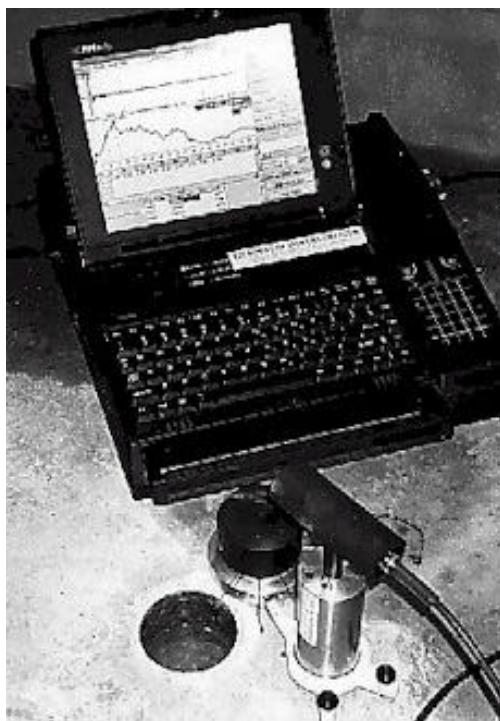
11. Debonding of composite structures

Prior to performing the time consuming and destructive Bond-Testing, impact-echo was used to point out areas not bonded, quickly and non-destructively.

Coring at a couple of locations in non-bonded areas confirmed the impact-echo test results

In the areas found by impact-echo to be bonded, the Bond-Tests were performed subsequently.

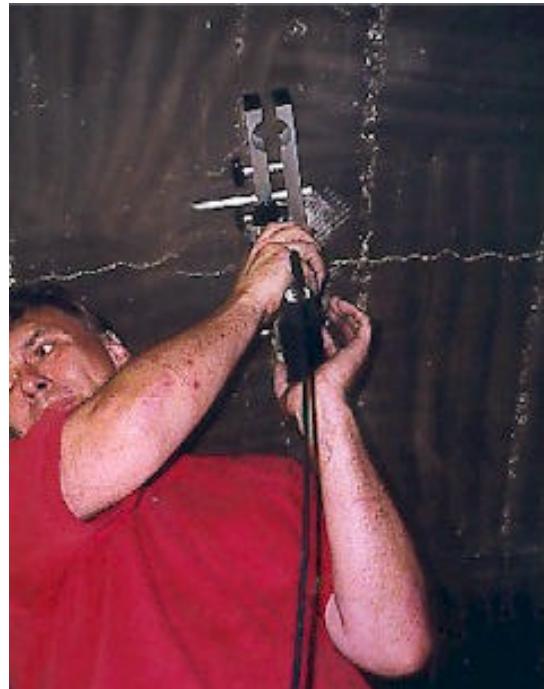
12. Integrity of a fire damaged deck

An intensive fire broke out in a high voltage transformer room of an industrial building complex. The 300 mm reinforced concrete deck and walls were heated vigorously for about one hour.

Surface opening cracks showed up, especially on the underside of the deck, after cooling of the structure.

The wave speeds of the deck ranged from 2200 m/s to 2800 m/s. The depth of the surface opening cracks were measured between 19 mm to 109 mm. Delaminations were detected at depths ranging between 83 mm and 270 mm.

The deck was subsequently supported and strengthened by a steel structure.

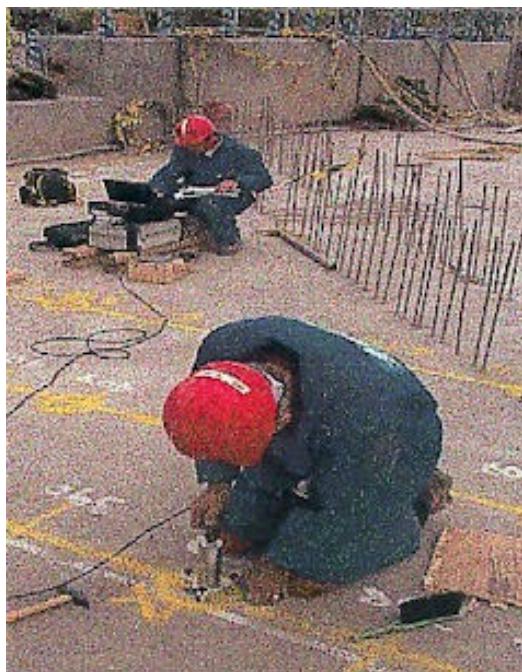
13. Voids below two layers of reinforcement

Impact-echo detected, using a 5 mm impactor, the voids at a depth of 120 mm from a measured frequency of 10.4 kHz.

The solid parts of the roof were evaluated by means of the solid frequency at 1.92 kHz and the absence of the 10.4 kHz void peak in the frequency spectrum.

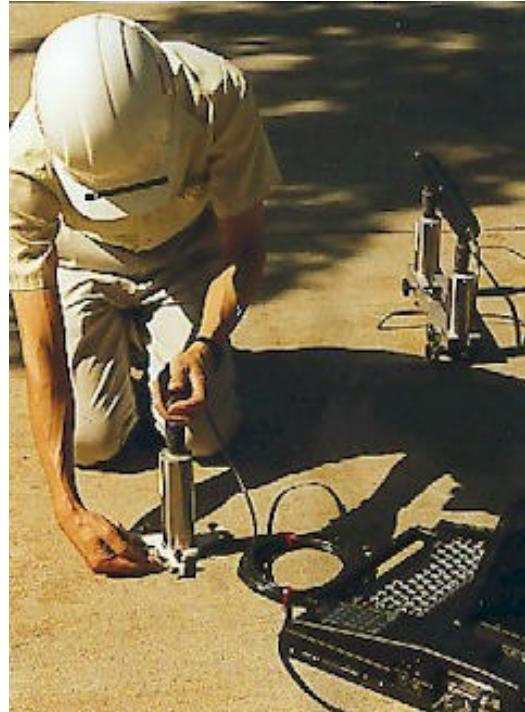
14. Thickness of concrete pavement

800 measurements were performed. The thickness estimated was at 8 locations compared to the actual thickness. The thickness measured by impact-echo was within ± 5 mm from the actual measured ones.

The 200 mm design thickness of the pavement was met by 92% of the test results.

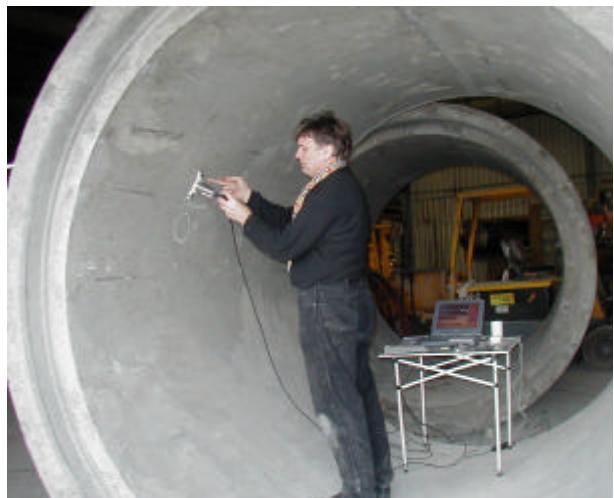
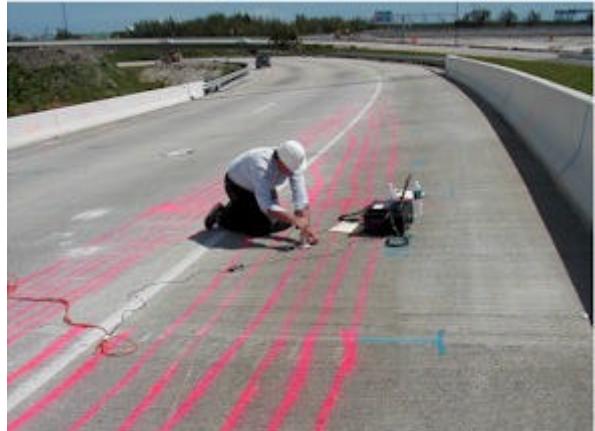
Testing for voids in steel cable ducts in a bridge deck

The cable ducts were located accurately by means of radar. Subsequently, impact-echo was used to detect the voids. The wave speed of the concrete was found to be 3,820 m/s using the Longship.

Testing was performed above the cable ducts. A number of voids were detected. At one location the concrete was removed and the depth to the void of 123 mm, estimated by impact-echo, was found to be 122-125 mm deep. Opening of the duct revealed strands not protected by grout. The strands showed signs of corrosion.
