FIELD MEASUREMENTS AND EXPERIENCE OF CHLORIDE INDUCED CORROSION OF REINFORCEMENT IN SUBMERGED STRUCTURES

Peter Shaw, Materialröntgen AB and Tomas Kutti, AB Färdig Betong, Göteborg, Sweden

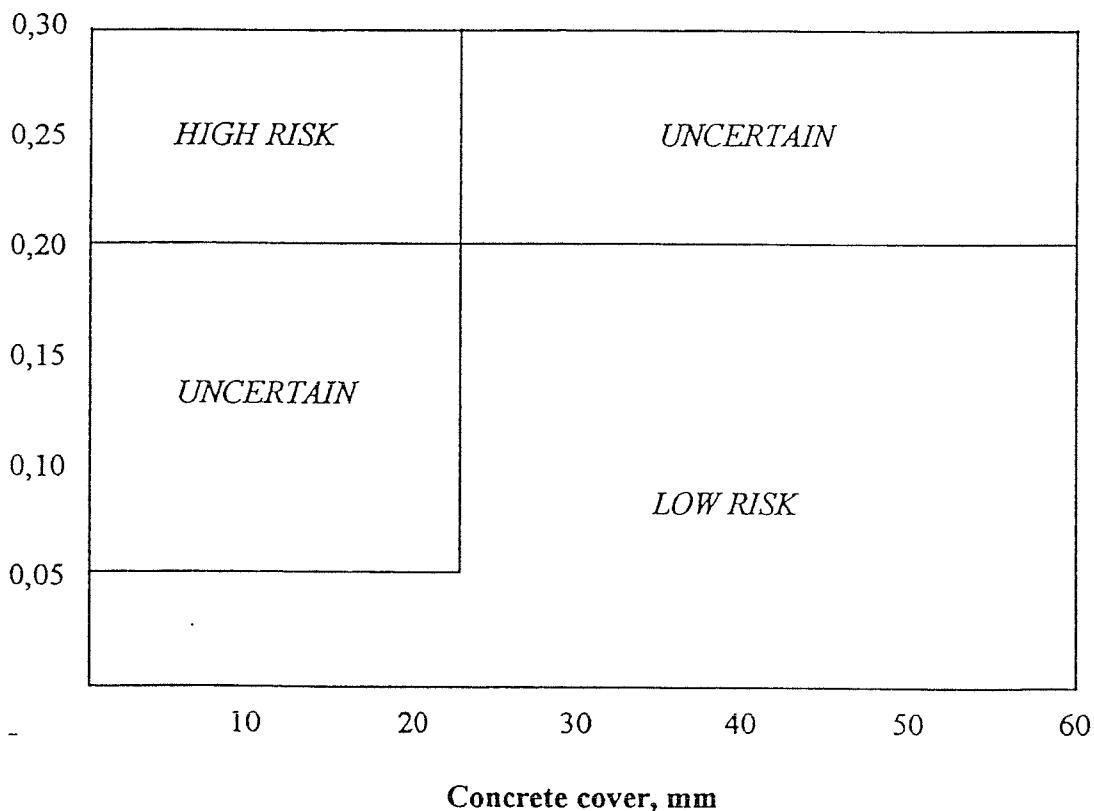
Reinforcement corrosion is common where cover thickness is less than ~20 mm, see Figure 2.

Figure 2. Estimation of corrosion risk in submerged structures based on measured chloride content and concrete cover.

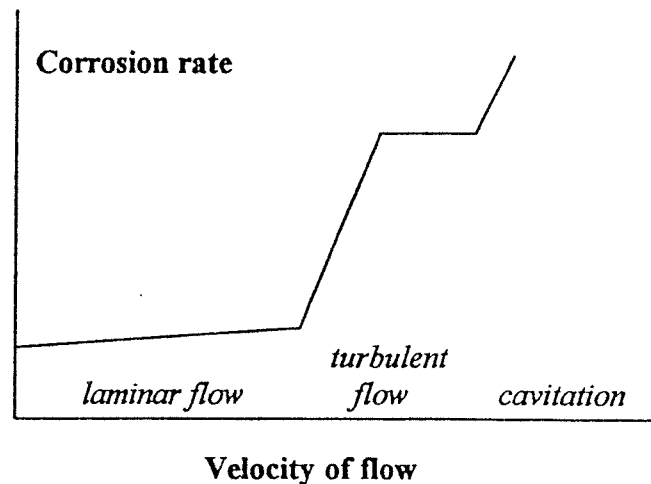
In laminar flow conditions the transport of oxygen occurs by diffusion, the rate of diffusion increasing with flow-rate as the thickness of the laminar layer decreases. As shown in Figure 1,

a transition from laminar to turbulent flow (at critical Reynolds number) is associated with a sharp increase in corrosion rate.

Figure 1. Corrosion rate versus velocity of flow [1].

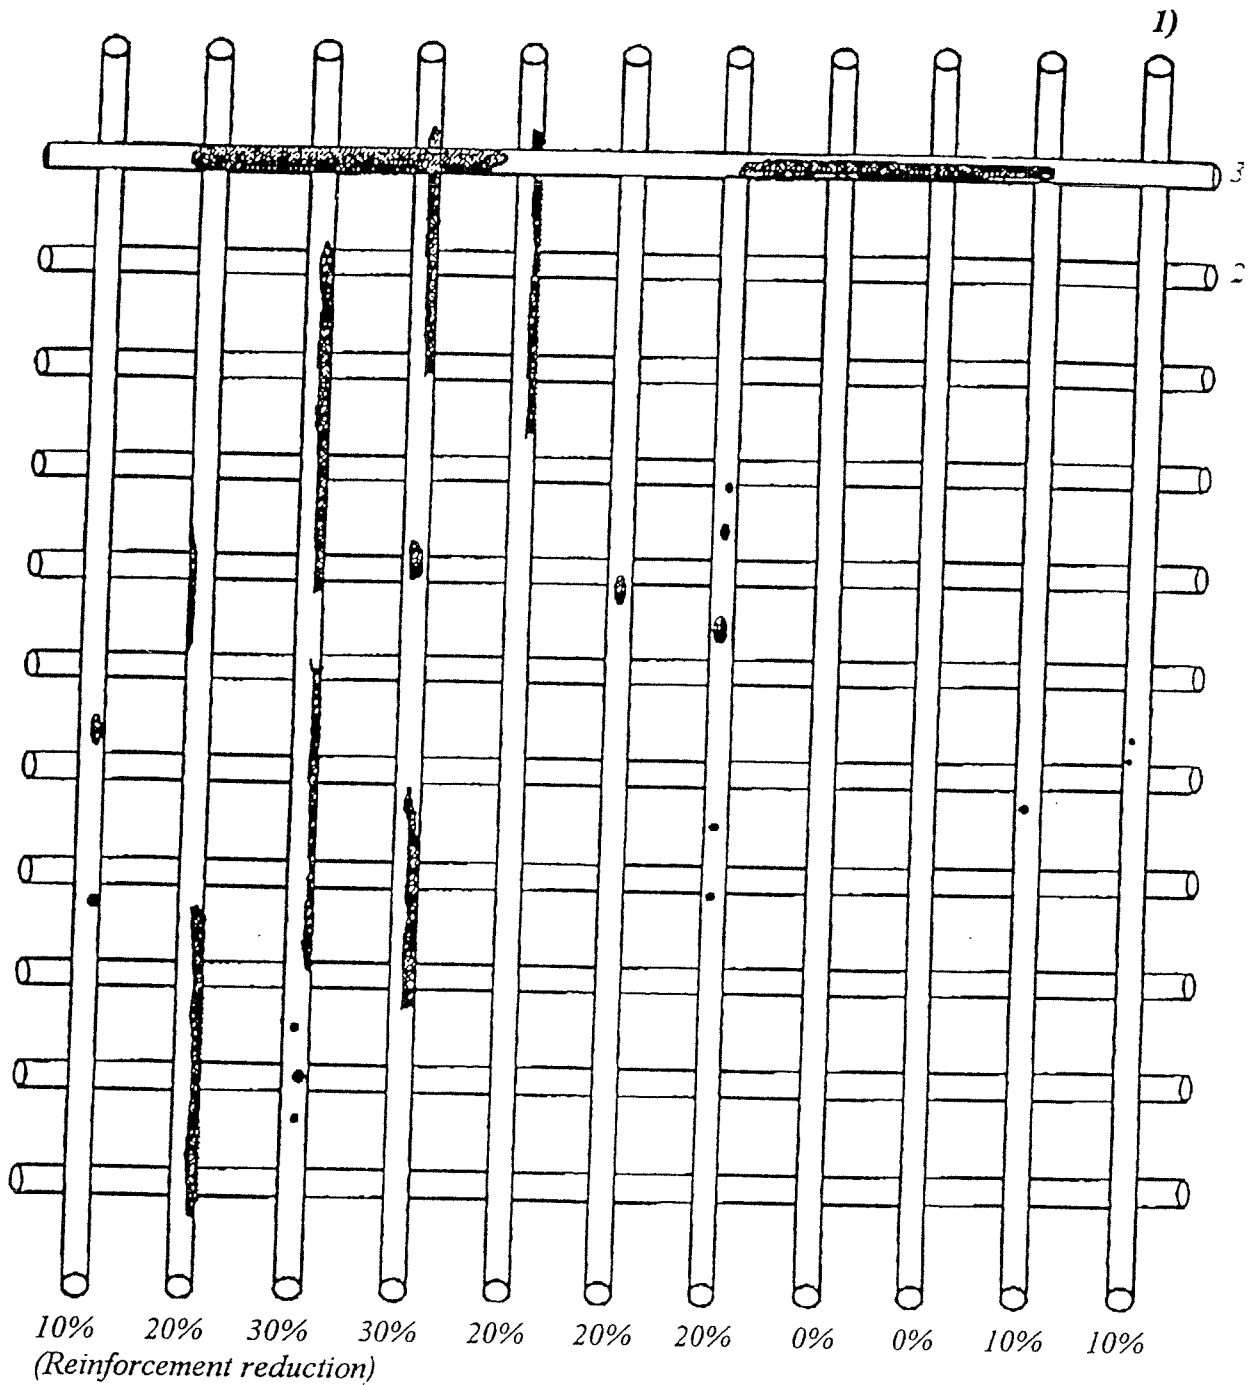
In Figure 3 the distribution of corrosion damage along the main reinforcement of a section of outlet culvert roof-slab is shown. The main reinforcement on the slab underside is placed across the section at c/c-spacing 125 mm, with secondary reinforcement placed on top of these at 200 mm centres (typically). At the point shown the measured chloride levels are 0,45% of concrete weight and cover to main reinforcement is 30 mm. The corrosion damage is in the form of pitting, with reductions of as much as 30% on individual bars. The corrosion is spread up to about 300 mm along sections of the reinforcement and is confined to the surface nearest the exposed surface. The secondary bars are unaffected.

Figure 3. Corrosion to roof-slab reinforcement. Outlet culvert, Barsebäck 2. Position +93 m. Seen from below. From [2].
