**STRUCTURAL MATERIALS TECHNOLOGY (SMT):  
NDE/NDT FOR HIGHWAYS AND BRIDGES 2004**

**Title:** Verification of concrete placement in post-tensioned bridge box girders using a rapid nondestructive test method.

**Authors:** Kevin Michols\*, Allen Davis\* and Claus Germann Petersen\*\*

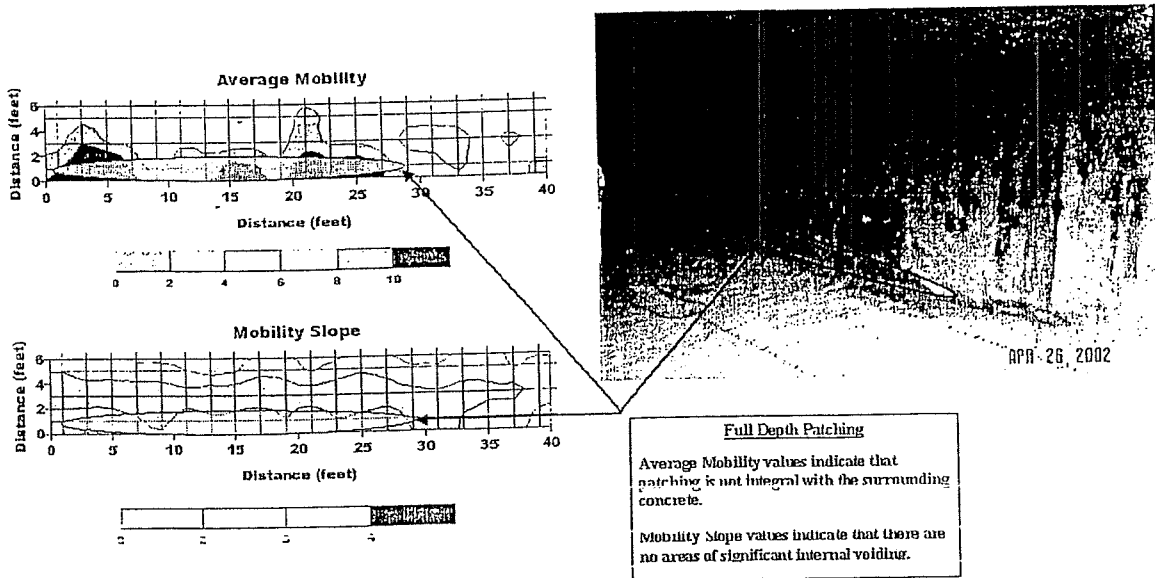
Figures 6 and 7 are IR test contour plots adjacent to photographs of the tested areas in the plots. The high mobility values in the vicinity of the full-depth patch repair in Figure 6 indicate that the patching is not integral with the surrounding concrete, but also that no voiding remains within or around the patch (normal mobility slope values). Figure 7 confirms the presence of localized internal voiding behind a partial depth patch, indicated by high values for both mobility and mobility slope.

Fig. 6 Poor Patching Shown by Mobility Contours

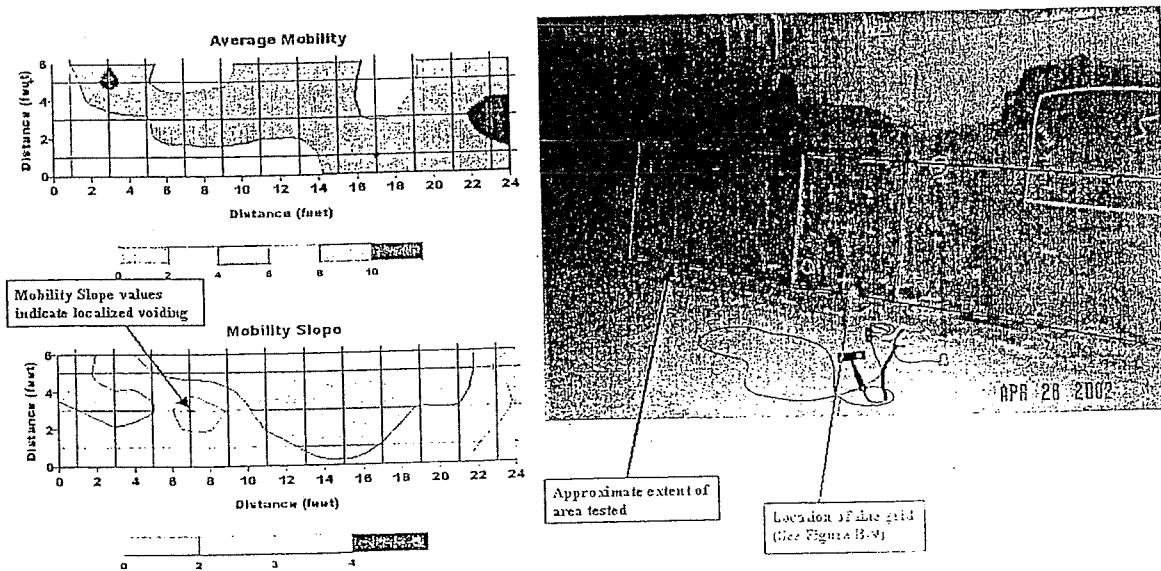
Fig. 7 Localized Internal Voiding Shown by Mobility Slope Contours
