## **s'MASH Impulse Response Testing Cases**

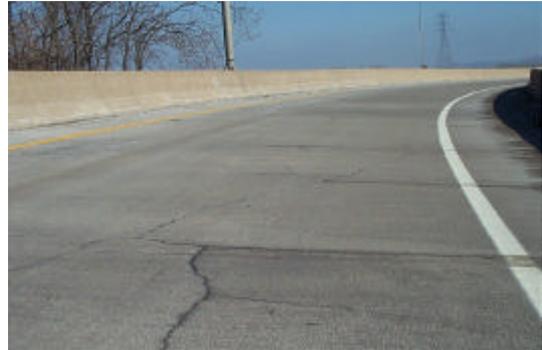
### ***1. Debonding of concrete bridge deck overlay***

An existing reinforced concrete approach ramp to a freeway has been overlain with a 75-mm thick silica fume unreinforced concrete. Surface cracking appeared six months after construction, with debonding of the overlay becoming apparent at certain locations on the slab. s'MASH testing was brought in to determine the exact extent of the debonding using the mobility contour plot for the whole deck. Testing was completed in three hours, minimizing traffic closure. Additionally, an estimate of those areas of the deck with incipient debonding problem was made by analyzing the s'MASH stiffness and mobility slope contour plots. This facilitated the decisions to be made for the repair solution and the quantity of deck overlay to be replaced.

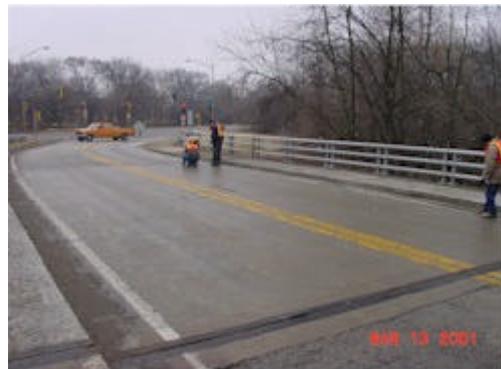
### ***2. Prestressed concrete box beam bridge***

A common form of prestressed beam bridge structure relies on cross-rods and grouted keyways between the beams to form a single span bridge. Each hollow core beam is usually between 20 and 30 m long and 900 mm wide. s'MASH tested one of these bridges through a 100-mm thick concrete overlay, with much greater mobility and lower stiffness on one half of the bridge. In the half of the bridge with higher stiffness the transverse rod system is functioning as designed. However in the other half of the bridge the opposite is true; either the transverse rod system was not properly installed or not present. It was reported that during recent renovation of the bridge, the crew had problems with one of the rods. s'MASH testing showed the ability of the method to detect changes within the bridge, such as a loss in functionality of the transverse rod system. This loss in the rod system can be detrimental to the overall load carrying capacity of the bridge. The speed of the s'MASH testing makes it a valuable tool for testing other similar bridges.

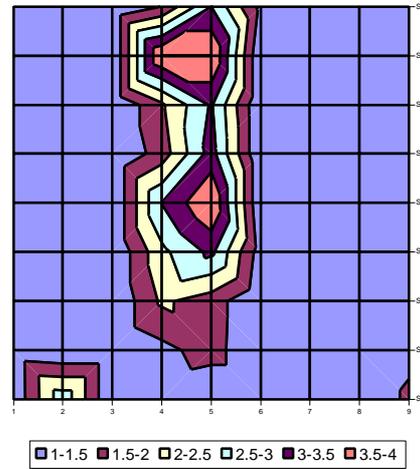
Industrial Floor, 40 m x 40 m Section  
Voiding Index

The s'MASH test evaluated a 9600 sq m industrial reinforced concrete floor slab for the presence of poorly consolidated areas, as well as voiding in the slab sub-base. The slab design thickness for the entire area tested was 200 mm. The s'MASH mobility and stiffness contour plots indicated areas with probable slab thickness less than 200 mm. Coring of select locations and impulse radar traverses correlated overall floor slab thickness with core thickness. The s'MASH Voiding Index when >2 showed voided/poor support areas beneath the slab. S'MASH also identified an area of potentially honeycombed or voided concrete. This was confirmed by coring at selected locations. In addition, areas of lower stiffness were located by s'MASH along construction joints, which is typical of jointed slabs on grade. Fieldwork was completed in 3 days!

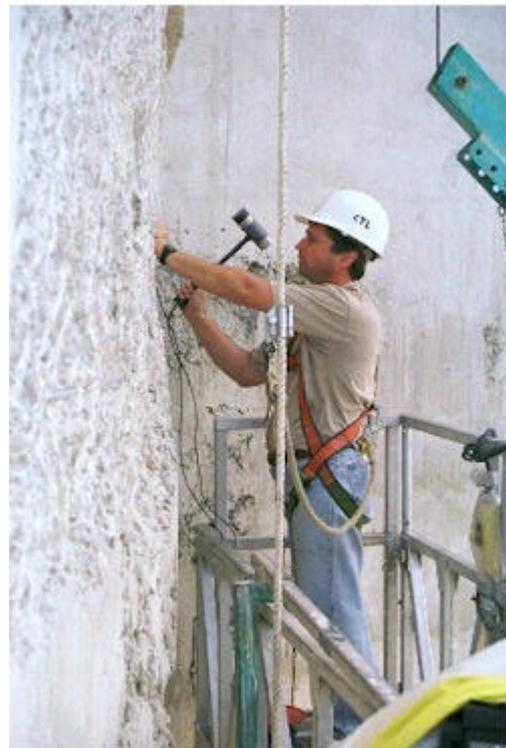
**4. Poor concrete consolidation in cement silos**

Two 60 m high x 30 m diameter cement silos were being constructed by the slip-form technique. Low density and honeycombed concrete was observed on the silo surfaces immediately above the interior silo ring beam at 20 m above ground level when the forms were raised. The concrete on the interior and exterior walls immediately above and below the steel ring beam was tested by s'MASH, as well as the concrete at the level of the steel ring beam on the silo exteriors. No areas of high s'MASH mobility and/or mobility slope were detected in areas of visibly sound surface concrete. No delamination of the concrete along reinforcement planes was observed from the test results. It was concluded from the s'MASH testing that the concrete in the walls was sound and integral, apart from those areas where rock pockets and tear cracks were readily visible on the concrete surface. Cores were taken in the concrete above the ring beam, including one core through a visible tear crack. All the cores contained sound, continuous concrete, confirming the s'MASH test findings.

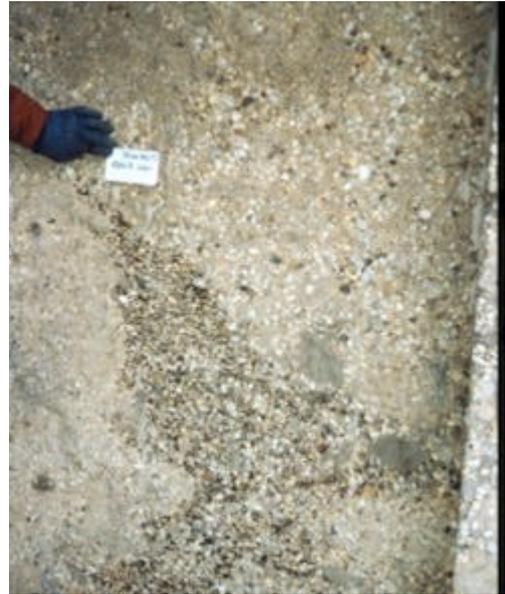
### **5. *Honeycombing in cooling tower wall***

A mechanical-draft cooling tower with four cells included 300-mm thick reinforced concrete walls 15 m high. The walls were lined with 2-mm thick plastic coating to prevent excessive water loss through the concrete. After 2 years in service, blisters were observed on the walls, and when pierced, showed zones of saturated, poorly consolidated concrete. s'MASH testing of the concrete through the lining mapped out zones of honeycombed concrete, and gave an accurate estimate of repair quantities. All zones with poor concrete consolidation located by s'MASH were confirmed during the repair program when the old liner was removed. The speed of testing and analysis meant that no facility downtime was necessary, resulting in great savings for the owner.

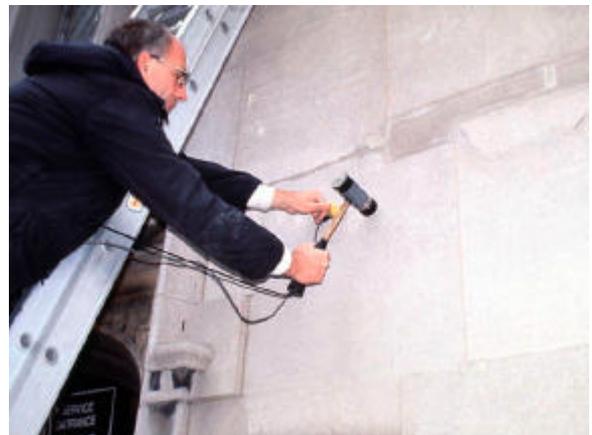
### **6. *Cladding on high-rise buildings***

Vertical cracking distress was observed in terra cotta clad column covers and mullions on the Wrigley Building, Chicago. s'MASH tests were conducted from the 4th to the 13th floor. The tested column and mullion were representative of similar elements around the entire perimeter of the building where the problem of vertical splitting or cracking of the terra cotta cladding was confirmed. Features such as debonding of the unit from its supporting back-up masonry, and non-visible internal delamination or splitting within the terra cotta unit were detected by s'MASH. The stiffness recorded for each terra cotta unit was plotted versus the position or height of the unit from the 4th floor upward. For the column cover, the residual stiffness measurements indicated very strong concentrations of high compressive stress directly above and below the position of the steel shelf angles supporting the terra cotta at each floor line.

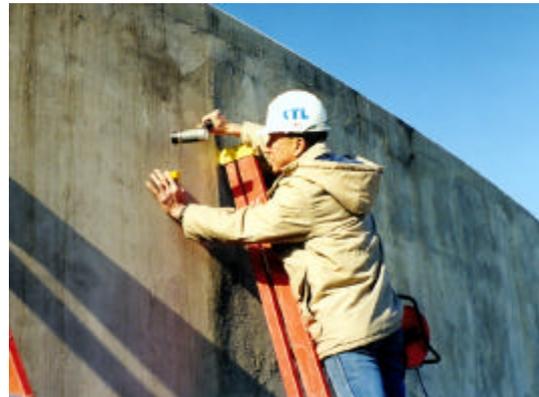
**7. Leakage in fluid-containment concrete tanks**

A 180 m circumference by 5 m high aeration tank showed water leakage at cold joints. s'MASH testing of the tank walls was used to locate and quantify the extent of any hidden poorly-consolidated pockets that could have an effect on the engineering performance of the structure. Those areas considered to have the lowest degree of concrete consolidation were located, and selected cores were taken. The s'MASH test responses showed minimal evidence of poor consolidation, with no significant areas of low density or honeycombing. Low-density patches were limited to superficial areas, particularly at the base of the tanks. All the cores taken at test points with the highest recorded values of the product of s'MASH slope x mobility showed sound concrete. It can be concluded from the s'MASH analysis that any areas of poor consolidation had already been identified at the tank surfaces.

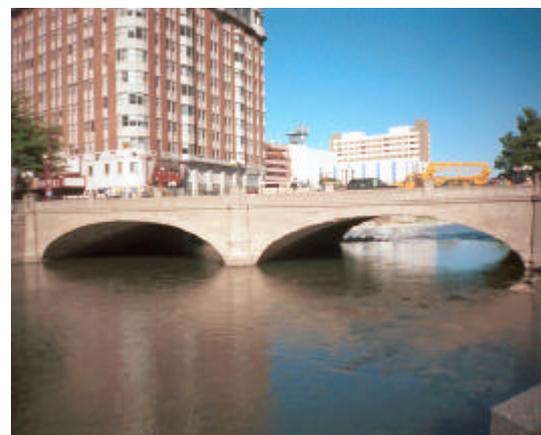
**8. Evaluation of old closed spandrel arch bridge**

The bridge was built in 1907, and the spandrel arches are approximately 25 m wide by 25 m long. Preliminary information suggested that the arches are approximately 1.1 m thick at the spring line, decreasing to 600 mm thick at the soffit, and that they are filled with soil to form the subgrade for the flexible paving bridge deck. The concrete in the piers had been placed in wooden forms in approximately 300 mm lifts. The undersides of the arches showed spalling of concrete in places, particularly along construction joints in the bridge alignment, and in zones along the water line. Water was seeping through these spalled zones, presumably from the soil fill below the deck. The three s'MASH parameters of mobility, dynamic stiffness and mobility slope revealed areas of poor compaction and honeycombing, as well as delamination of the surface concrete around the reinforcement. The condition of the concrete in the arches was shown to be good, given the age of the structure, and the core compression strengths were lower than normally encountered.

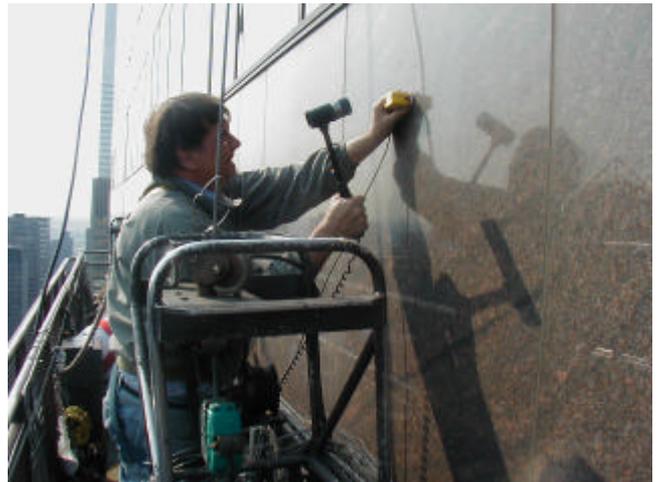
**9. Evaluation of the anchor quality of granite panels.**

The granite panels had been fastened to the steel frame by means of 6-8 epoxy anchors. Holes had been drilled into the panels to half depth of the thickness, the anchors epoxied in the holes and subsequently fastened to the steel frame.

By means of the dynamic stiffness and the average mobility the s'MASH classified the panels in three groups: loose panels, panels without regular anchoring and well-fastened panels.

The test results were confirmed subsequently by visual inspection of the anchors from the inside of the building.
