NDTitans in action

Repair monitoring of cracked concrete industrial floor with s'MASH Impulse-Response & DOcter Impact-Echo

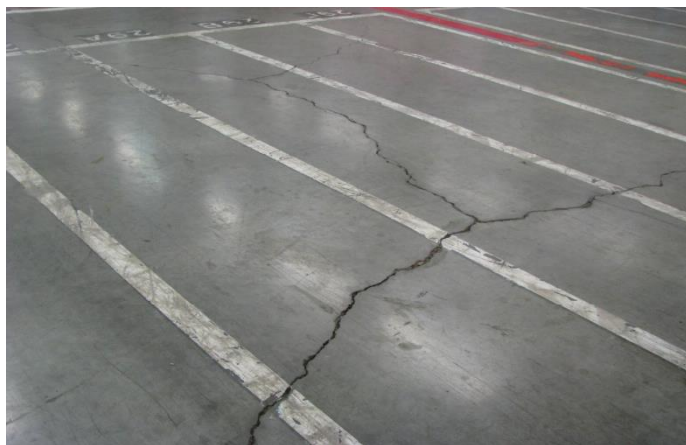
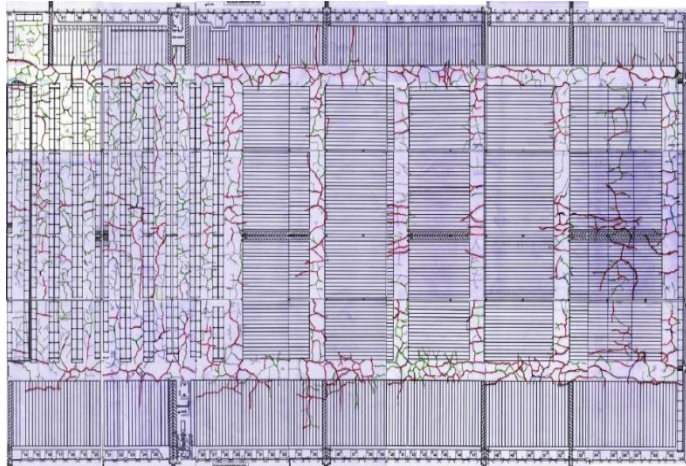
The entire concrete floor of a 36,000 m² warehouse, built in 2005 in Athens, Greece, suffered from extensive cracking. It was designed with a C25/30 class concrete with 40 kg/m³ of steel fiber content and it would be supposed to be 18 cm thick.

It was documented that curling of the slabs' corners occurred and that the first cracks developed a short time after the construction. Progressively, more cracks were appearing by the stresses produced by the forklift traffic of the plant's operation.

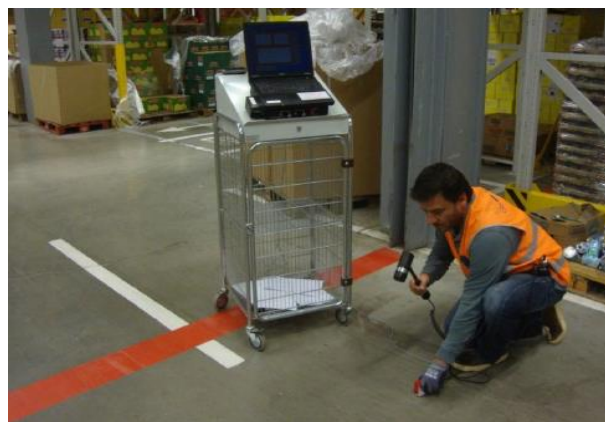
Then the **s'MASH Impulse-Response** system was used to quickly identify all the areas with bad support by evaluating the so called parameter "void index".

In general, an area with a value of void index higher than 2 was considered suspicious (red color areas on countour plots). After the testing, some cores from selected locations were taken to confirm the results and gaps below the slabs were clearly identified in all cases.

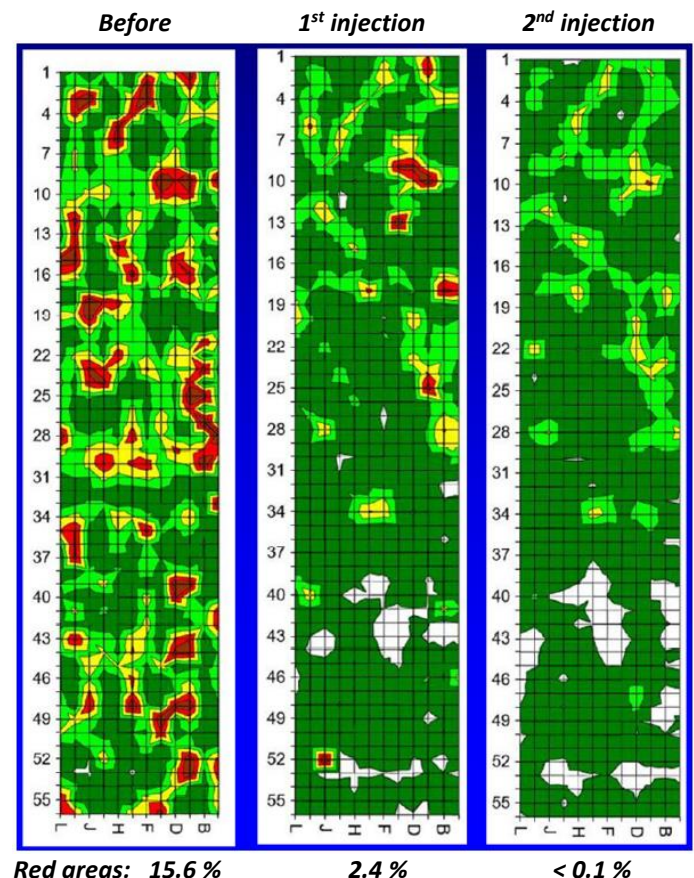
After the injection, the s'MASH Impulse-Response survey was repeated to evaluate the improvement of the void index values. In a second phase, the small areas that still showed a void index value higher than 2 were reinjected and reevaluated with the s'MASH system. The image below is an example of the results from one of the corridors that was part of the 36,000 m² successfully rehabilitated.
