Rapid non-destructive test method at the Taiwan High-Speed Rail project

by Allen G. Davis, Ph.D., D.Sc.
Construction Technology Laboratories, Inc

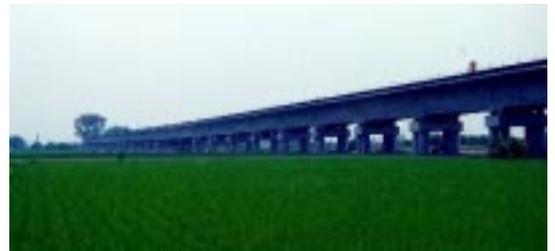
Fig. 1 General View of Elevated Girder Section

Figures 1 to 4 show general views of viaduct girder construction, as well as details of one of the post-tensioning systems used. Typical concreting deficiencies appeared on some girders in the early stages of construction (both precast and cast-in-place), primarily

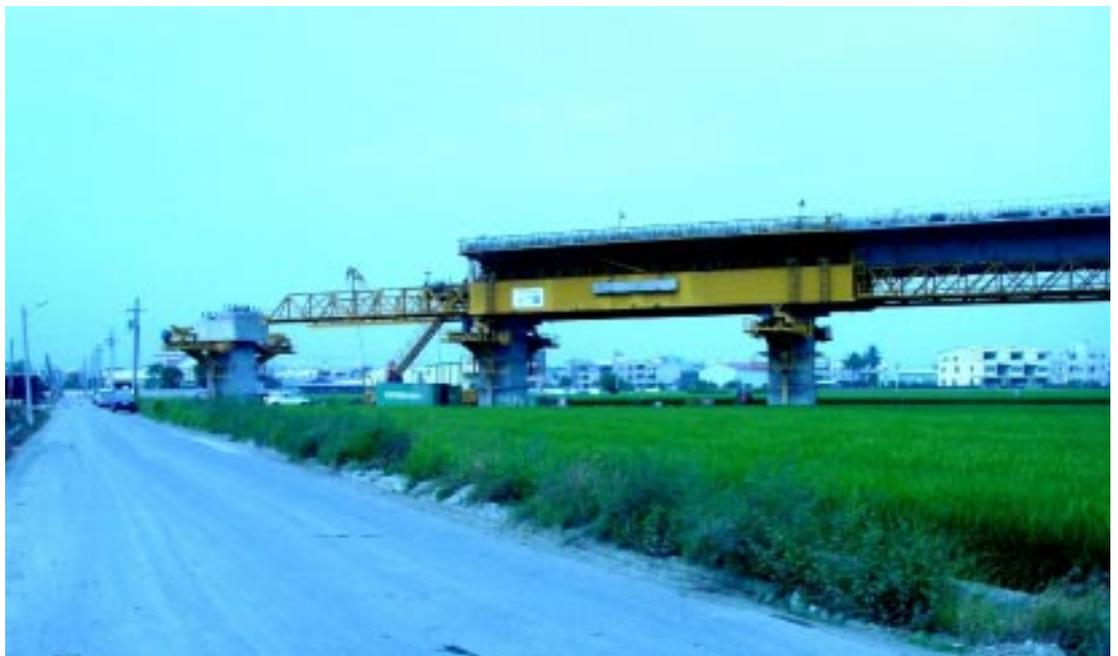
Fig. 2 Cast-in-Place Girders Under Construction.

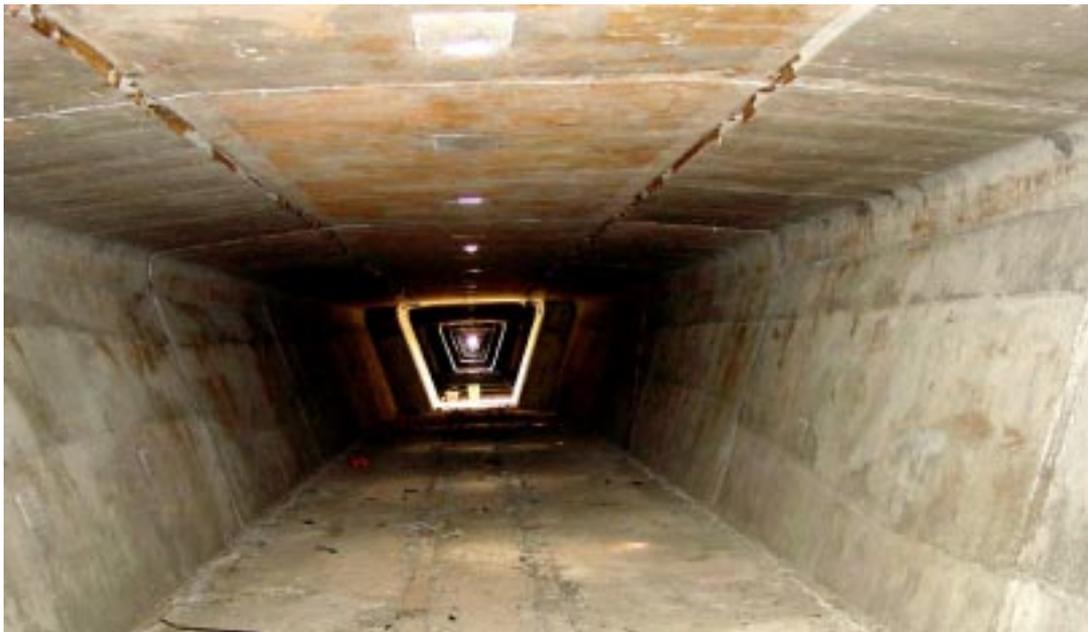
Fig. 3 Box Girder Internal View.

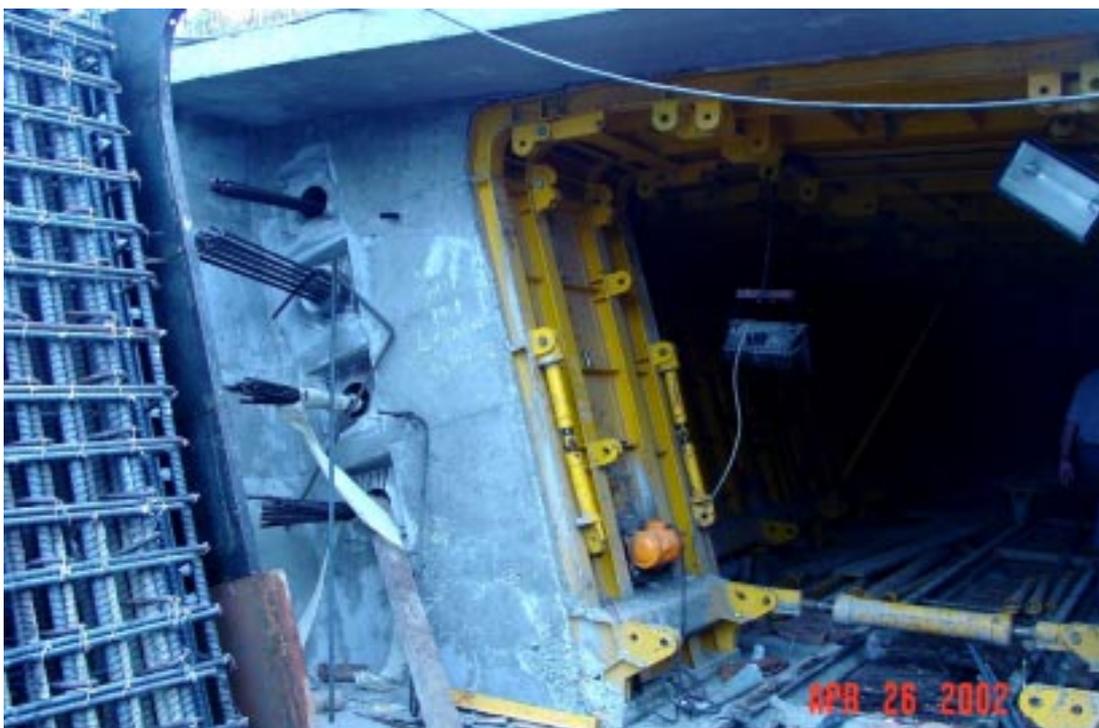
Fig. 4 Post-Tensioning Details at Diaphragm.

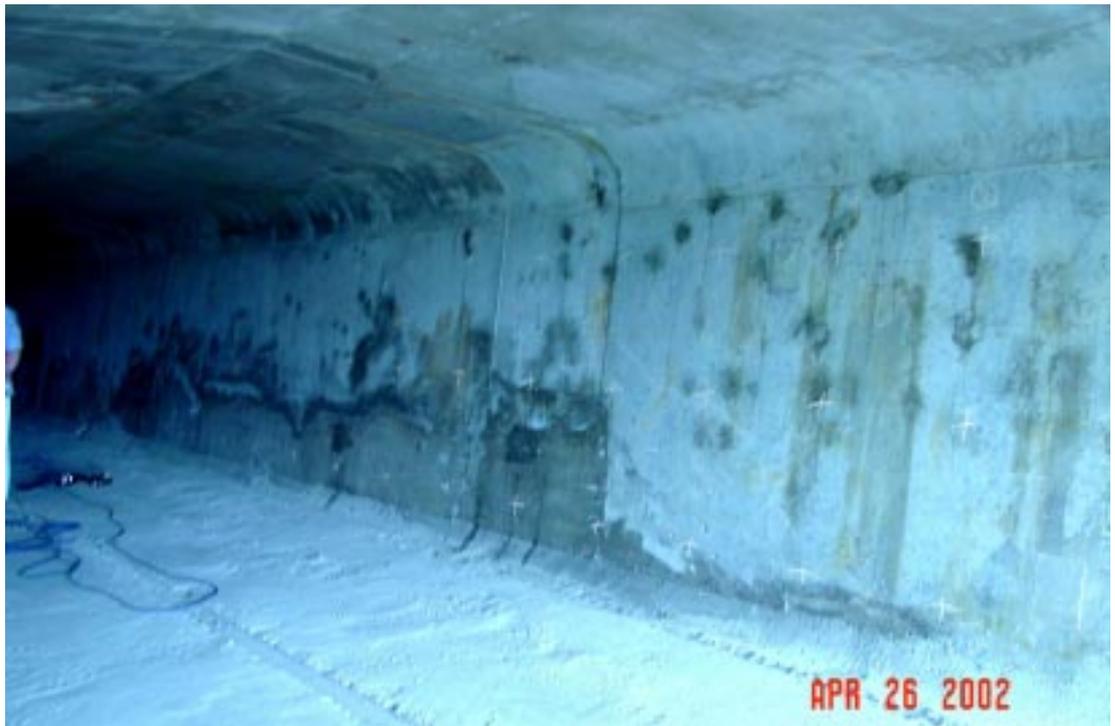
Fig. 5 Repair Patching.

bedded reinforcement, debris present in the body of the concrete, and questionable concrete repairs (Figure 5). Incomplete consolidation of concrete resulted in areas of segregation, honeycombing, and voids. Large quantities of steel reinforcement at girder end diaphragms, plus box girder webs with either large-

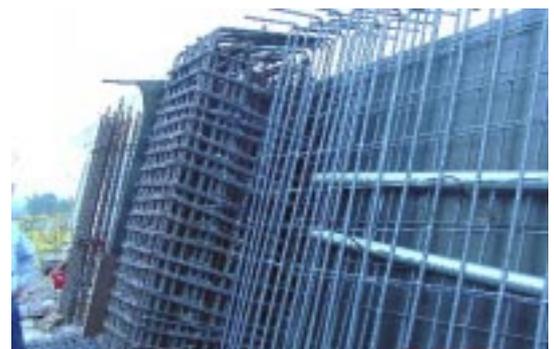
Fig. 6 Density of Steel Reinforcement.

- CTL's experience on other similar projects had shown that the IR method could detect the nature and quantifies the severity of defects typically observed in these girders (e.g., poor concrete consolidation, voids, and repair patch debonding).
- The close spacing of reinforcing steel in the girders (*Figure 6*) ruled out other non-destructive methods.
- The IR test can rapidly cover the large areas to be tested.
- A trained engineer can quickly assess the test results onsite. Test results are obtained by a field computer and processed immediately.

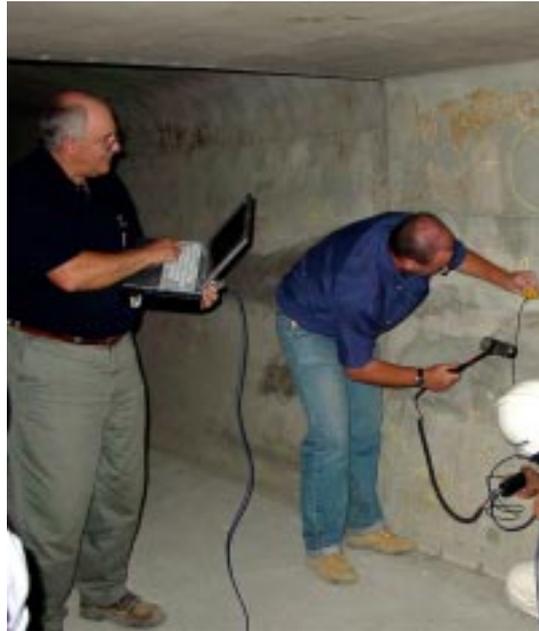
Fig. 7 Impulse Response Equipment.

The IR test is also used to assess the quality of deep foundation construction, where it is more commonly known as a bored pile integrity test (Ref. 1). The method applied to concrete structures has been developed relatively recently, and is fully described in Reference 2. A low-strain impact is used to send stress waves through the tested element. The impactor is usually a 1-kg sledgehammer with a load cell built into the hammerhead.

The maximum compressive stress at the impact point in concrete is directly related to the elastic properties of the hammer tip. Response to the input stress is normally measured using a velocity transducer (geophone). Both the hammer and the geophone are linked to a portable field computer that acquires and stores data (Figure 7). Both the time records for the hammer force and the geophone velocity response are processed in the field computer using the Fast Fourier Transform (FFT) algorithm.

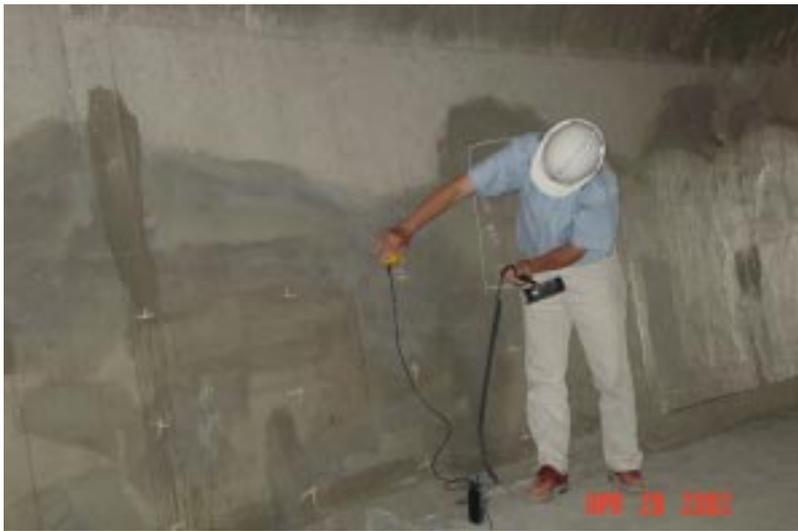
Fig. 9 IR Test on Girder Web.

Figure 9 shows an IR test being performed inside a girder web. The demonstration project included IR testing on girders in three separate contract sections; two with cast-in-place and one with precast construction techniques. Any visible surface concrete deficiencies had been cleaned and patched prior to testing.

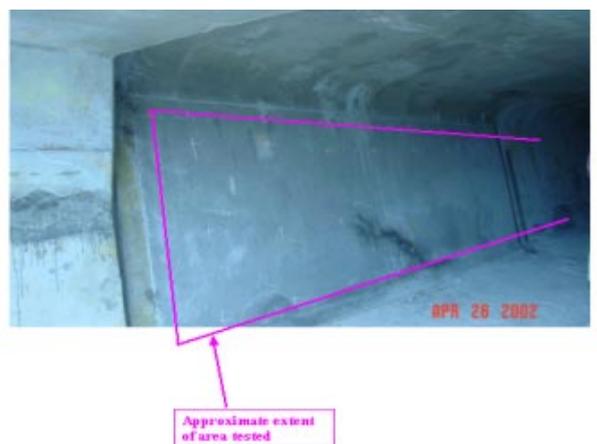
Fig 10.

Figures 10 to 13 are IR test contour plots adjacent to photographs of the tested areas in the plots. Figure 10 (B-1a) shows a patched area with no concrete deficiencies; however, the increasing mobility values from right to left indicate the web thickness decreasing from 750 mm to 500 mm.
