Construction and Building Materials

Inspection, evaluation and repair monitoring of cracked concrete floor using NDT methods

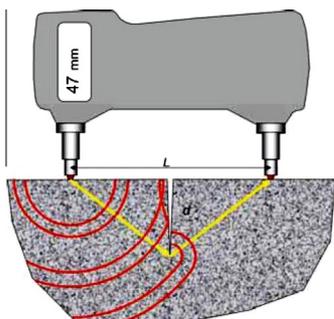
Fig. 1. Crack depth measurement using ultrasonic pulse velocity measurements (www.germann.org).

where d = crack depth, L = distance between transmitter and receiver. For the measurements, the PUNDIT ultrasonic equipment from PROSEQ company and portable Surfer's from ACS company were used. (Fig. 1). The measurements were calibrated by concrete cores cutting.

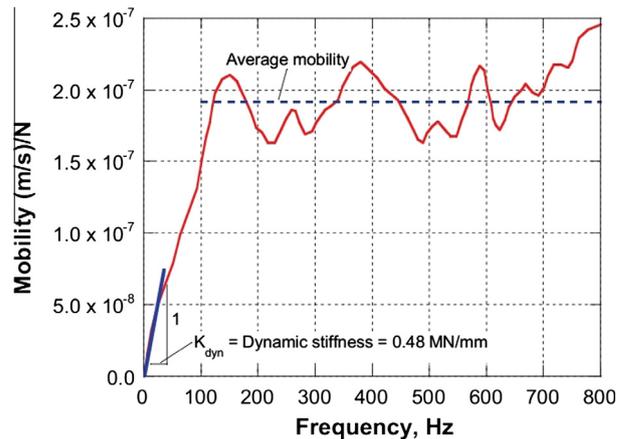
Fig. 2a. Mobility diagram and the used parameters.

The parameters of the mobility diagram (Fig. 2a) used for assessing integrity are:

- The dynamic stiffness, the inverse of the initial slope of the mobility spectrum from 0 to 40 Hz, expressed in units of N/m.
- The average mobility (lined bar).
- The mobility slope between 100 and 800 Hz.
- The voids index (the ratio between the width of the initial maximum mobility to the value of the average mobility).

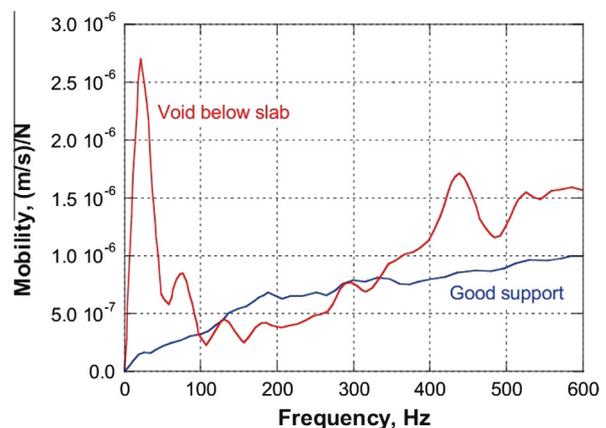
Fig. 2b. Mobility diagram for ground floor with and without void.

An example is shown in Fig. 2b which compares the mobility of a ground floor with the existence of a void underneath and the mobility of a solid ground floor [5].

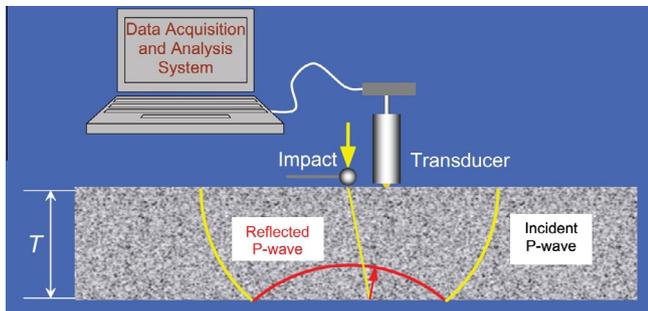
Fig. 3. Operating principle of the Impact-Echo method.

The DOCTer system from GERMANN INSTRUMENTS company and the layout shown in Fig. 3 was used for the measurements.

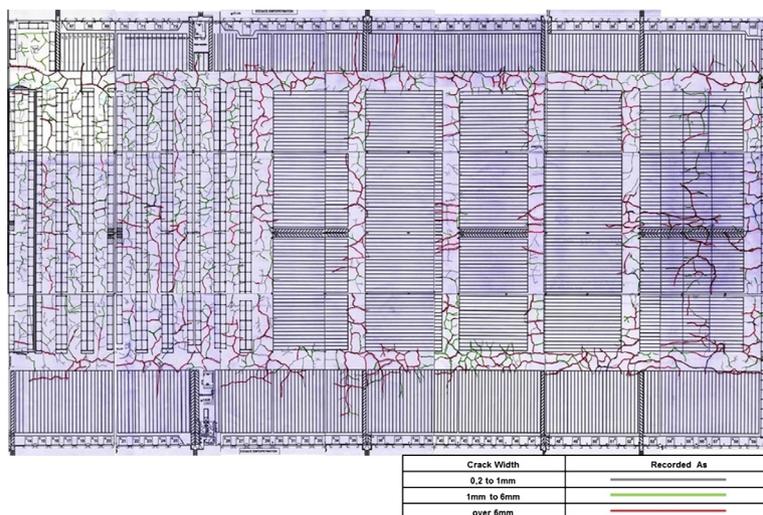
After the recording of the appearing cracks (as shown in Fig. 4), crack depth measurements were carried out using ultrasonic pulse velocity measurements for cracks of various surface width, in different parts of the floor of the warehouse. Furthermore, to calibrate the measurements concrete cores were cut off to measure the actual depth to which the cracks extend. From the instrument calibration it was shown that the measurements taken from instrument appear to be approx. 20% higher than the actual depth of cracks, due to the fact that the cracks that were measured, were not strictly perpendicular to the surface and the existence of neighboring micro-cracks that had further reduced the speed of the ultrasonic pulse. Indicatively, some crack depth measurements are presented in Table 1.

Fig. 4. Main area of the warehouse (around 25,000 m² divided into 21 slabs) with recorded cracks.

The deterioration of the floor's condition was due to a combination of different decaying processes. The initiation of cracks was due to shrinkage cracking of the early age concrete at the time of manufacturing. These cracks – and more likely new ones – propagated by extensive bending moments due to the reduced thickness and the locally un-compacted base. As the plate was deformed and cracked by bending the gaps between the plate and the substrate were increased leading to further instability, which extended the appearance of cracks due to improper seating of the plate. Based

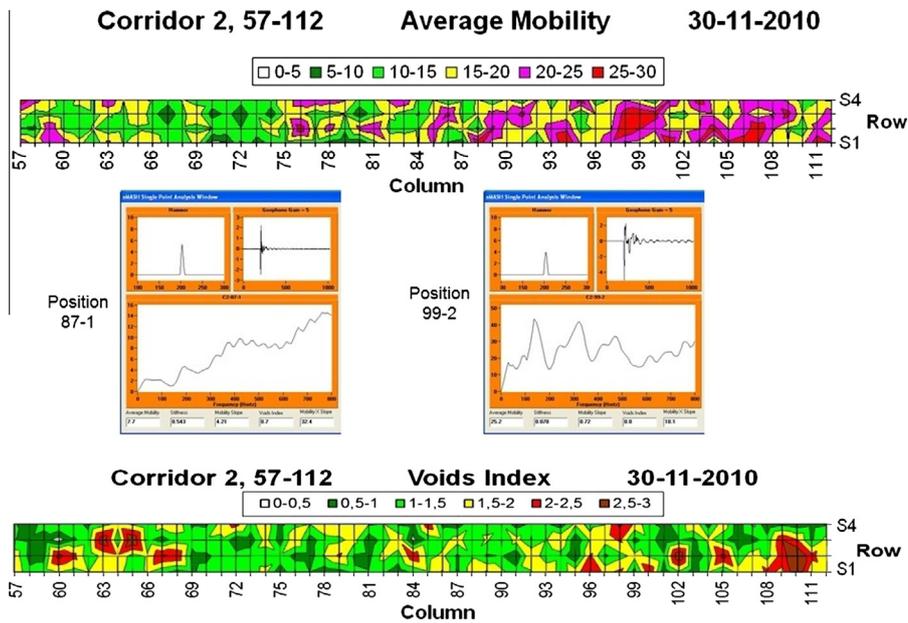
In areas with very high average mobility values (over 25) and displayed as red color in the diagram, there is reduced thickness of concrete (less than 15 cm) and internal discontinuities.

In areas with high average mobility values (15–25) and displayed in red, there is reduced concrete thickness (15–17 cm),

Areas with high rates voids index (greater than 2.5), show a gap between concrete and substrate in the order of 2 mm or more that was confirmed by core sampling.

Indicative results are presented from two corridors (Figs. 5 and 6) and the waveforms of indicative characteristic points. As an example, the difference in voids index (the ratio between the width of the initial maximum mobility to the value of the average mobility) is clearly seen comparing the waveforms of position 4-2 over a confirmed void and position 12-2 which was quite healthy, in Fig. 6.

Fig. 5. Average mobility and voids index results (corridor 2).

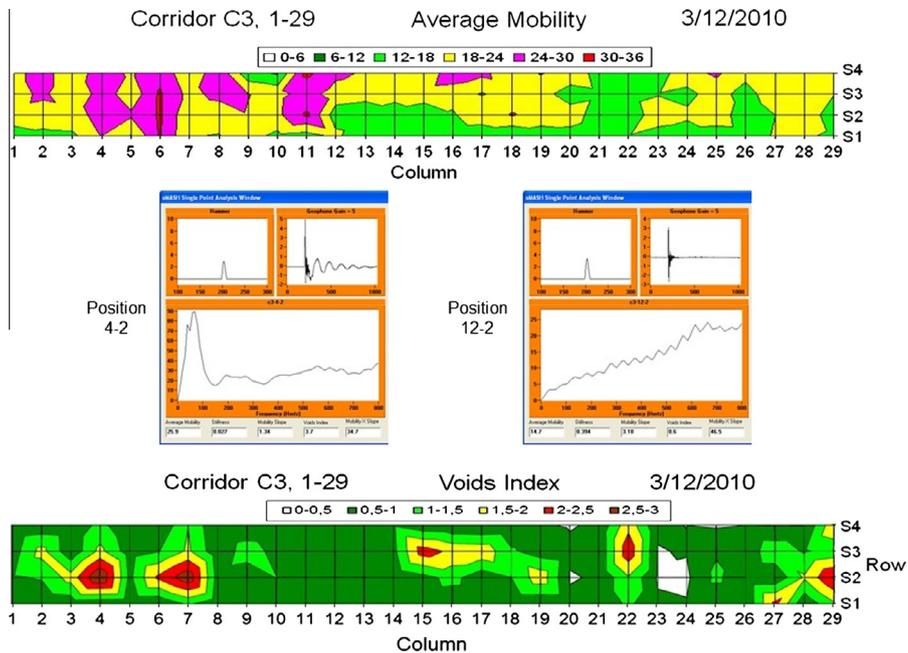
Fig. 6. Average mobility and voids index results (corridor 3).

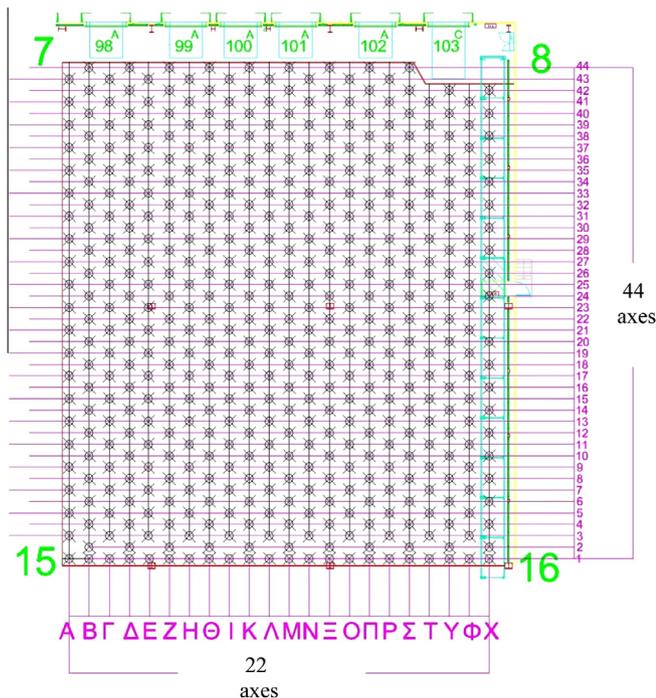
Fig. 7. Injection (points) and Impulse-Response testing (points and line junctions) grid.

The injections were executed in a grid that was designed for this purpose (Fig. 7) and were monitored using the Impulse-Response method. Specifically, a triangular grid was designed, with side dimension of 1.60 m and holes of 26 mm diameter were drilled up to a depth of around 20–22 cm. The reference point was the point A1, which was placed at a distance of 0.5 m from each joint and the injecting grid, as well as the Impulse-Response method testing grid were based on that.

The primary grid was designed prior to the execution of the repair works and was dependent on standard positions of the slab, in order to secure the same grid for the holes and the test positions with the impulse-response method. The drilling and testing positions were marked on the floor. The secondary grid was designed on site to treat areas that appeared to still have voids. The secondary grid was dependent to the holes of the primary grid at certain areas.

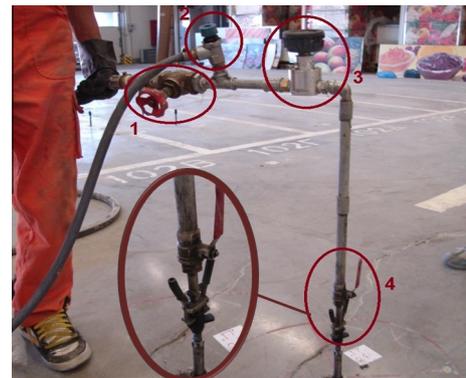
Fig. 8. Grout injection nozzle.

The nozzle that was used for injecting the grout was designed and assembled to facilitate the operator and to be safe against the development of high pressure. It was equipped, as shown below, to supply a control valve (1), a 3 bar mechanical valve (2), an oil pressure gauge (3) and a special nozzle connector (4) with the grout intake system in the floor (packers and tappers, detail, Fig. 8). The intake system consisted of metal packers and plastic tappers from the German company Desoi. The packers' dimensions were $\varnothing 25 \times 200$ mm, with a free-flow diameter of $\varnothing 9$ mm.

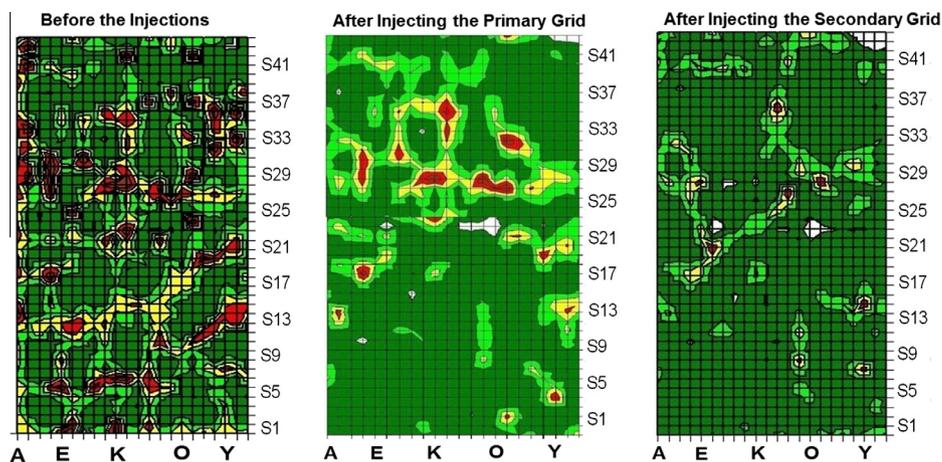
Fig. 9. Graph presentation of voids index results from the inspections of the repair using the Impulse-Response method.

The holes that were injected were 484 in the primary grid and 232 in the secondary grid. The results of the inspection with the Impulse-Response method are presented in Fig. 9 and in Table 3. It has to be noted that in a total of 968 positions that were tested in the three inspections, before the grout injections 28.62% (277 spots) had voids index over 1.5 and after completing the injection in the secondary grid only 4.85% (47 spots) had voids index over 1.5.

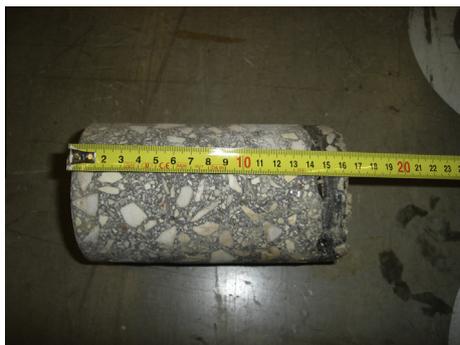
Fig. 10. Concrete core, cut off after the grout injections, with visible grout attachment on the bottom side.

After the end of the works, the results of the Impulse-Response method were verified by cutting concrete cores at test positions that had a voids index value over 1.5 that was lowered after the injection, as shown in Fig. 10.
