EVALUATION OF HISTORIC REINFORCED CONCRETE BRIDGES

By Allen G. Davis¹, Carlton A. Olson² and Kevin A. Michols³

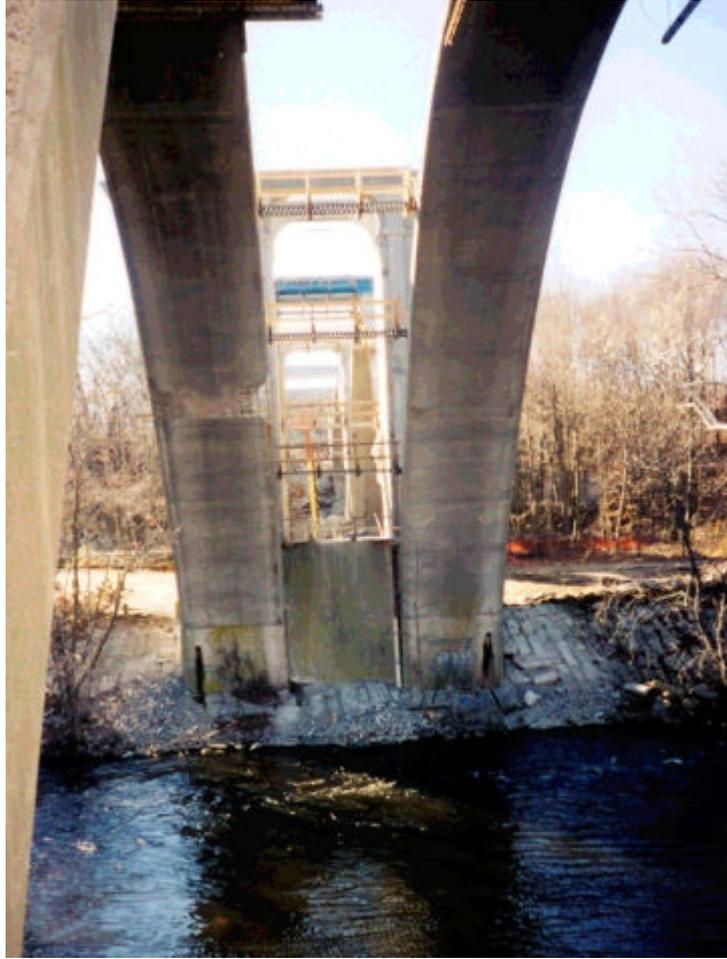
Figure 5. Rhode Island Arches

This bridge consists of two approach spans and five arched spans. Each arched span includes a north and south arch. The arches are cast-in-place reinforced concrete structures built between 1934 and 1936. Center-span arches measure approximately 18-m (60-ft) high and span 48 m (160 ft) across the river below. The bridge deck was considered to be too deteriorated to be saved, and was removed for reconstruction (see Figure 5). Areas of low quality concrete were reportedly detected on the center span arches during bridge rehabilitation work. Coring in several locations indicated that the low quality or damaged concrete areas were not all readily visible. Selected areas of the arch had been removed for patching, and some of the removed areas had been filled while others remained open. The NDT survey described here was intended to evaluate the location and the extent of cracking, delamination, as well as areas of freeze-thaw deterioration and poor consolidation.

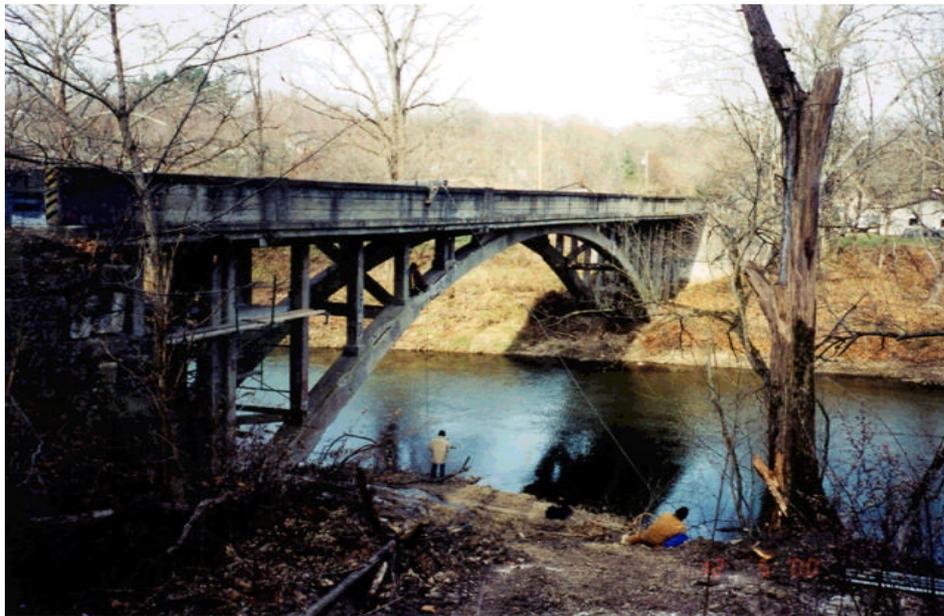
Figure 8. Putnam County Bridge

This open spandrel single-arch bridge was completed in 1929 and appeared on the surface to be in very bad condition (Figure 8). The bridge consisted of two short approaches and one 39-m (127 ft) span with a bridge width of 5.5-m (18-ft). However, IR testing along both spandrel arch beams revealed that the interior of the beams were in relatively sound condition, with good concrete consolidation and little cracking. Most of the damage had occurred because water draining through the deck beam expansion joints flowed down the arches, resulting in freeze-thaw activity in the cover concrete, followed by limited reinforcing

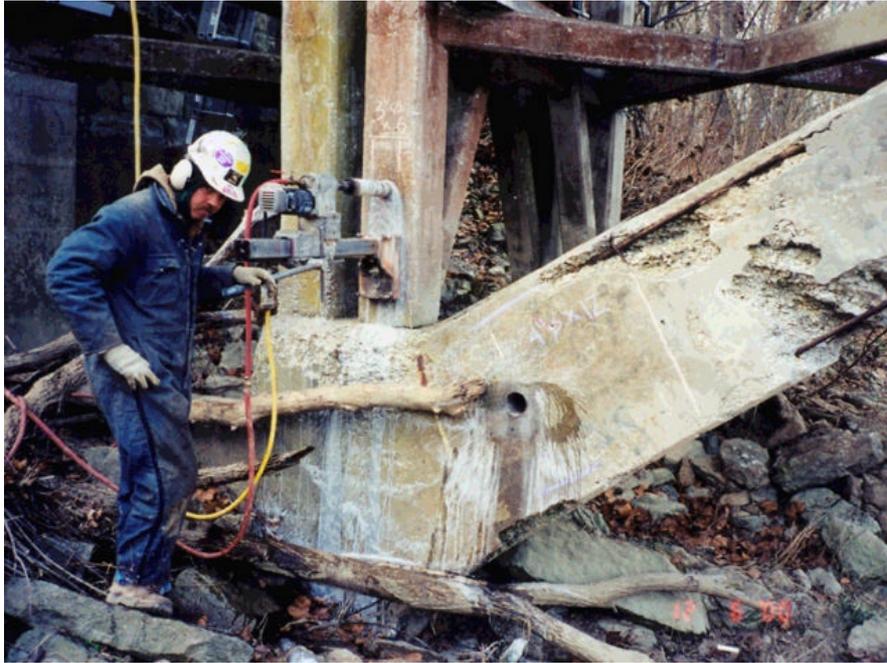
Figure 9. Coring Operation

corrosion. Occasionally, the IR tests revealed zones with high average mobility and mobility slope. Core locations were selected as a result, and Figure 9 shows a core location in what appears to be sound concrete at the surface. Figure 10, however, reveals that the concrete in the core hole is poorly consolidated, as indicated by the IR tests. The positive conclusion about the concrete quality in the body of the arches could not have been reached based on visual and invasive testing alone.

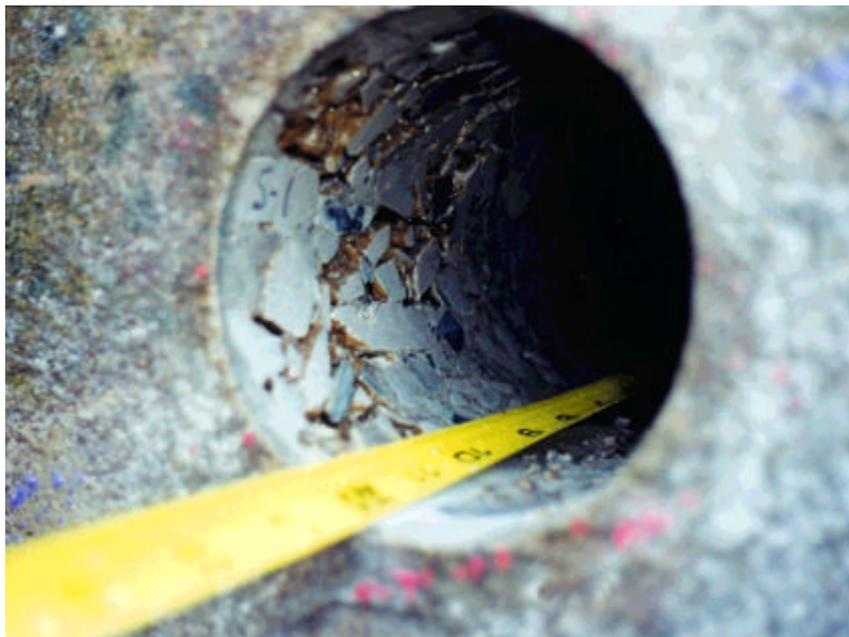
Figure 10. View inside core hole showing poor consolidation
