The nondestructive impulse response test in North America: 1985–2001

Allen G. Davis*

Construction Technology Laboratories, Inc., 5400 Old Orchard Road, Skokie, IL 60077-1030, USA

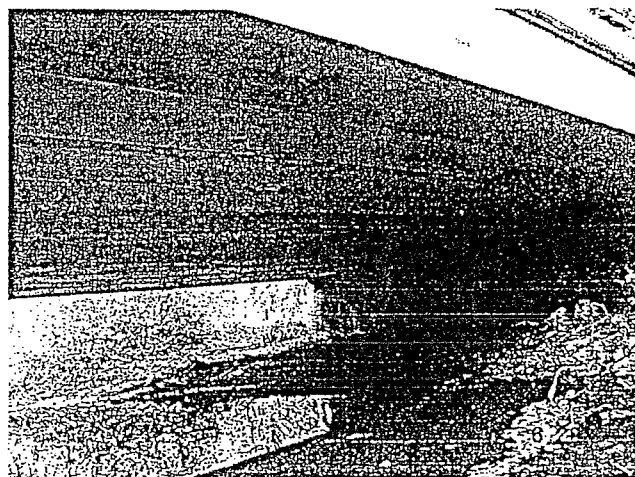
Fig. 12. Underside of bridge in Fig. 11.

Each hollow core beam is usually between 20 and 30 m long and 900 mm wide (Fig. 12). IR testing was performed on one of these bridges through a 100 mm thick concrete overlay, with much greater mobility and lower stiffness on one half of the bridge (Fig. 13). In the half of the bridge with higher stiffness the transverse rod system is functioning as designed. However, in the other half of the bridge the opposite is true; either the transverse rod system was not properly installed or not present. It was reported that during recent renovation of the bridge, the repair crew had problems with one of the rods. IR testing showed the ability of the method to detect changes within the bridge, such as a loss in functionality of the transverse rod system. This loss can be detrimental to the bridge load carrying capacity. The speed of IR testing makes it a valuable tool for testing bridges of this type.

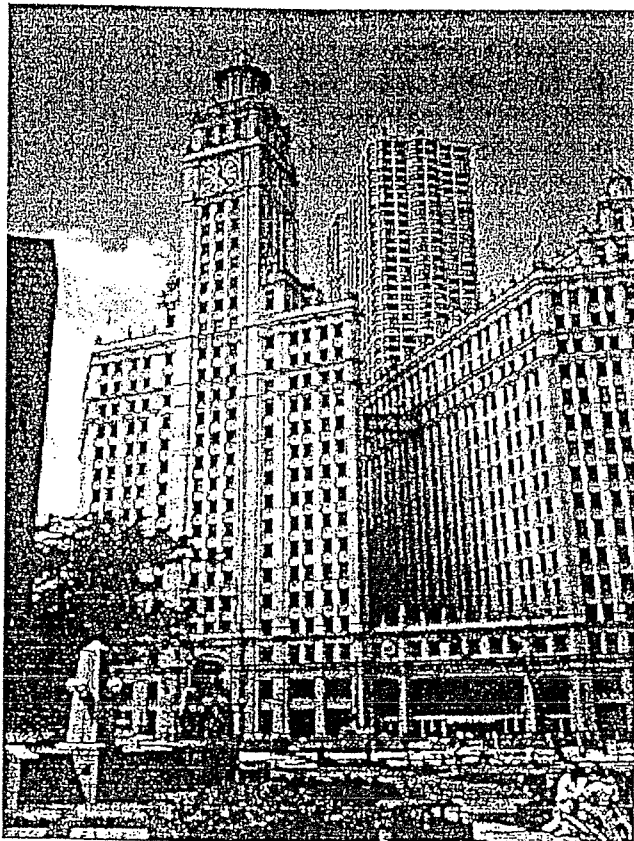
Fig. 16. Wrigley building, Chicago.

Vertical cracking distress was observed in terra cotta clad steel column covers and mullions on the Wrigley Building, Chicago (Fig. 16), constructed in 1926. IR tests were conducted from the fourth to the 13th floor. The tested columns and mullions were representative of similar elements around the entire perimeter of the building where the problem of vertical splitting or cracking of the terra cotta cladding was confirmed. IR detected features such as debonding of units from their supporting masonry, and nonvisible internal delamination or splitting within the terra cotta. The stiffness recorded for each terra cotta unit was plotted versus the position or height of the unit from the fourth floor upward (Fig. 17). For the column cover, the residual stiffness measurements indicated very strong concentrations of high compressive stress directly above and below the position of the steel shelf angles supporting the terra cotta at each floor line.
