Case EC-1. Strength testing at the “Hestetorvet” slab in Roskilde, Denmark. Development of the CAPO-TEST

Hestetorvet, Roskilde, Denmark

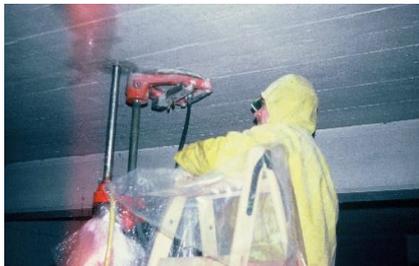
We drilled from below of the slab, 80 cm thick, to ~28 mm from the surface.

Broke the core and drilled a center hole, 8 mm in diameter, planed the surfaces for a 25 mm distance, inserted a LOK-TEST disc from below and threaded it into a pull bolt from above, connected to the LOK-TEST pull machine. Tested to failure and got 28 kN as the pull force. One test lasted 1 day.

LOK-TEST
after coring from
below

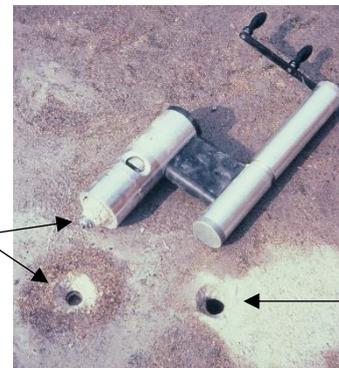
We went back to the slab, cored a hole, planed the surface, recessed the groove, inserted the compressed ring on the expansion tool, expanded the ring to full insertion in the groove, and loaded the ring to failure of the concrete, similarly as with LOK-TEST.

First CAPO-TEST
in the world,
1974

It worked! And one test only lasted 20 minutes.

On 6 tests we got pullout forced ranging between 25 kN and 30 kN, averaging 27.0 kN (equiv. to 27.7 MPa cylinder strength based on the general correlation).

Asking Professor Mogens Peter Nielsen what he wanted to use the test results for, he answered: “The shear capacity of the slab is low due to corrosion of reinforcement. However, the slab has a lot of concrete around it, making it act as an arch, that is why I want the strength at the top of the slab for calculations”.
