CONCRETE PAVEMENT JOINT DIAGNOSTICS USING ULTRASONIC TOMOGRAPHY

Paper submitted 1 August 2011 in consideration for
Transportation Research Board 91st Annual Meeting,
22-26 January 2012

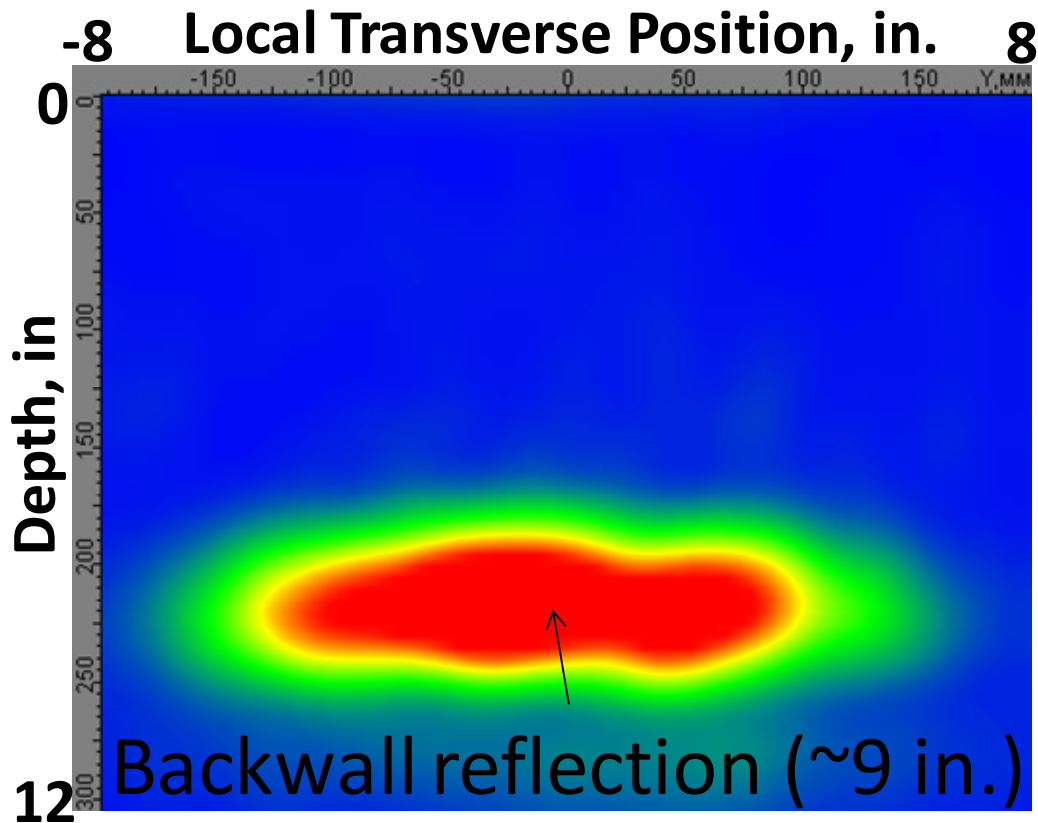
When evaluating SAFT B-scans, changes in acoustic impedance (affected by material stiffness changes) will cause a high intensity of reflection (red) associated with the location of the anomaly. This method can be used to detect debonding between concrete layers among other subsurface anomalies. Figure 2 shows the result of a MIRA scan taken at a full depth repair location. This example SAFT B-scan indicates little to no reflection (blue) until a high intensity of reflection (red) at a depth of approximately 9 in. (~225 mm) at the interface between the concrete and base material. This type of strong

“backwall” reflection at the depth of the concrete and base interface should be expected if there is no significant flaw in a single concrete layer.

Figure 2. Example B-scan taken at a full depth repair area showing a typical backwall reflection (red) at the interface between the base concrete and base at approximately 225 mm.

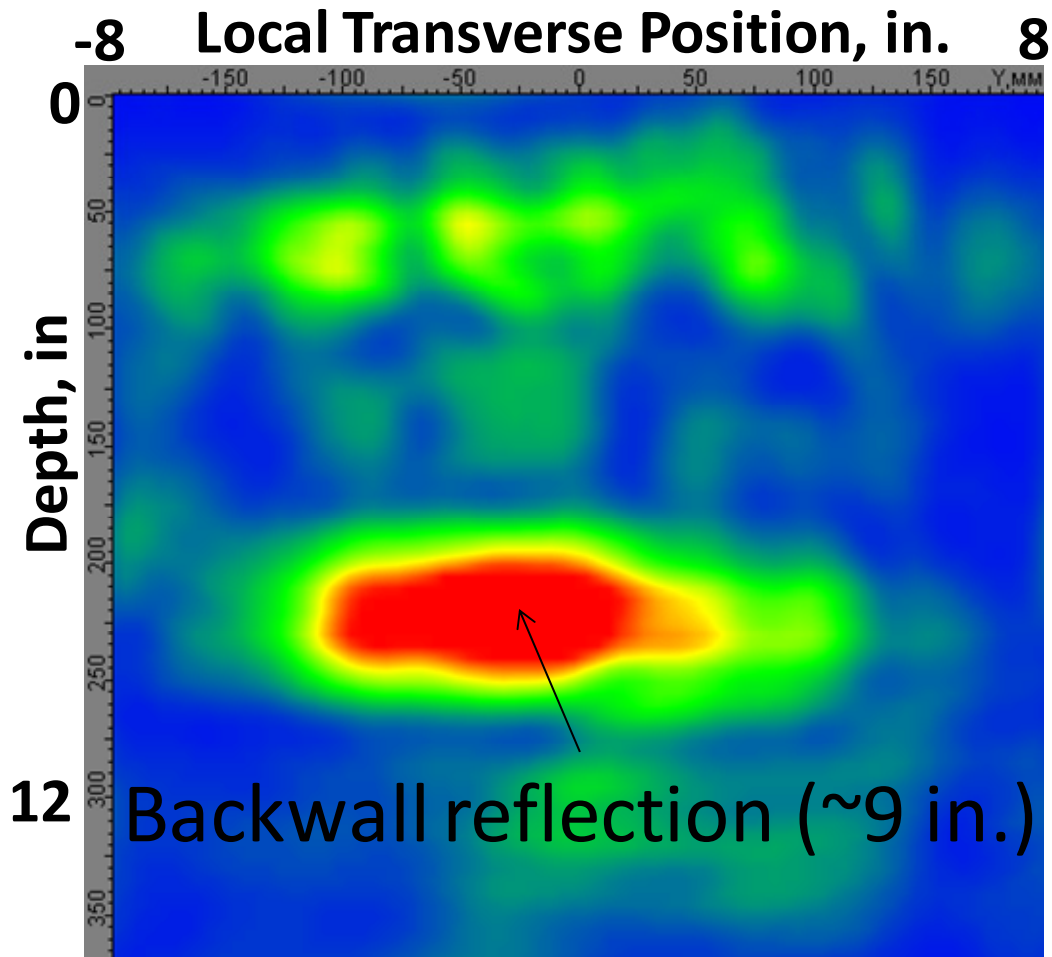
It is important to note that this signal is much cleaner (blue with little to no green, yellow, or red at depths above the backwall reflection) than that of even a properly bonded partial depth repair over existing concrete. Figure 3 shows an example B-scan taken at a properly bonded partial depth repair location showing a typical backwall reflection at the interface between the concrete and base as well as some additional lower intensity reflection at shallower depths where the new and old concrete interface is located. These lower intensity reflections are caused by the presence of two different concrete layers with slightly different acoustic impedance as well as coarse aggregate. This was determined through the consistent appearance of moderate intensity reflections in B-scans at the depth of the repair material layer, even in cases where cores verified a proper bond.

Figure 3. Example B-scan taken at a partial depth repair location where no metal reinforcements are present.

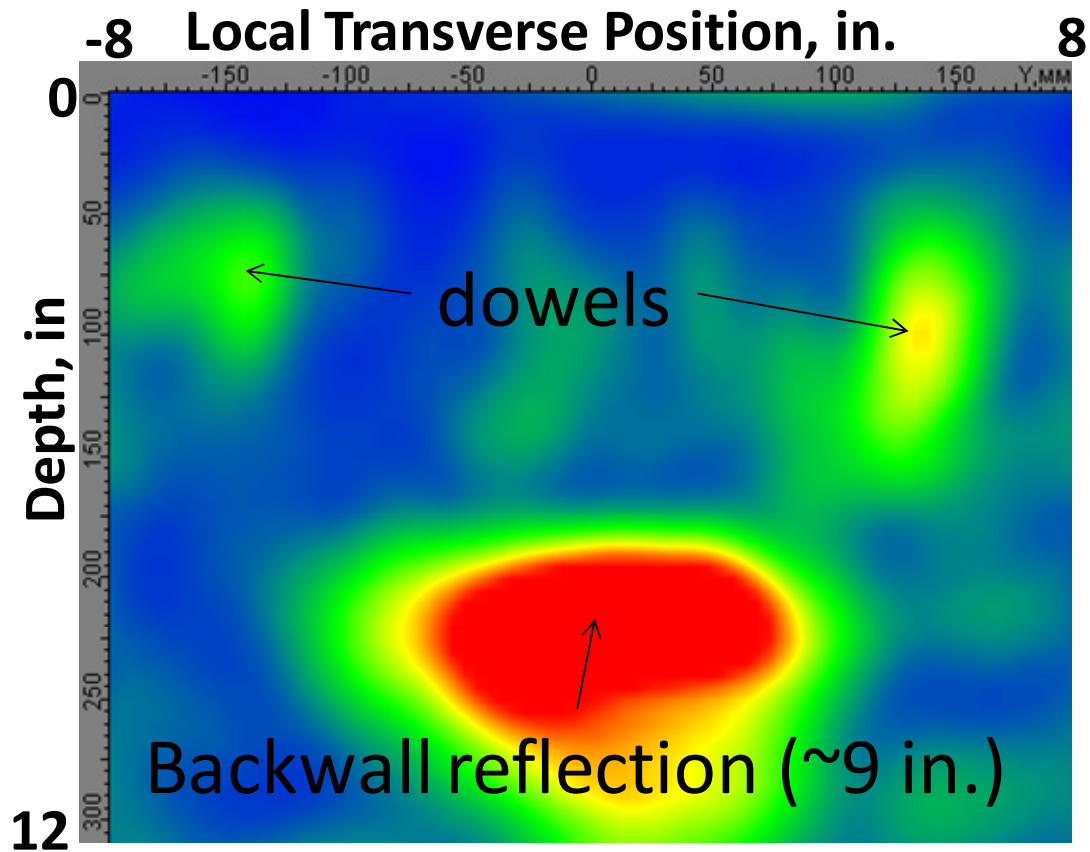
Metal inclusions can also cause reflections of the shear waves. Figure 4 shows an example scan taken at transverse joint indicating the presence of dowels. The high intensity reflections near 4 in. (~100 mm) indicate the presence of dowels. However since the MIRA B-scan uses multiple measurement pairs, the presence of the backwall reflection between the concrete and base is still visible.

Figure 4. SAFT B-scan taken at a partial depth repair near a transverse joint where dowels are present.
