**STRUCTURAL MATERIALS TECHNOLOGY (SMT):  
NDE/NDT FOR HIGHWAYS AND BRIDGES 2004**

**Title:** Verification of concrete placement in post-tensioned bridge box girders using a rapid nondestructive test method.

**Authors:** Kevin Michols\*, Allen Davis\* and Claus Germann Petersen\*\*

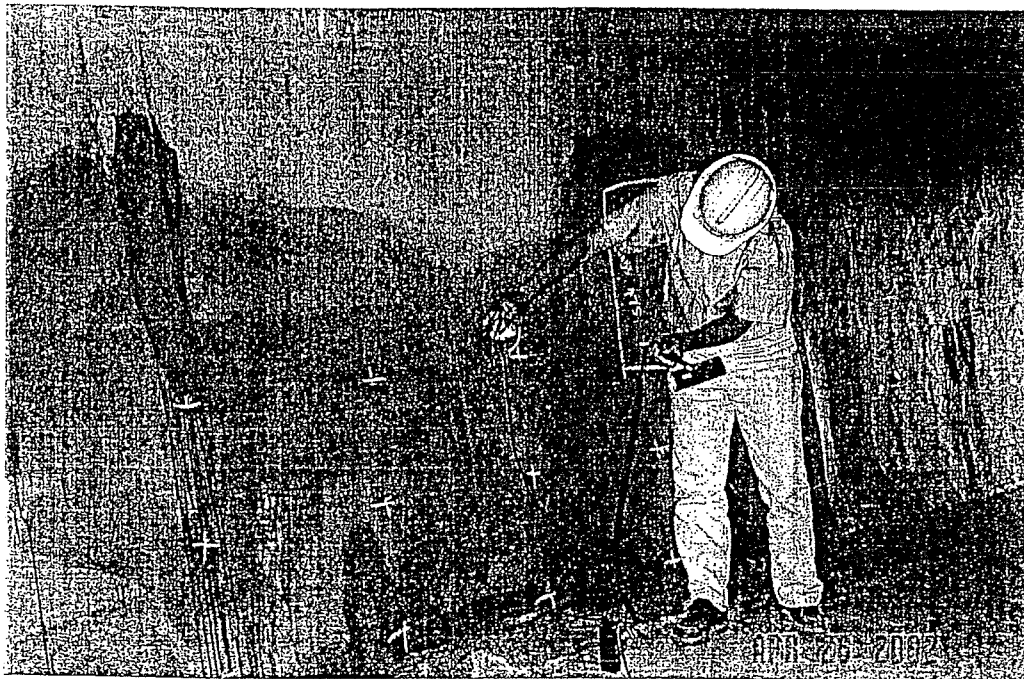
Fig. 4 IR Test on Girder Web

Figure 4 shows an IR test being performed inside a girder web, producing test results as in Figure 5. The demonstration project included IR testing on girders in three separate contract sections; two with cast-in-place and one with precast construction techniques. The contractors had made concrete patch repairs to areas with visible honeycomb surface deficiencies prior to our arrival

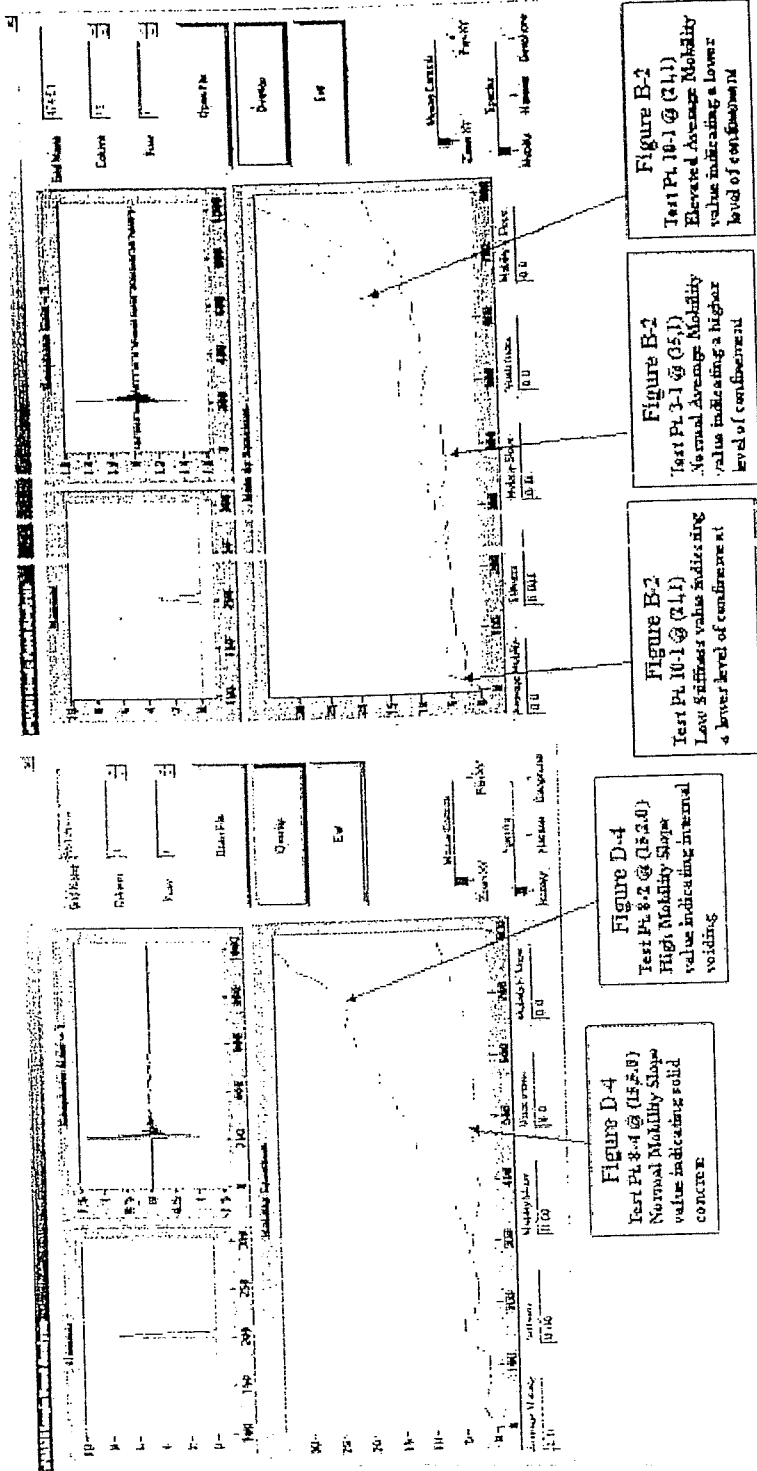
Fig. 5 Examples of IR Test Output

The IR test was originally developed to assess the quality of deep foundation construction, where it is known more commonly as a drilled shaft integrity test (Ref. 1). The method as applied to concrete structures in general has been developed relatively recently, and is fully described in Reference 2. A low-strain impact is used to send stress waves through the tested element. The impactor is usually a 2-lb sledgehammer with a load cell built into the hammerhead. The maximum compressive stress at the impact point in concrete is directly related to the elastic properties of the hammer tip. Response to the input stress is normally measured using a velocity transducer (geophone). Both the hammer and the geophone are linked to a portable field computer that acquires and stores data. Both the time records for the hammer force and the geophone velocity response are processed in the field computer using the Fast Fourier Transform (FFT) algorithm. The resulting velocity spectrum is divided by the force spectrum to obtain a transfer function, referred to as the *mobility* of the element under test. The test graph of mobility plotted against frequency from 0 to 800 Hz contains information on the condition and the integrity of the concrete in the tested elements. Typical test outputs are given in Figure 5.

When the *mobility* of a sound concrete plate element (such as the web of a girder) is compared with that of concrete with voids or honeycombing, the latter shows increasing mobility with increasing frequency, whereas the former maintains a relatively constant mobility over the same frequency range. This IR parameter is referred to as the *mobility slope*. Figure 5 shows different values for mobility slope, and when this parameter >4, it indicates poor consolidation. The severity of internal voiding increases with increasing mobility slope. This applies to voiding within the original concrete, as well as voiding in or beneath repair patches. If repair patches are debonded or adhere poorly to the substrate, then the IR test shows an increase in a parameter referred to as the *voids ratio* (ratio of peak mobility from 0-100 Hz to the average mobility between 100 and 800 Hz). When the voids ratio exceeds 2, patch debonding is probable. At the same time, debonding reduces the *dynamic stiffness*. The *mobility* and *stiffness* of concrete with locked-in stresses (such as those created by prestressing/post-tensioning) are different from those for the same concrete with no applied stresses (such as repair patches after post-tensioning). The mobility is discernibly higher and the stiffness lower in the latter case.
