# NDTitans

*Test Right – Sleep Tight*

**NDTitans** is an international group of highly specialized, skilled and dedicated engineers, scientists and companies with many years of structural engineering and testing experience related to all aspects of concrete and reinforced concrete structures. The **NDTitans** are from Denmark, Finland, Poland, Greece, Ireland, India, Mexico, USA and Canada.

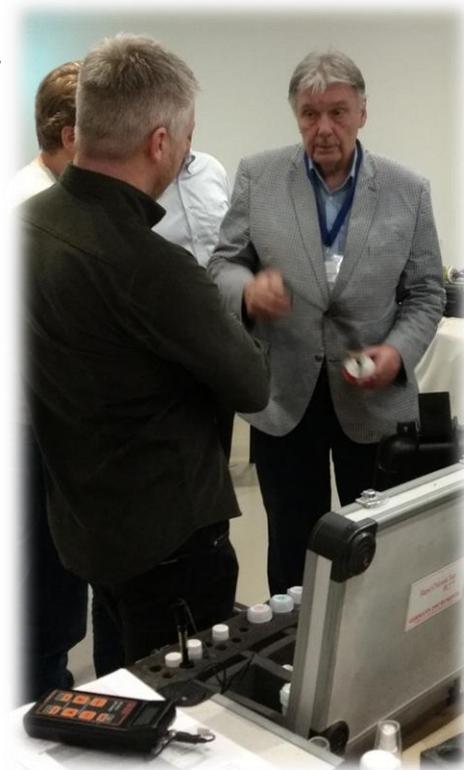
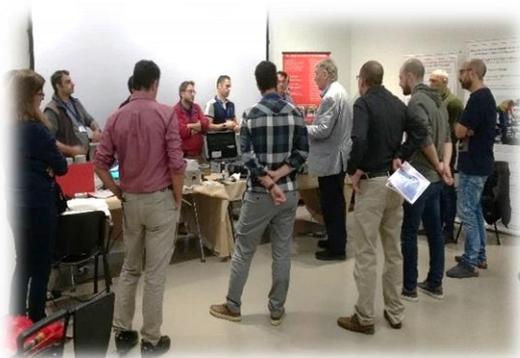
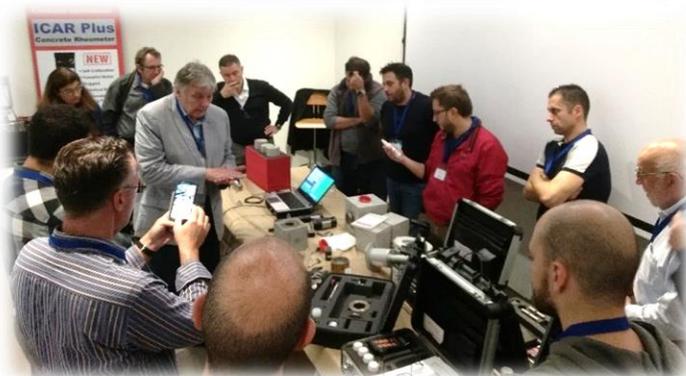
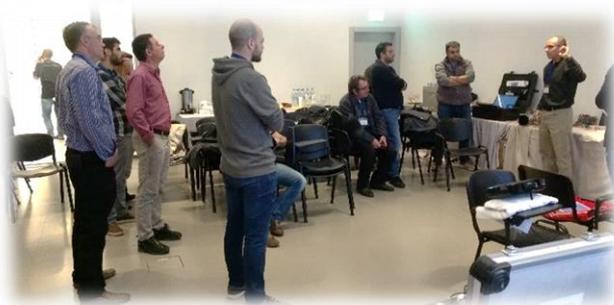
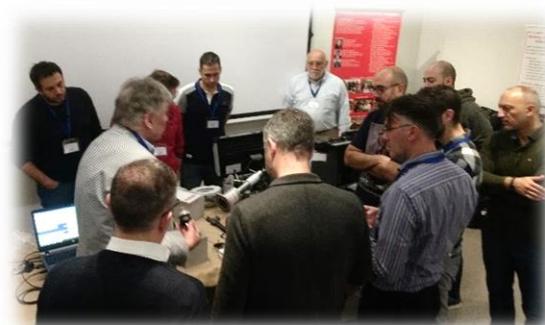
**Mr. Hugo D. Orozco** ran a test with the ICAR Plus on silicone oil to demonstrate the steps the device follows to measure the viscosity and the yield stress. After that, he used some samples of saturated concrete to demonstrate the Merlin (resistivity) and the GalvaPulse (Corrosion Potentials and Corrosion Rate).

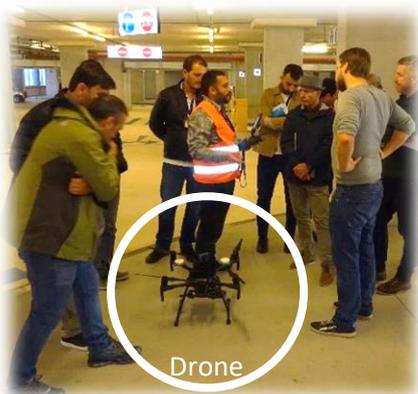
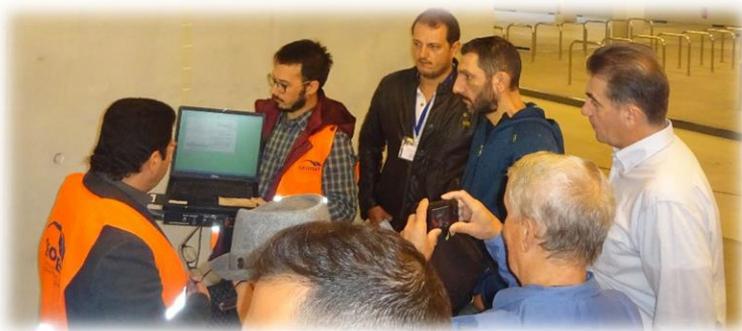
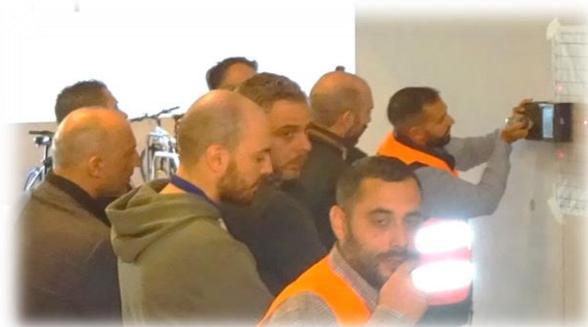
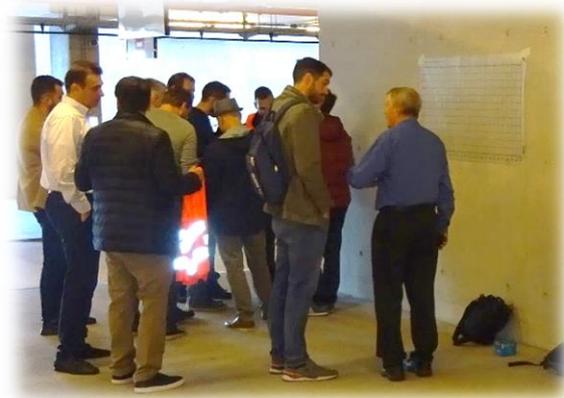
The demonstrations in the near-by parking garage started with a Drone for inspection of structures, the main topic by NDTTitan Mr. **Anastasios Gkatzamanis** lecture in the beginning of the workshop. After that, using a wall in the parking garage NDTTitan Mr. **Guy Rapaport** demonstrated the MIRA Tomographer, the DOCTer impact-echo and the s'MASH impulse response.

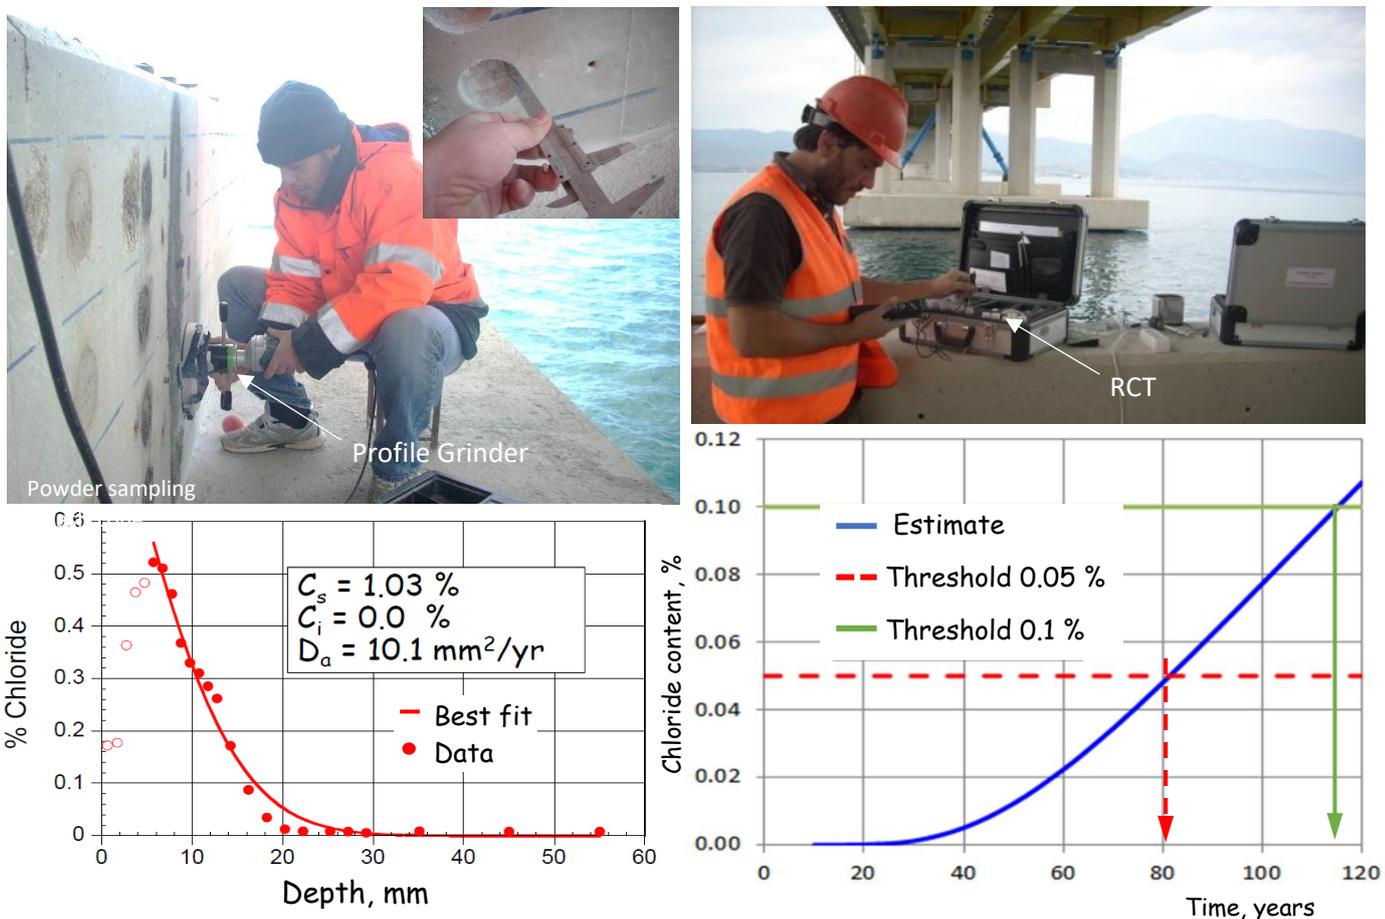
### Case A. Chloride Profiling and Service Life estimation of a Bridge in the Mediterranean Sea.

With the objective of estimating the remaining service life of the structure, testing for chlorides was done in a bridge in the Mediterranean Sea using the **Germann Instruments' RCT** (Rapid Chloride Test).

At the time of testing, the concrete under investigation had been exposed to the sea water for 5 years and the cover of the reinforcement was in average 80 mm.

Depending of many variables, the threshold chloride content at the depth of the reinforcement to initiate active corrosion is normally in the range of 0.05% to 0.1% (by weight of concrete). For a content of 0.05%, the remaining service life was calculated to be about 80 years. For a threshold level of 0.1 %, which might be a more reasonable value for saturated concrete, active corrosion was estimated to start at a time of 115 years.

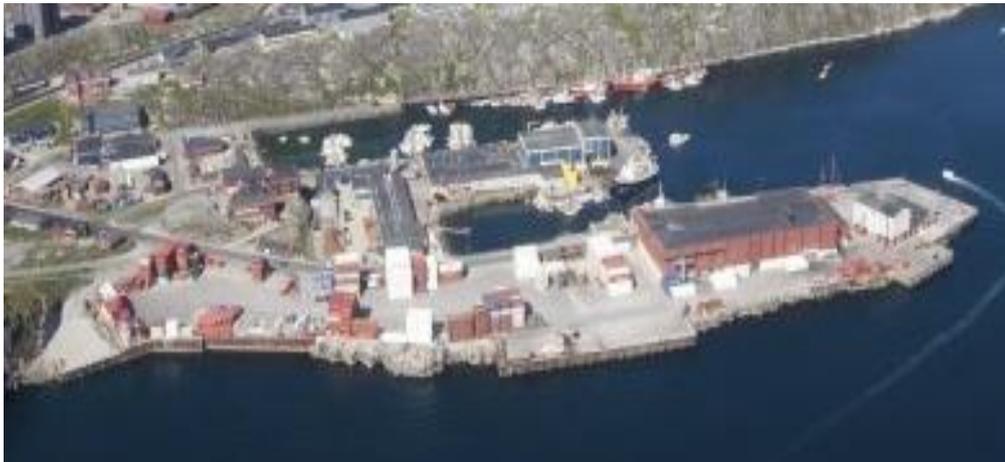
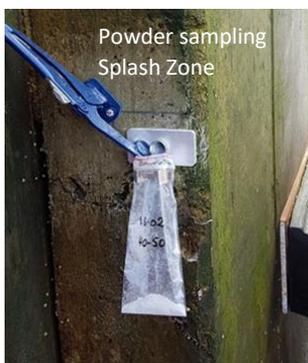
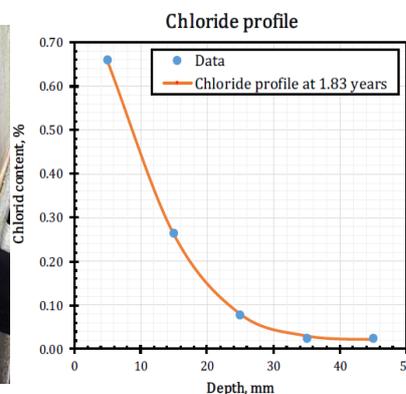
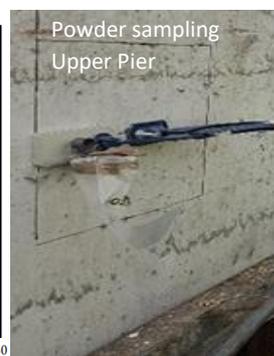
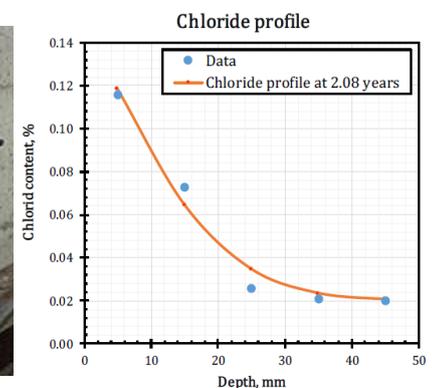
### Case B. Service life estimations, the Nuuk Container Terminal, Greenland

In 2013 the construction began of the new 47,000 square meter container terminal in Nuuk, Greenland, and was opened to operation in 2017. Some months later, under suspicions of low strength concrete in some elements of the piers, investigations of chloride penetration in the cover layer were carried out using the **Ger mann Instruments' RCT** (Rapid Chloride Test).

In a few elements, concrete powder samples were extracted by drilling at five different depths towards the reinforcement at 50 mm depth: 0-10, 10-20, 20-30, 30-40, and 40-50 mm. The chloride content by weight of concrete at each depth was determined with the RCT method, and this chloride profile was used to estimate the service life of the steel reinforcement, understood as the estimated time at which a chloride threshold reaches the depth of the reinforcement and accelerated corrosion might initiate.

The conclusion seems to be that, despite the low concrete water-cement ratio of 0.37, the concrete design was improper for the exposure conditions. Simulations of predicted service life for the same concrete mix showed that additions of about 10% to 12% of silica fume or fly ash would have resulted in a service life above 50 years.

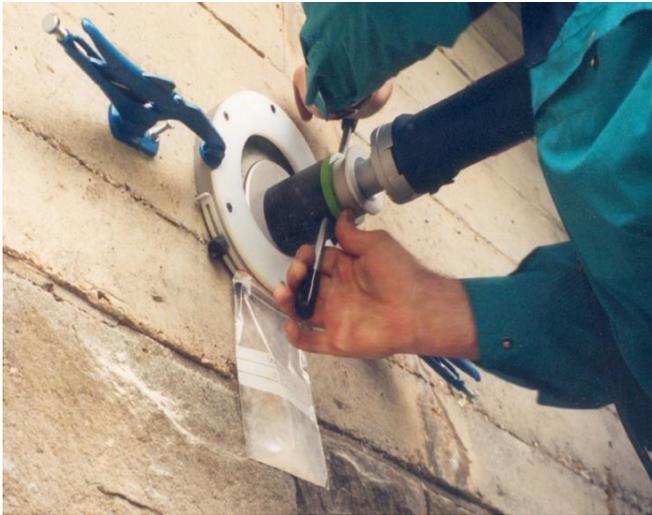
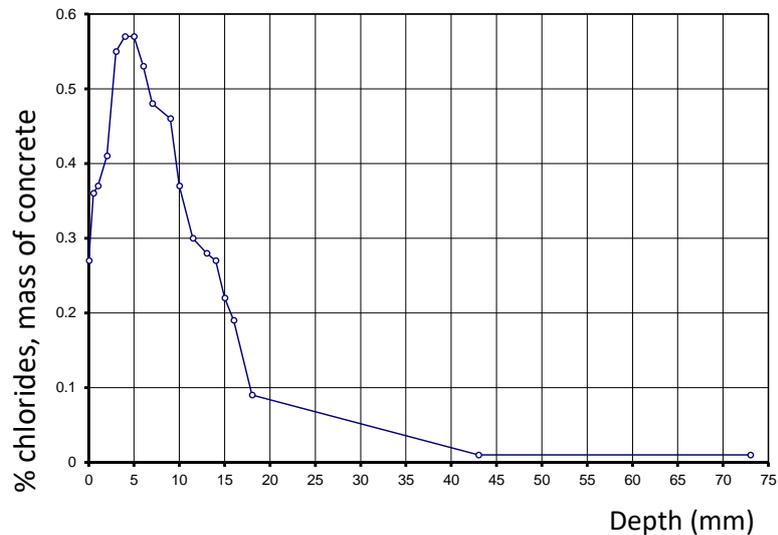
## Case C. Remaining Service Life of one-year old sea wall, at the splash zone, Denmark

The quality of the one-year old seawall's cover layer was questioned. The owner wanted an estimation of the remaining service life before corrosion would take place in the reinforcement based on the first year's ingress by diffusion of chlorides.

The cover was 50 mm.

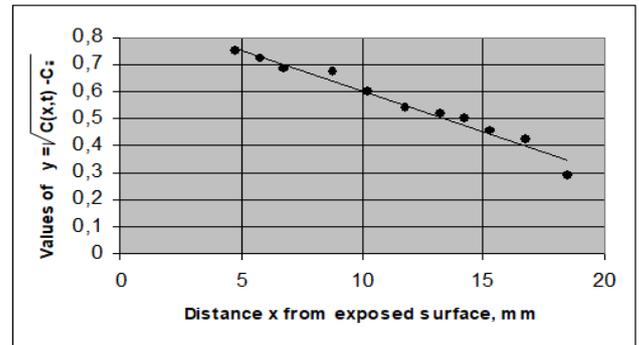
Linear regression analysis of the data was performed

Producing the following relationship  $y = 0,9060 - 0,0302 Ax$  and the chloride concentration at the surface as:

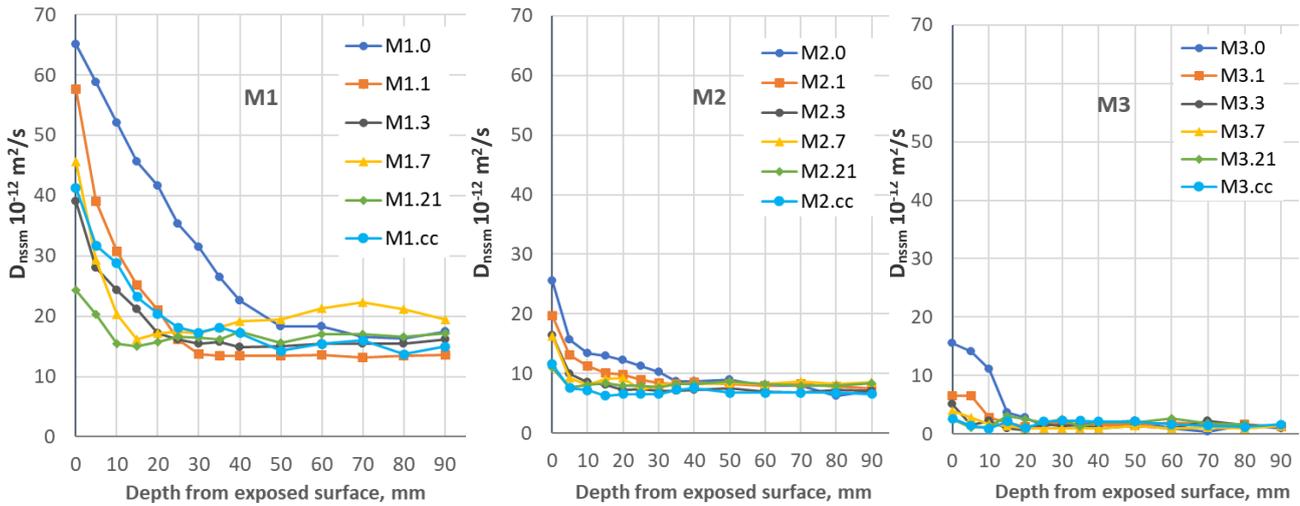
## Case D. LOK-TEST / CAPO-TEST for rapid in-situ screening of bad curing and its implication on durability and cost of structures.

It is well known that bad curing conditions affect not only the potential strength of the concrete, but also its durability in terms of penetration of deleterious ions such as chlorides that causes corrosion of the steel reinforcement in structures exposed to marine environment or deicing salts.

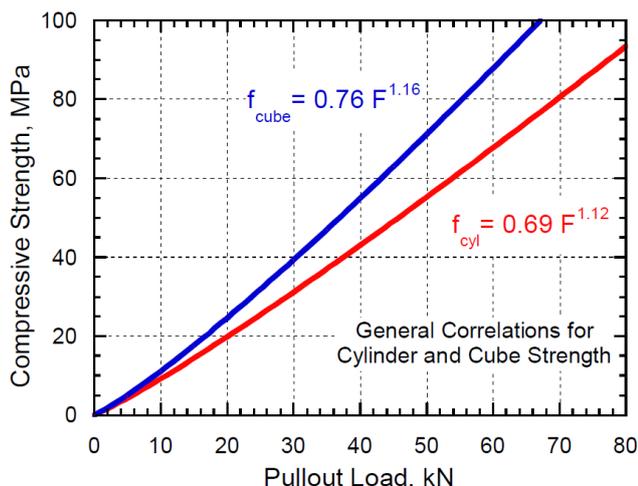
cover layer within a few minutes at any accessible location. Unlike any other indirect test methods, the LOK-test (for inserts in fresh concrete) and CAPO-test (for inserts in hardened concrete) have been extensively proven to have a robust general correlation with compressive strength which can be used to quickly estimate the actual value of the strength of the cover layer. So, if this value is found to be significantly lower than the expected one, not only this is an alarm for investigating the inner strength of the concrete, but it is also an immediate indicator of poor quality of the cover layer and of the potential risk of an important reduction in durability of the structure.

Even though there is no fixed correlation to infer the value of the increase of the chloride diffusion coefficient based on the reduction of strength, LOK and CAPO test will quickly indicate the affected areas for further evaluation.

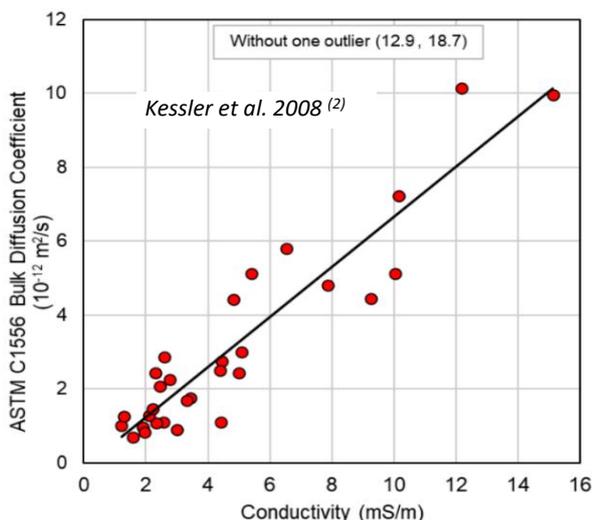
For instance, one property that does have a fundamental relationship to chloride diffusion is the electrical conductivity (or its inverse, resistivity). In the literature, one can find published relationships between the chloride bulk diffusion coefficient determined by ASTM C1556 vs. conductivity, and this property can be easily measured in the cover layer if a core is extracted from the suspicious area and the top end is sliced away for testing with the **MERLIN** conductivity/resistivity meter.

This conductivity value can be compared with the one obtained from the inner part of the core. The difference finally allows us to estimate the increase of the diffusion coefficient caused by the affected cover layer as well as the inherent implication in service life and future maintenance costs.

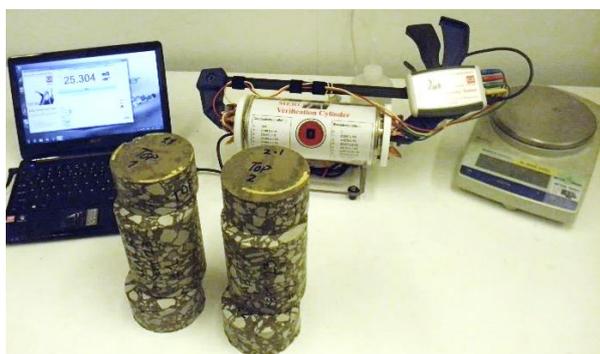
In order to evaluate the consequences in durability, two cores, 100 mm in diameter and 230 mm long, were drilled out. A 50 mm thick slice was cut from the top end of the cores (the cover layer) and conductivity measurements with MERLIN were performed on these slices and compared to measurements of the center part of the cores (bulk concrete).

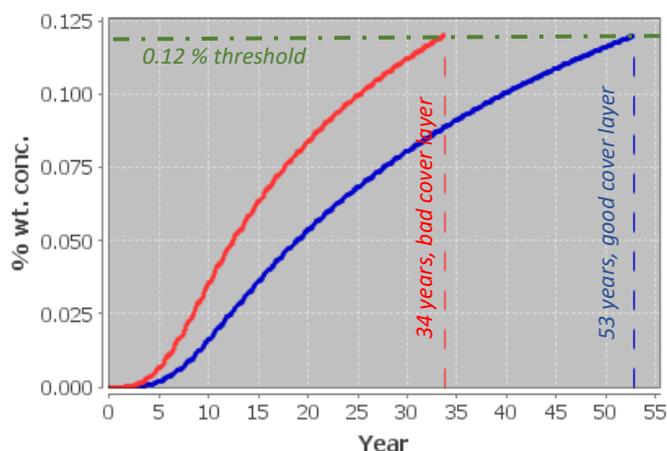
The average values of conductivity were converted to Chloride Diffusion Coefficients,  $D_{cl}$ , with the correlation published by Kesler et al., and with these coefficients, a simulation for predicting service life and life-cycle cost was made using the Life-365™ Software, available free at [www.life-365.org](http://www.life-365.org), assuming a cover layer thickness of 60 mm, typical exposure conditions of chlorides coming from deicing salts used on bridges<sup>(3)</sup> and a chloride concentration threshold value of 0.12 %.

The simulation shows that the reduction of 27% of conductivity might represent a reduction of **36% of service life**, 34 vs. 53 years (time for initiation of corrosion of the steel reinforcement).

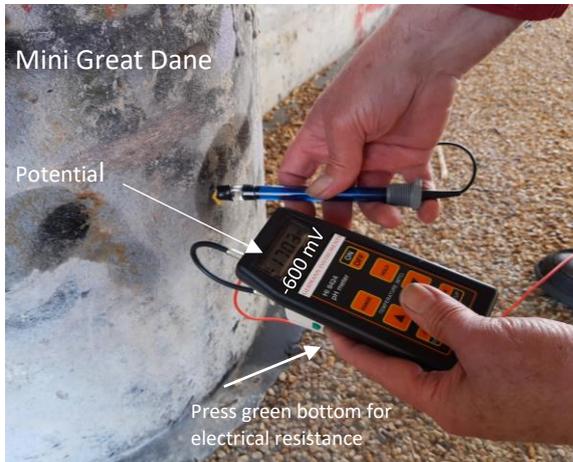
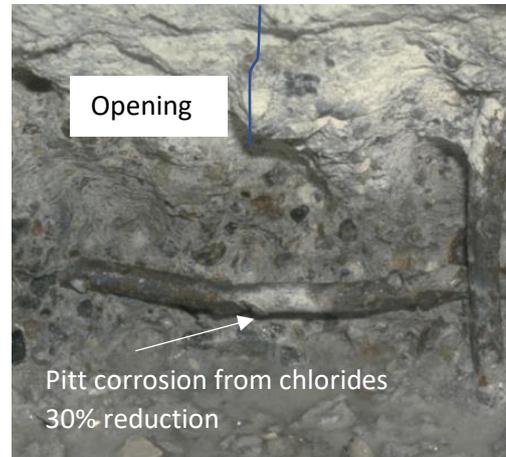
Case E. Electrical resistance and potentials for corrosion evaluation, Denmark

Electrical Resistance (kOhm)						level
25	21	20	14	18	26	75 cm
20	26	20	8	10	19	60 cm
18	19	15	6	10	20	45 cm
10	8	6	4	7	10	40 cm
2	0	5	2	2	1	25 cm
0	0	0	1	0	0	10 cm

A 5-year old highway bridge column, close to the traffic lane, exhibited a crack (width 0.2 mm) vertically in the column. Suspecting corrosion of the rebars from splash water with chlorides, the following investigation was made.

Evaluation: From 40 cm height and downwards the electrical resistance of the cover layer is low, indicating presence of moisture and chlorides.

The potentials are low in the same region with the lowest potentials at the footing, close to the crack, -600 mV. The cover was opened at the location at the lowest potential and the reinforcement was corroded in pits, as illustrated above.

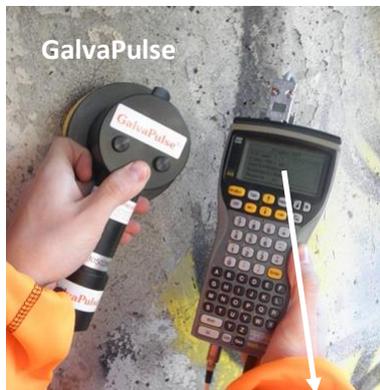
Highway bridge with deteriorating columns at the footings

The columns of a 30-year-old highway bridge were investigated at the lower parts for corrosion of the rebars with a cover layer of ~40 mm.

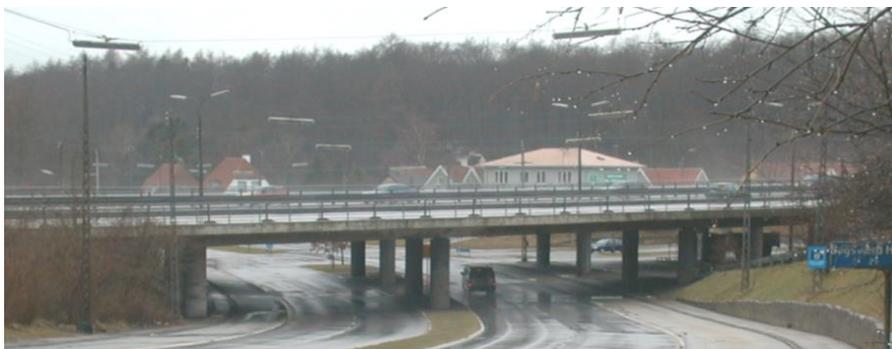
M: \galva\44	
X,Y - point 8 , 1	<p>Polarization curve</p>
E-corr. -388.0 mV	
Icorr 15.85uA/cm2	
Resistance 0.2 KOhm	
Measured 61

The Ag/AgCl potential is -388 mV and the electrical resistance 0.2 kOhm, indicating high corrosion risk and a moist cover layer, probably contaminated by chlorides. The polarization curve is regular and the corrosion current, calculated from this curve, 15.9  $\mu A/cm^2$ , equivalent to a loss of steel, following Faraday's Law, of 190  $\mu m/year$ , ~0.2 mm/year, highly active corrosion.

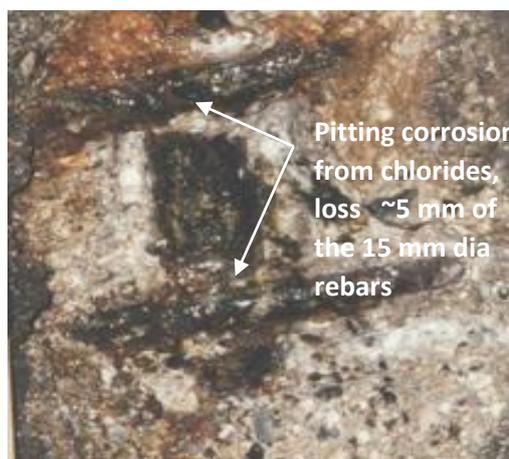
Assuming 20 years of corrosion, the corresponding loss of reinforcement cross section would be 20 x 0.2 mm = 4 mm, quite close to the actual reduction of ~5 mm.

Pitting corrosion from chlorides, loss ~5 mm of the 15 mm dia rebars

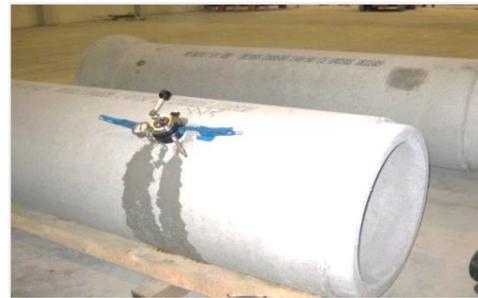
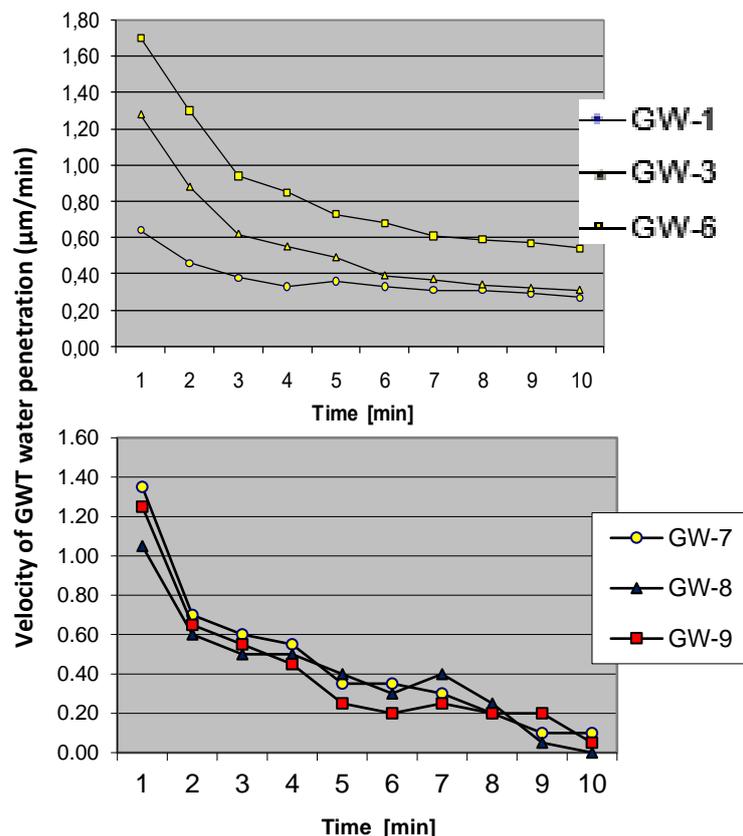
Correlations have been established between the speed of the GWT piston travel and the depth of water penetration using EN 12390-8 “Testing Hardened Concrete, Part 8: Depth of Penetration of Water under Pressure”. It has been found that the definition “watertight” concrete of <50 mm penetration depth (EN 12390-8) 72-hour pressure test relates to a GWT water flux of < 0.32 μm/min<sup>#)</sup> after 10

As will be seen, all sewer pipes passed the watertight requirement of a GWT flux <0.32 μm/min, except pipe GW-1.

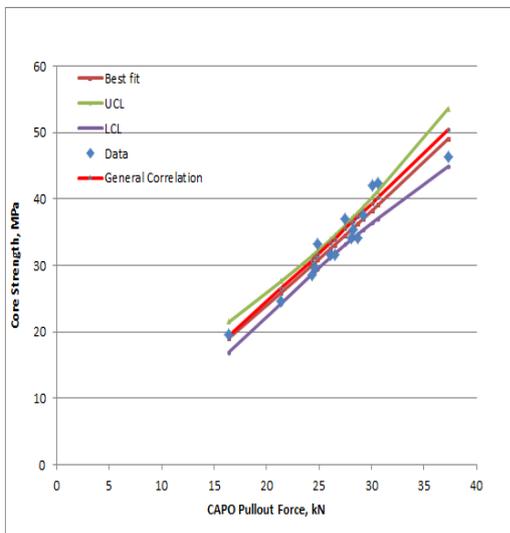
The number of cores and CAPO-TEST's for each bridge are reported in the referenced ACI publication. The average values are plotted below.

As will be seen, the best fit curve (purple) matched almost identically the general correlation for cubes (red):

$$f_{\text{cube}} = 0.76 F^{1.16}$$

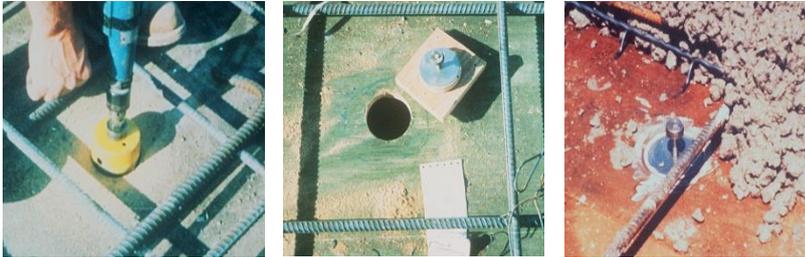
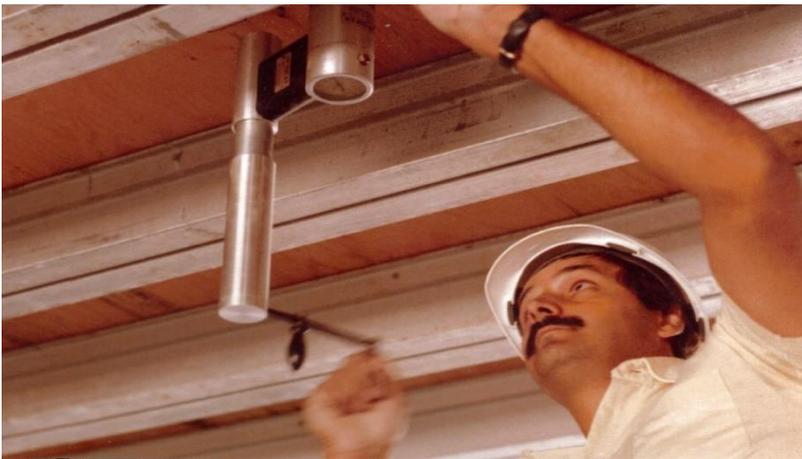
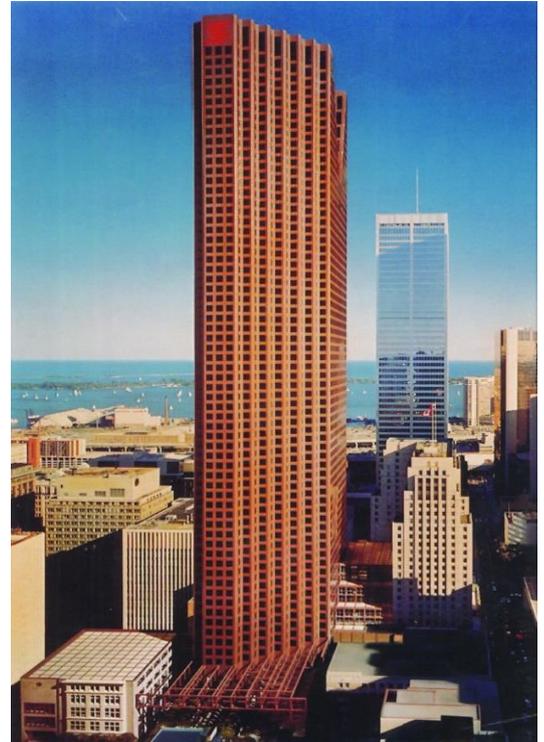
Not only for accelerating construction schedules, but also for safety, the LOK-TEST pullout system is being extensively used for testing the strength of slabs on high rise residential and office structures. The system is used in conjunction with optimized concrete mixes, by which a scheduled time of construction can be reduced, saving interest, costs on formworks, reshoring, winter heating and earlier rental.

In a 100 m<sup>3</sup> slab pour 10 to 15 LOK-TEST inserts are installed equally distributed in the bottom of the slab as illustrated above through prepared port holes. Inserts can also be installed as floating inserts in the top, but the bottom installation is preferred due to simplicity.

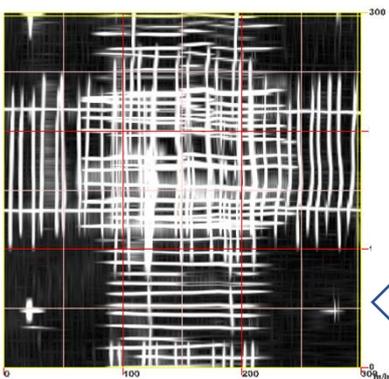
Fig. 1 Crack-free slab, top reinforcement

**Crack-free slab:** The two images below are the top reinforcement (fig.1) and bottom reinforcement (fig.2)

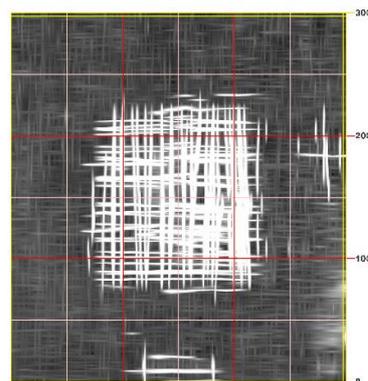
Fig.3 Cracked slab, top reinforcement

**Cracked Slab:** Both images, fig. 3 and fig.4 below are shown at the same depths as fig.1 and fig.2. The image fig.3 reveals that the column strip reinforcement was not present at the required shallow depth which would have prevented the cracking as in fig.1. The image fig. 4 reveals that the column strip reinforcement was present, but had also dropped lower during concrete placement

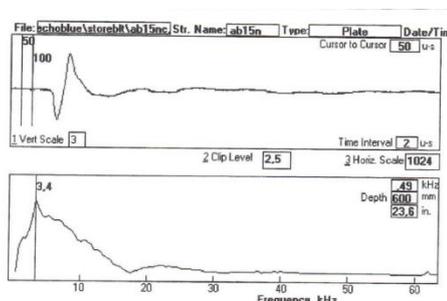
3.4 kHz, Solid 600 mm

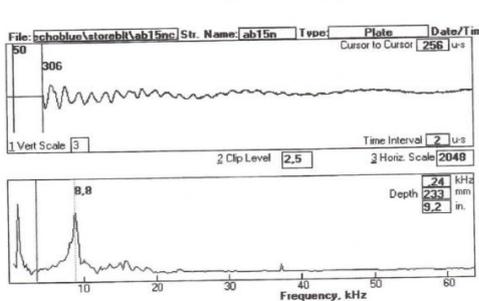
8.8 kHz, Delamination 233 mm deep

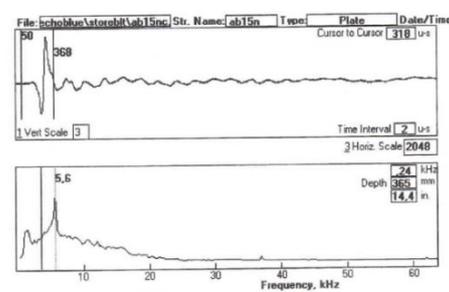
5.6 kHz, Delamination 365 mm deep

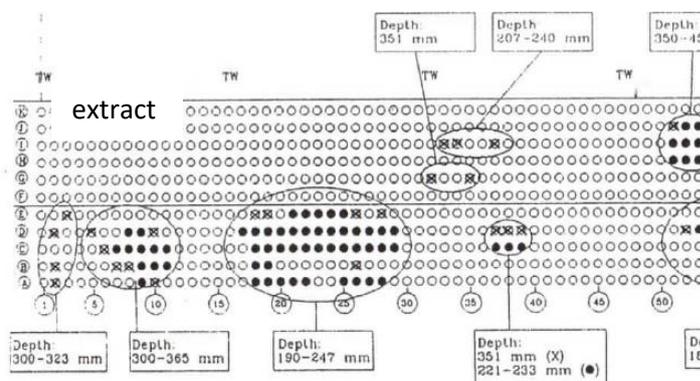
The **DOCTer Impact-echo** was used in a blind pilot test and based on these results all the walls were tested with this system. A total of 6,000 DOCTer Impact-Echo were performed, clearly detecting the

cracking despite the presence of the dense reinforcement and the cable ducts.

75 cores were drilled out for confirmation. All the core results matched 100% with the impact-echo findings. Injection was performed in the cracked areas to the full satisfaction of the owner.

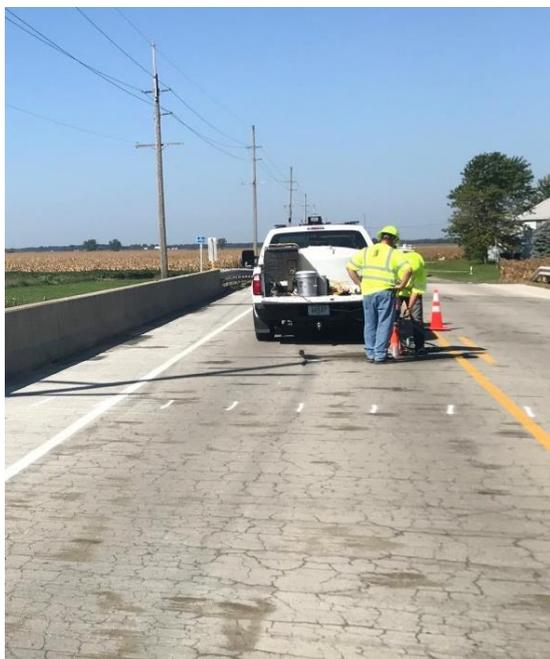
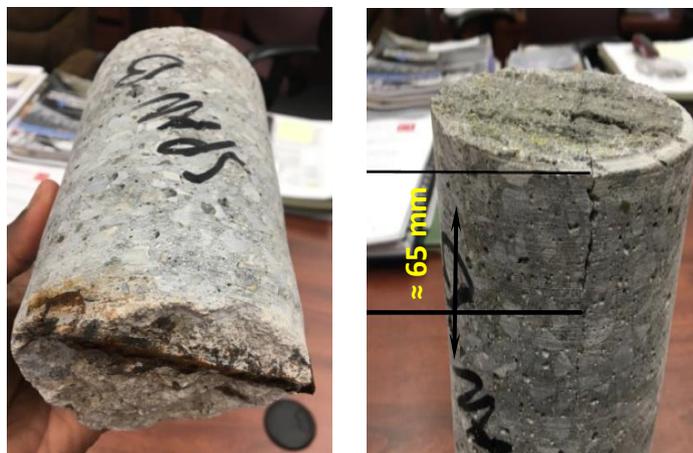
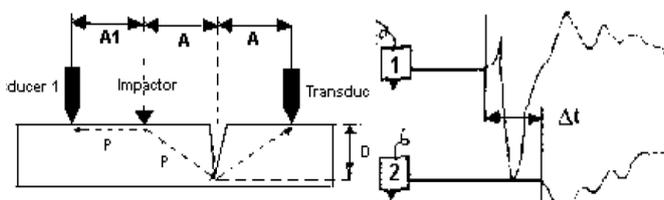
### Case O. Crack depth estimation with Impact-Echo on a bridge deck in Medaryville, USA

A concrete overlay cast over the existing deck of a bridge located in Medaryville, Indiana, USA, exhibited generalized cracking. The available documents and drawings showed that the thickness of the overlay was specified to be 1- $\frac{3}{4}$ ". However, after drilling some cores, the thickness was found to be up to 6" in some areas.

**Impact-Echo** tests with the **Germann Instruments DOCTer** system were carried out to quickly estimate the average depth of the cracks and avoid having to drill too many cores.

The P-stress wave velocity in the concrete was first measured with two displacement transducers placed at a certain distance. With this value, the transducers were positioned as shown in the bottom right picture with a distance  $A = 50$  mm. The P-wave produced by the impactor travels on the surface to transducer 1, but cannot pass the surface opening crack, so it travels down along the side face of the crack. It is refracted at the bottom of the crack and returns as a tension wave

to transducer 2. The geometry of the travel paths and the time intervals measured with the transducers allow calculating geometrically the estimated depth of the target crack.

The testing was divided into two locations. The average depth of cracking was found to be  $59 \pm 9$  mm in location 1 and  $85 \pm 7$  mm in location 2.

Two cores were taken to corroborate the results and the actual measured depth matched reasonably well with the results obtained. In the top right photo, the crack is 65 mm deep while Impact-Echo calculated 67 mm at that particular point.

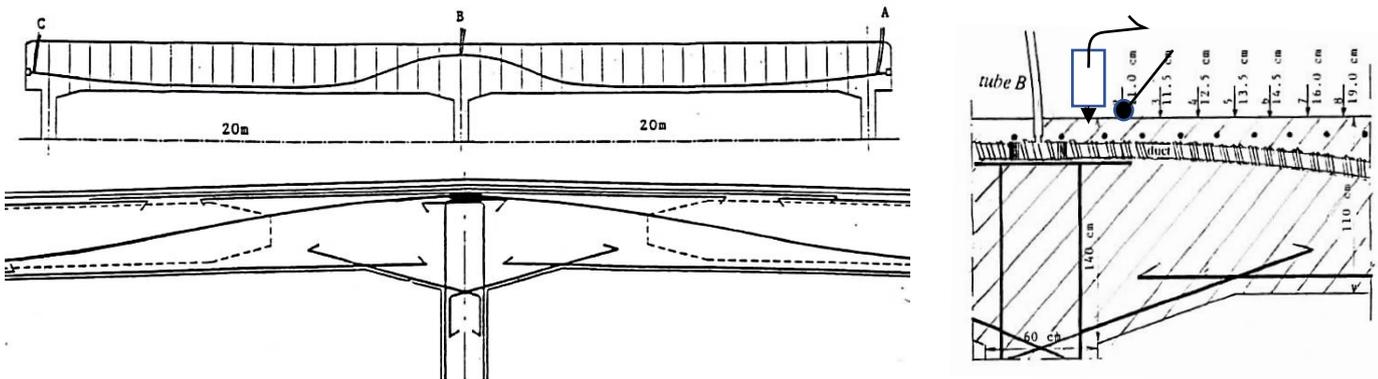
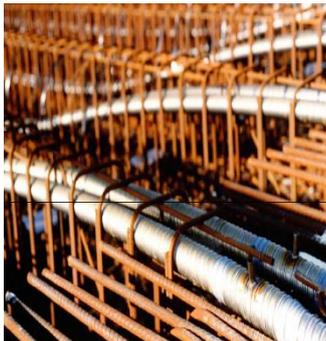
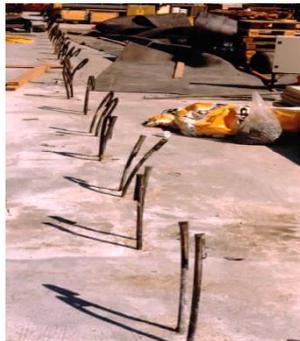
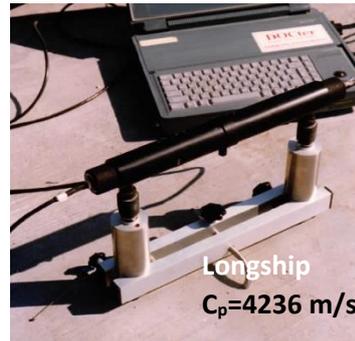
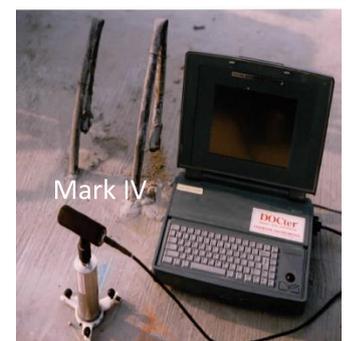
## Case P. Injection quality of new cable ducts

In the Eastern part of Denmark, a large bridge slab was constructed, the slab being 110 cm thick with 40 cable ducts installed in the 40 m span of the slab. After tensioning of the strands injection with a grout was performed, partly by pressurizing the grout from tube “A” shown in the cross section and partly by pressurizing from tube “B”.

Filling up of the mortar in the corrugated steel tube is quite important, not only because of stress transfer from the strands through the mortar to the slab, but also for protection of the strands from corrosion in the future.

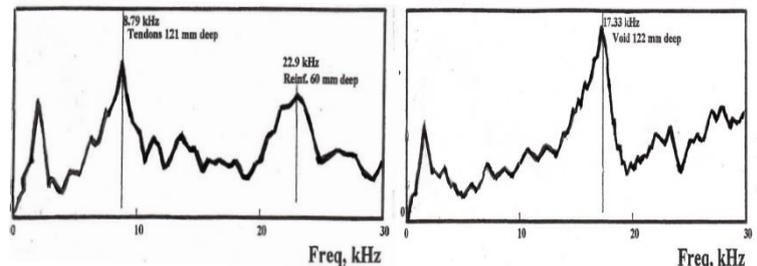
Typical signals are shown below, for an injected and for a not injected duct

First peak at ~2 kHz, backwall reflection. The P-wave runs through the cable duct and is also reflected from its strands at 8.79 kHz, related to a dept D of the strands  $D=C_p/4f=4236\text{ m/s}/(4 \times 8.79\text{ kHz}) = 121\text{ mm}$ .

**SOLID, FULL INJECTED DUCT, NO VOID** (reinforcement at 22.9 kHz)

After hardening of the grout, all tubes were cut at the surface of the slab and inspection made through the “B” hole. Of the cable ducts investigated 25% were not injected, matching 100% the DOcter Impact-Echo findings. Re-injection was recommended to be done through the “B” tube hole.

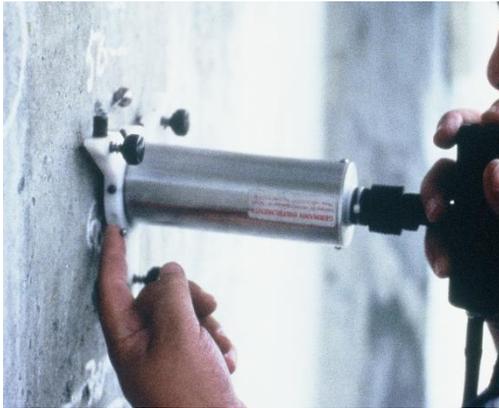
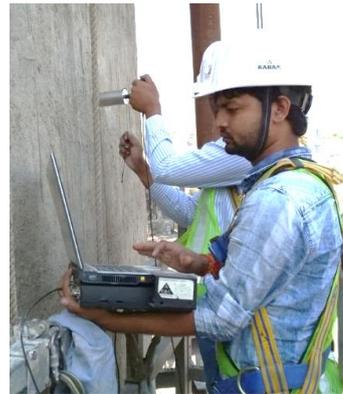
Avantech team carrying out Impact Echo test on wall of silo using the DOcter Impact Echo Test System.

The cylindrical RCC 190 mm thick wall of an in-use cement silo, in the state of Rajasthan - India was recommended for Non-Destructive Testing after the in-house inspection team at the cement plant observed deterioration in the silo wall during routine inspections.

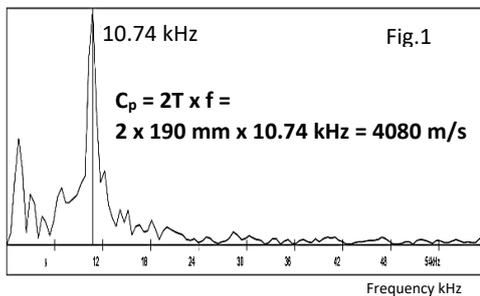
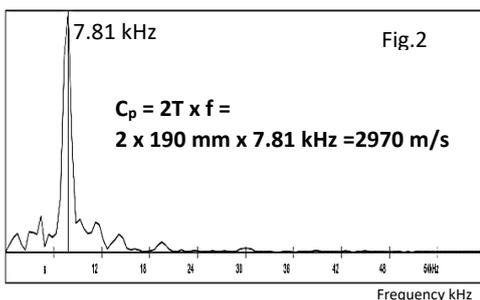
### Solid

One distinct frequency peak indicating a solid wall, but with different wave speeds (different concrete qualities), for 190 mm thickness.

Confirmed by coring.

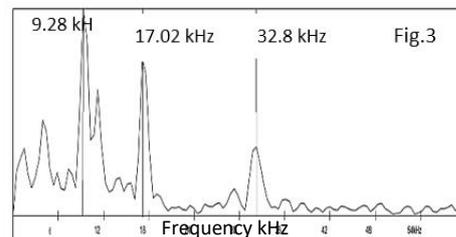
### Delaminations

The 9.28 kHz represents a drop from the 10.74 kHz "solid" frequency in fig.1. Hence, the P-wave is running longer than 190 mm – the thickness of the wall, as it is running around air interfaces. At the same time, the P-wave is being reflected from those air interfaces at 17.02 kHz and 32.8 kHz, indicating smaller delaminations, confirmed by coring.

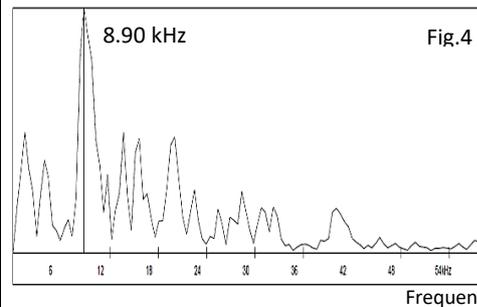
### Honeycomb/Delam.

The solid frequency has dropped to 8.90 kHz. Multiple peaks appear in the frequency spectrum indicating a honeycomb, confirmed by coring.

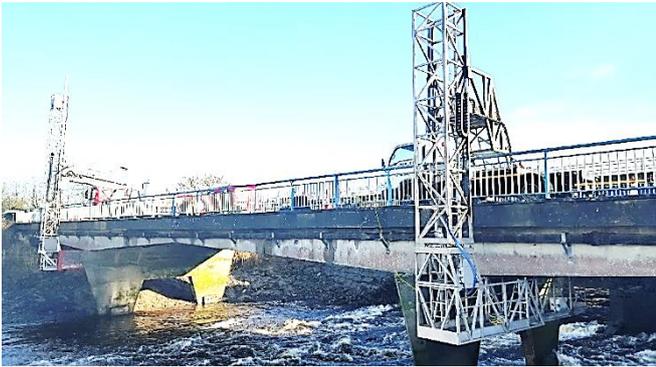
Conducted by Infrastruct Ireland, a Special Inspection was first performed to examine the condition of the concrete elements forming the bridge (designed in 1966), incl. surveys for cover, half-cell potential, resistivity, UPV and localized breakouts to examine the type and condition of the reinforcement and concrete sampling to establish the compressive strength of the concrete, the carbonation depth, the cement content of the concrete and the chloride ion content.

During the Special Inspection, post-tensioning ducts were located using GPR and a couple of exposures were made to the ducts and tendons. In two of the four ducts opened, fully voided ducts with corroded tendons were found. There was no evidence of water ponding within the ducts.

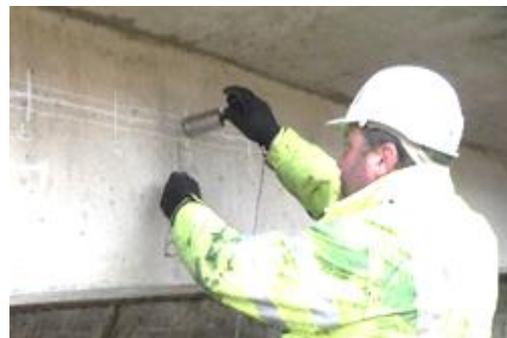
Impact Echo testing underway using the DOcter Impact Echo system to determine the ducts condition.

2000 Impact Echo tests were completed. 50% of the ducts were partially voided, 4% of the ducts were fully voided and only 46% of the ducts were found to be fully grouted.

*Impact echo testing using the DOcter Impact-Echo system carried out above the post-tensioned ducts to quantify the extent of voiding in the ducts.*

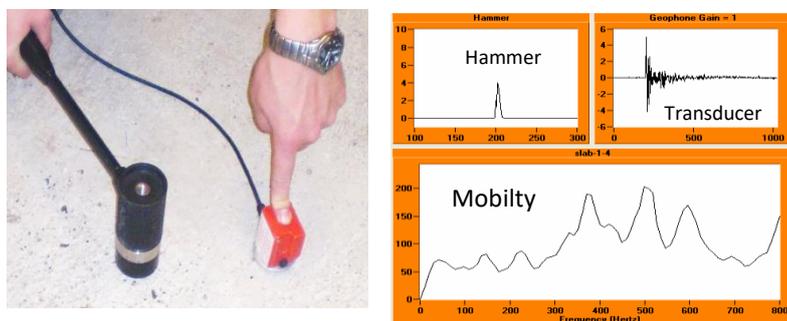
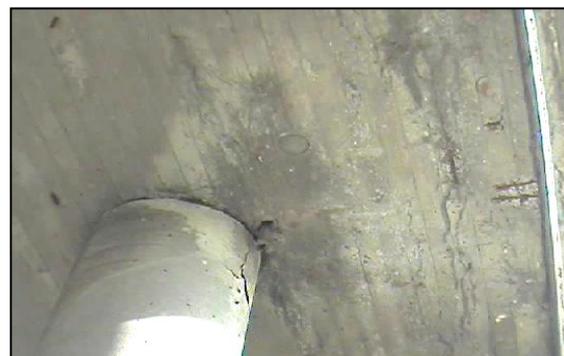
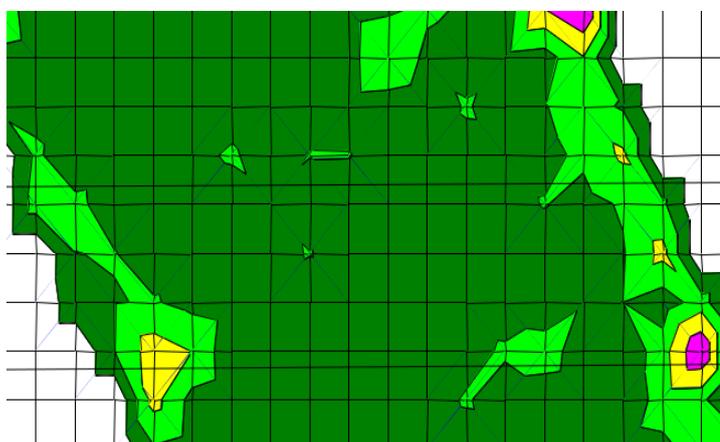
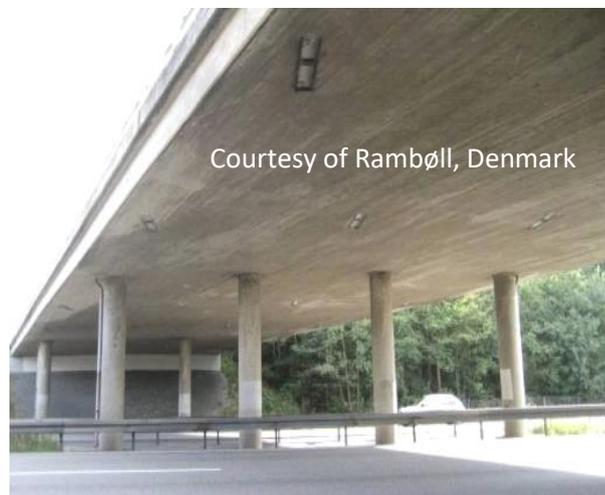
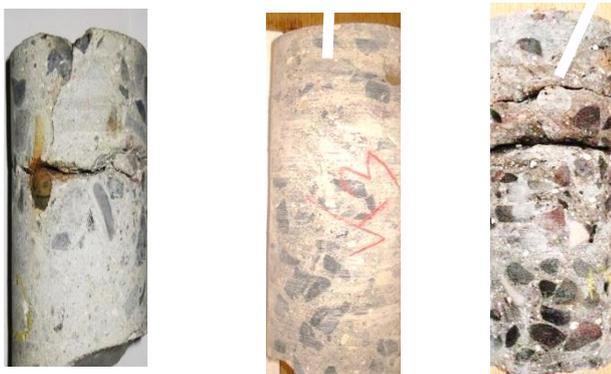
Average Mobility

□ 0-4 ■ 4-8 ■ 8-12 ■ 12-16 ■ 16-20

The soffit of a bridge slab showed starting deterioration at the edges. **Germann Instruments s'MASH** Impulse Response system was applied from the top of the slab.

Above is shown the instruments, a rubber tipped hammer with built-in load cell and a velocity transducer. A hammer stroke to the surface makes the member bend in a flexural manner, and e.g. the average mobility of the member is plotted.

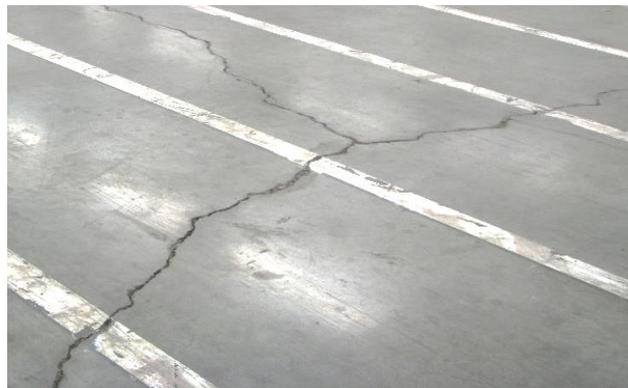
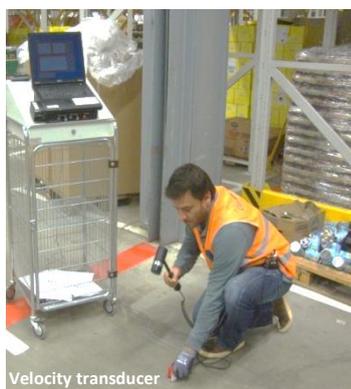
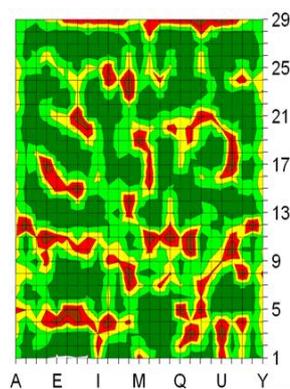
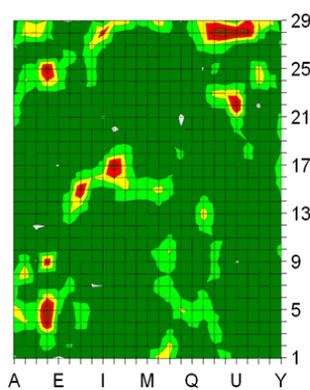
For speedy testing, the entire floor was tested with s'MASH Impulse Response, using its voids index option. Spacing between test points 1 m x 1 m. A section is shown below.

**NDTitan Nikos Zoides** doing the s'MASH testing and checking the voids index. The Voids Index is the maximum mobility peak divided by the average mobility, and if >1.6, a void is present (red and yellow color).

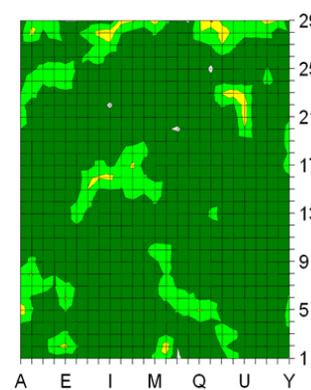
After 2<sup>nd</sup> injection

After hardening of the grout, re-testing was made with the sMASH Impulse Response.

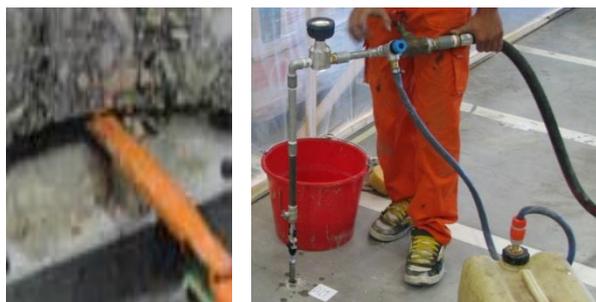
Coring confirmed the voids:

Subsequently, injection was made with a grout with a W/C ratio of 0,7 to 0,9 (under pressure of 2bars at the maximum) through 26 mm holes.

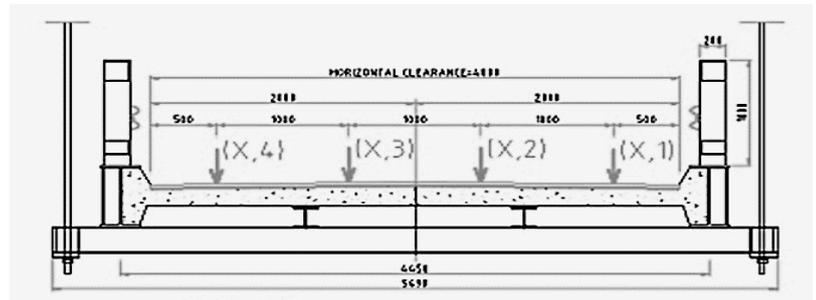
Cross section of the bridge. Deck: 50 mm asphalt on 250 mm concrete slab with waterproofing layer in between, area 350 m<sup>2</sup>  
Arrows indicate the s'MASH test points.

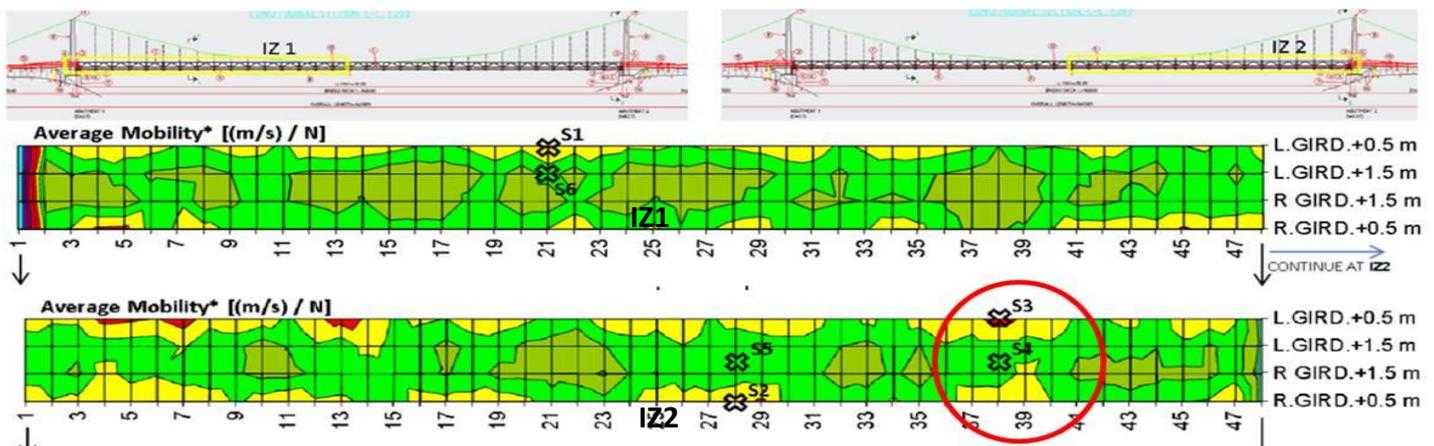
s'MASH Impulse Response testing was selected as the primary test system to detect defects, followed up by BOND-TEST of cores in areas pin-pointed by the s'MASH. Results: below showing the s'MASH Average Mobility maps.

Green areas have the relatively low mobility (sound) and the yellow-red (or higher) mobility (suspicious, i.e. not sound). For calibration of the NDT results, cores were taken and BOND-TEST's were performed at several test points.
