# NDTitans

*Test Right – Sleep Tight*

**NDTitans** is an international group of highly specialized, skilled and dedicated engineers, scientists and companies with many years of structural engineering and testing experience related to all aspects of concrete and reinforced concrete structures. The **NDTitans** are from Denmark, Finland, Poland, Greece, Ireland, India, Mexico, USA and Canada.

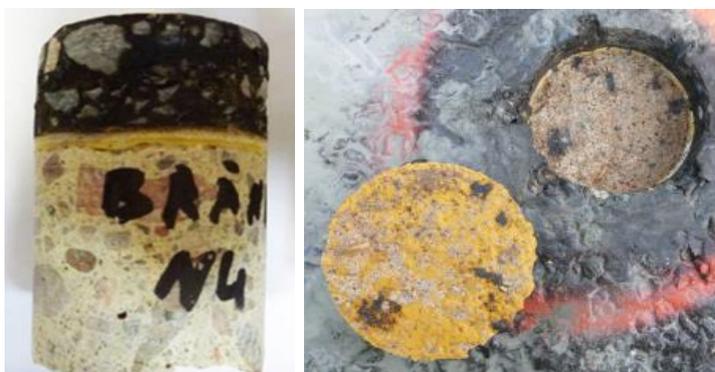
Validation points S4 and S3

- S4 (green area) bonded waterproofing, BOND-Strength ft=1.0 MPa (req. ≥ 1.0 MPa)
- S3 (red area) waterproofing debonded.

Conclusions & Recommendations: Good correlation between NDT and validation.

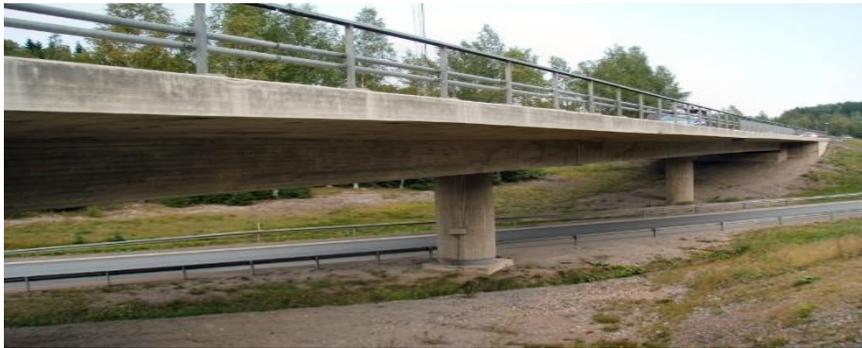
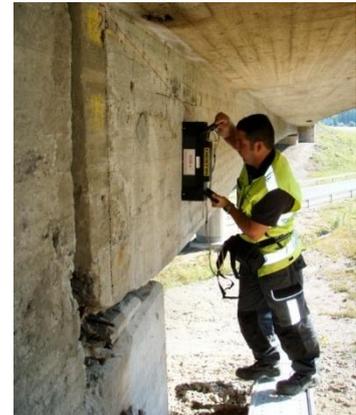
Evaluation of prestressing duct's condition (Ramboll Finland Oy) at various locations along the bridge, mostly at the anchoring zones and mid spans was performed by using the MIRA ultrasound tomography and Impact-Echo on the Leiviö over bridge in Finland for the Finnish Road Administration.

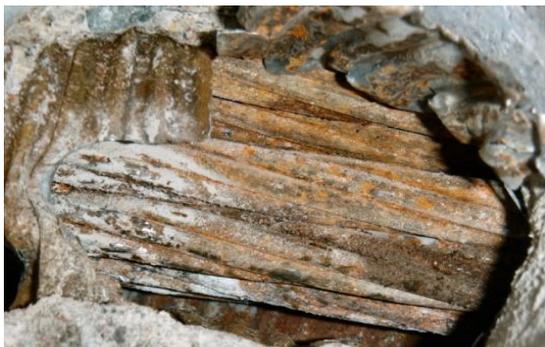
At one location it was decided to open the suspicious duct at a distance of 1 m from the head of the anchor holding the strands, carried out by coring to the corrugated tube, which was opened as well.

The finding is illustrated below.

The duct was empty of injection grout and the strands were severely corroded, yet only mildly pitted.

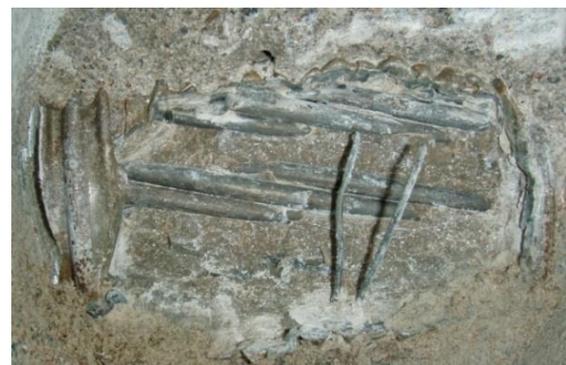
In comparison, in another area, where the MIRA did not show intensive reflections (red color), but only slightly green/yellow color (non-suspicious), another similar opening was made.

As seen, the strands were fully encapsulated by injection grout, well protected. The strands are in good condition with no signs of corrosion.

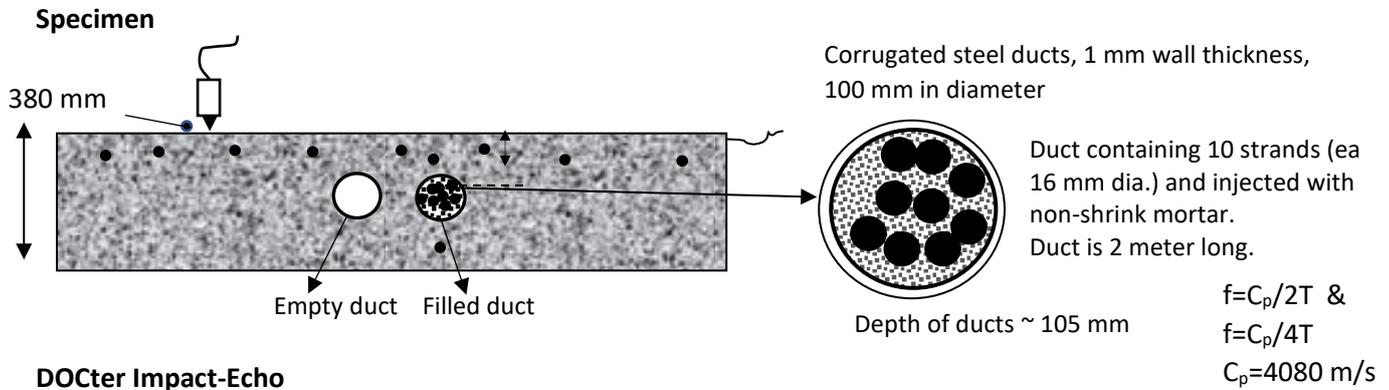
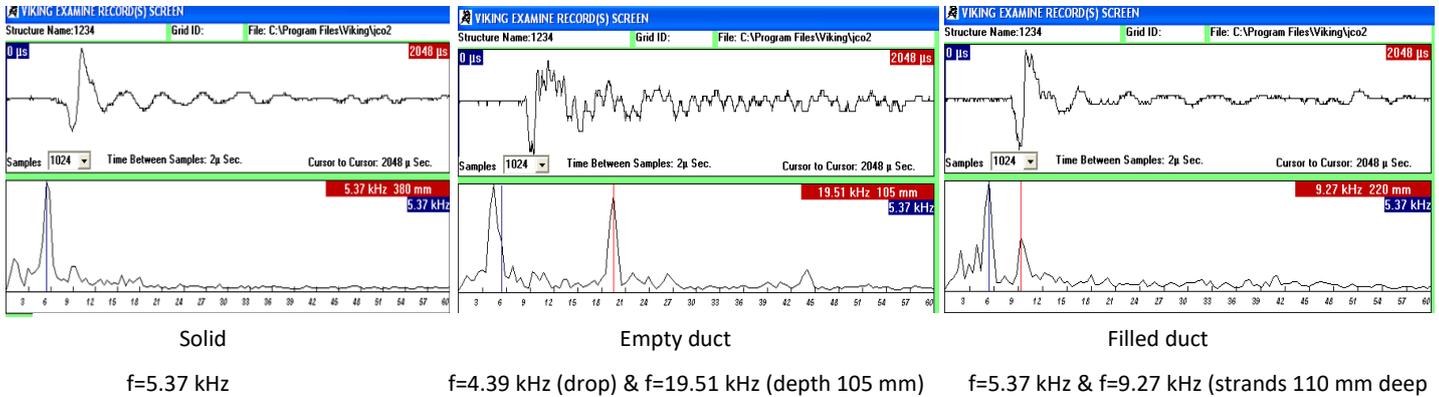
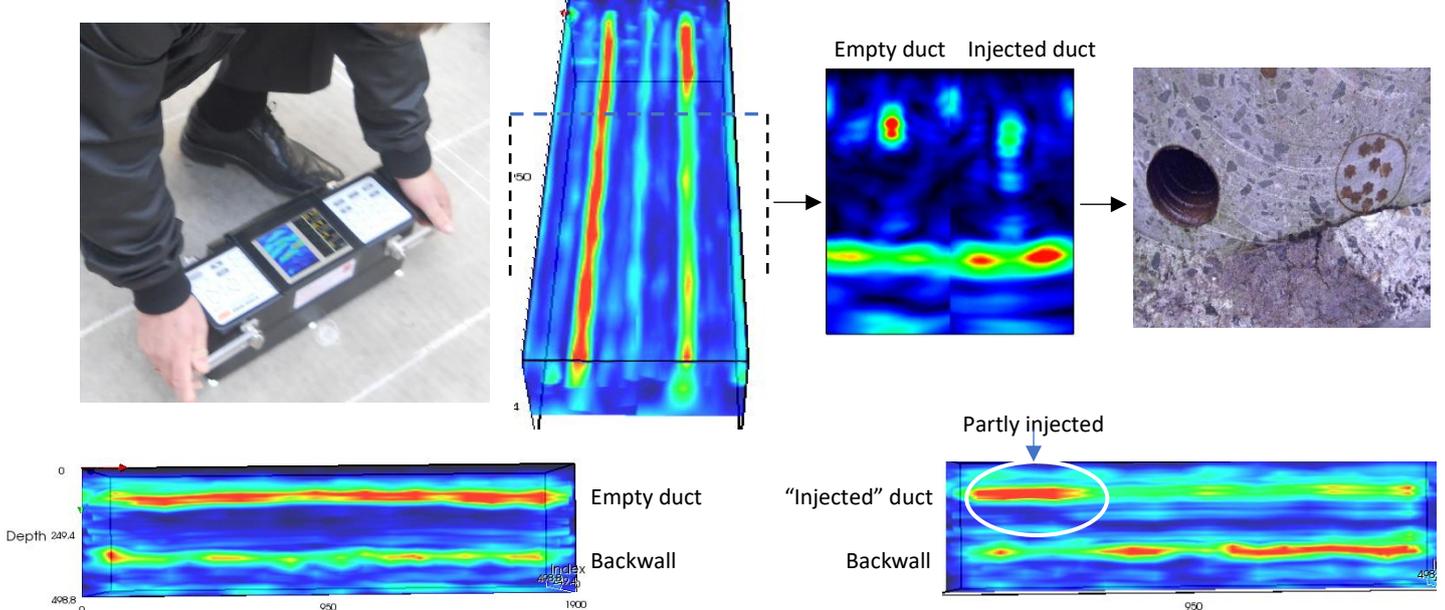
## Case X. Injection the quality of cable ducts, tested with DOcter Impact-Echo and MIRA Tomography on a controlled specimen

### DOcter Impact-Echo

### MIRA Tomographer

DOcter Impact-Echo and the MIRA identified the same conditions of the injection of the cable ducts as well as in the first area of the injected duct (the red color) found to be partly injected.

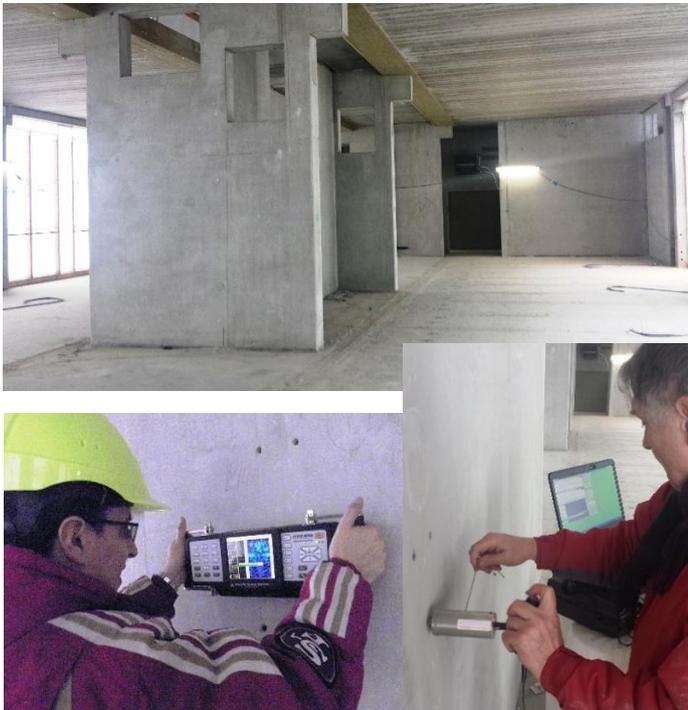
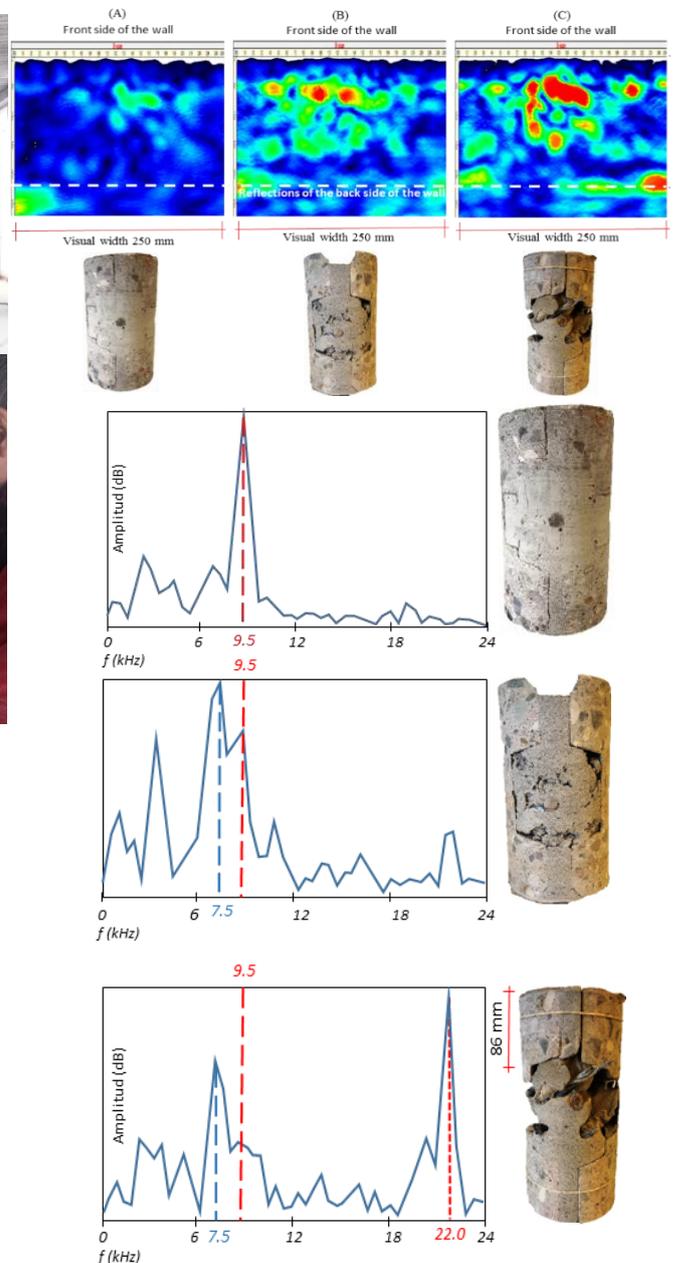
## Case Y. Non-destructive testing of joints in precast walls

In 2015, a new building complex in the Technical University of Denmark, DTU, was under construction. A demonstration of quality inspection of grouted joints reinforced with looped wire ropes was performed in the Life Science & Bio Engineering multi-story building where precast concrete walls were used. Knowing that the grouting process is very susceptible to human error, looking for possible defects is critical. Two instruments were used, the **DOcter**, which is based on the Impact-Echo method, and **MIRA**, an ultrasonic-echo tomographer. These stress wave, NDT assessment methods, are well known to be sensitive to these types of defects.

A vertical column of 17 to 18 testing points, with 100 mm spacing in between, were made for inspecting each of two randomly selected joints. The tested concrete walls were 200 mm thick. By analyzing the changes in the value of the resonance frequency compared to that of a solid part of the joints (9.5 kHz), Impact-Echo was able to identify the position and depth of several voids. The 2D images or B-scans made with MIRA corroborated the findings.

The contractor also extracted some cores and verified that the position and extent of the defects matched very well

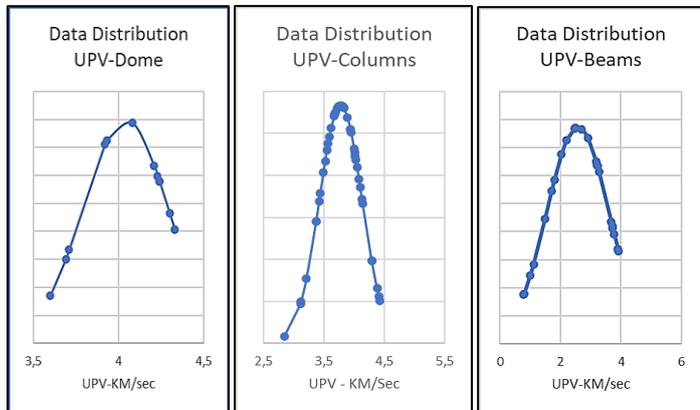
UPV (Ultrasound Pulse Velocity) tests were carried out to assess the general quality and homogeneity of concrete.

Aver: **4.0** Dome  
**3.8** Columns  
**2.4** Beams

Evaluated by UPV the quality of domes and columns was generally good and uniform with all UPV values above 3.5 km/sec. The beams exhibited the worst quality with about 74% readings below 3.5 km/s and average UPV only 2.4 km/s.

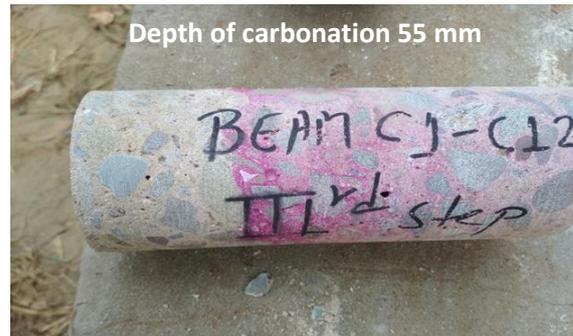
In almost all cases the depth of carbonation was larger than the depth of the reinforcement, causing loss of protection

from the concrete's alkalinity, and making the rebars corrode.

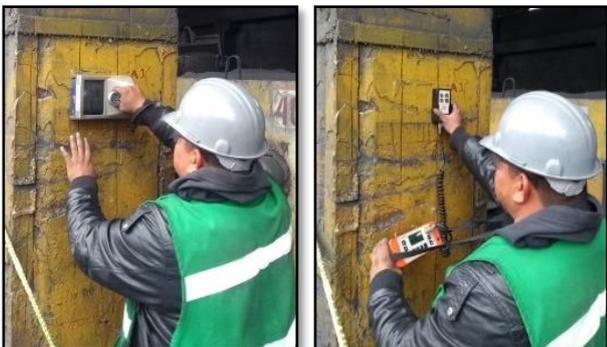
GPR for rebar depth      Covermeter for size of bar

Ground Penetrating Radar with a 2600 MHz antenna was used to scan the structural elements and Cover Meter was used to estimate the rebar diameter. It was found that the average cover layer of all columns and beams was 20 mm.

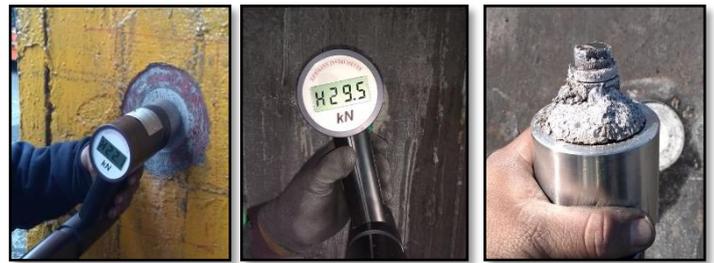
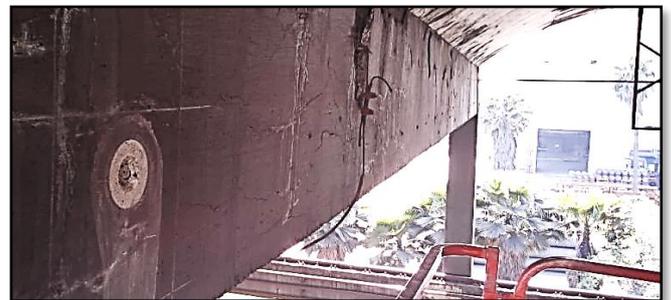
CAPO-TEST COMPRESSIVE STRENGTH SUMMARY	
Tested Elements	24
No of CAPO-TEST's	24 (one in each element)
Strength Range (MPa)	20 to 32 <sup>#)</sup>
Mean Strength (MPa)	25
St. Dev. (MPa)	4
C.V.	16%
Equivalent $f_c$ (MPa)	19

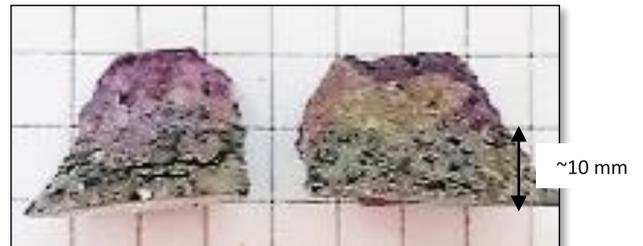
The CAPO test conical pull-out cones were tested for carbonation with a pH indicator. It was found that the depth of carbonation on columns was ~10 mm and the beams and roof ranged between 15 to 30 mm. The average cover layer was 20 mm. The reinforcement of beams and roof was at high risk of corrosion.

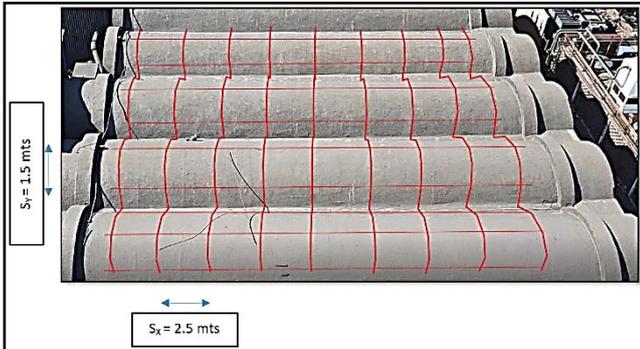
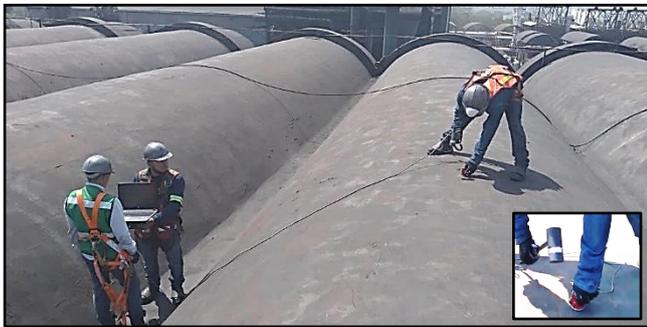
s'MASH Impulse Response on the vaulted roof

s'MASH Impulse-Response was conducted to quickly evaluate the structural integrity of the large concrete roof. 8,600 m<sup>2</sup> of roof were tested with around 1,200 points in 1 full day.

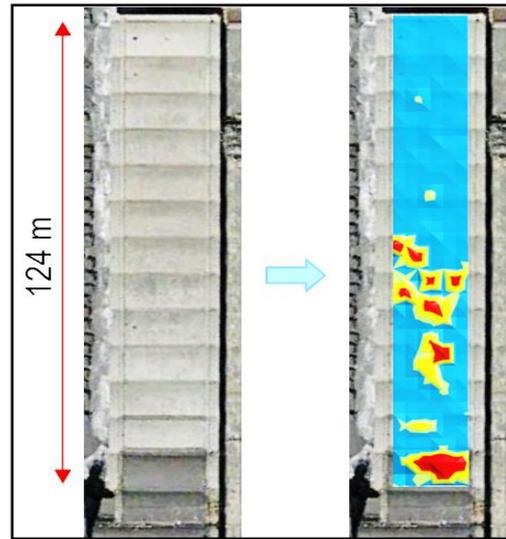
s'MASH contour plot of average mobility on the roof

The “average mobility” value of each point was used to compute a statistically modified contour plot as shown with the “sound” areas (blue) vs “unsound” areas (red / yellow). It was found that the areas with high “average mobility” (red / yellow) coincided with heavy corrosion induced damage from carbonation.

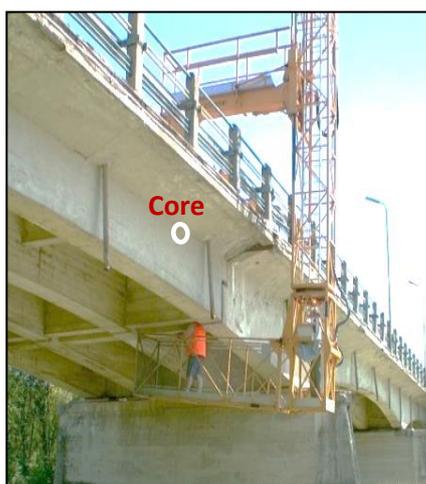
**Rainbow Indicator** and **Deep Purple** for depth of carbonation on a bridge girder

The Deep Purple and the Rainbow Indicator produced the same depth of carbonation, from the inside of the girder 54 mm and from the outside 25 mm. The reason for the **different** depth is that the outside is subjected to rain, slowing down the carbonation process, while the inside is relative dry.

Carb. depth 54 mm  
Inside of Girder

With the depth of the reinforcement 40 mm, misleading information concerning the protectiveness of the reinforcement could be given if testing was only made from the outside of the girder. The reinforcement positioned at the inside of the girder had in fact started corroding, while reinforcement at the outside had no signs of corrosion.

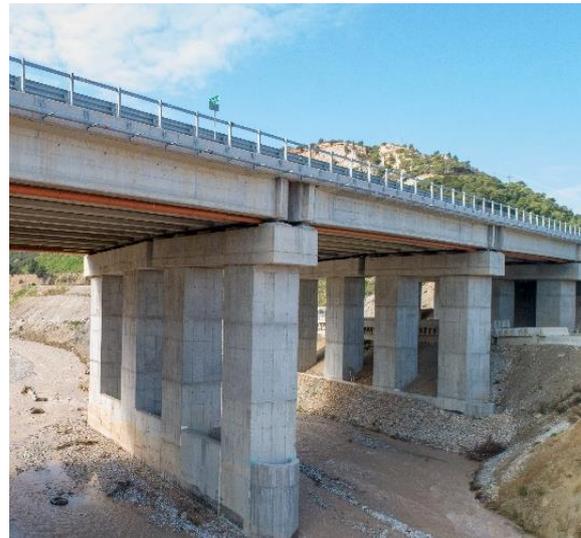
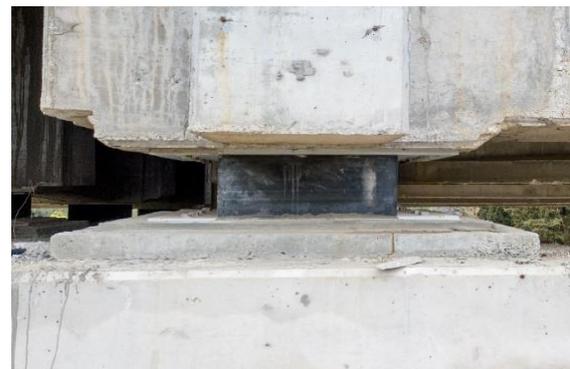
The soffit of the decks was inspected, as were the pier caps and the elastomeric bearings. Some bridges are above river crossings and inevitably access to elements demand the use of underside platforms if there are no Drones. The visual

inspection comprised, furthermore, traces or moisture that could indicate deficiency of waterproofing system over deck and expansion joints.

Finally, inspection for excessive deformations, bulging and oxidation of elastomeric bearings was performed with drones in a fast and efficient way with low cost.

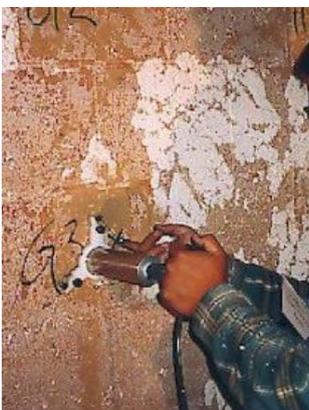
Pulp Plant, Canada  
De-bonding of tiles

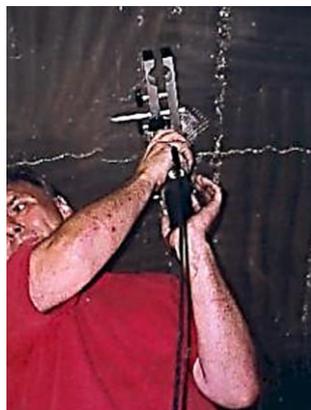
Fire damaged ceiling, Germany  
Depth of cracks

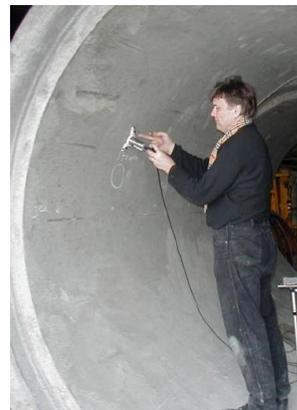
Sewer tubes, Denmark  
Delaminations

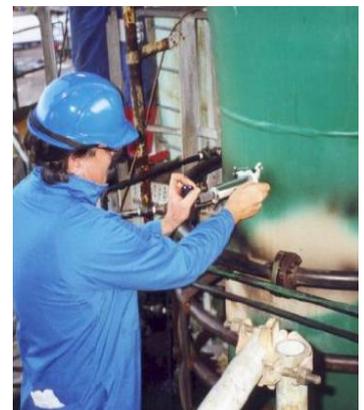
Thickness of concrete liner  
inside riser column, Sweden

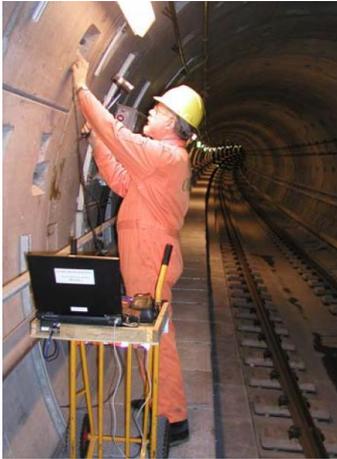
Tunnel lining, Denmark  
Voids in injection

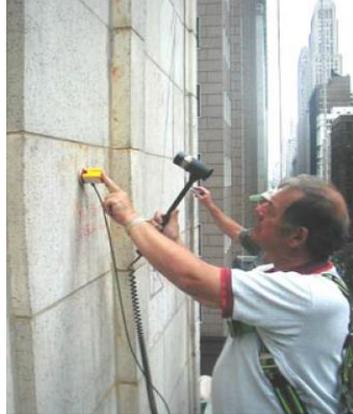
Terracotta Panels, Chicago  
Cracking / debonding

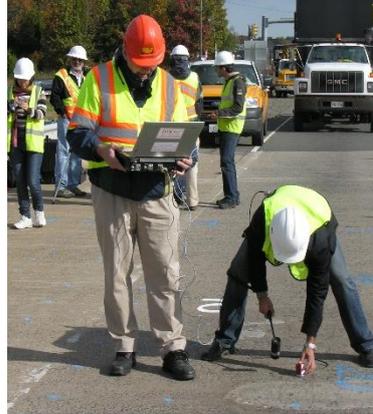
Bridge Slab, Virginia  
Voids / lack of support

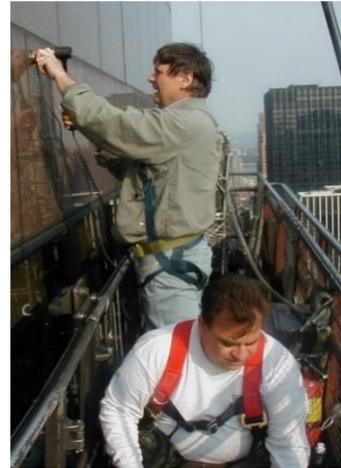
Granite Panels, New York  
Missing anchoring

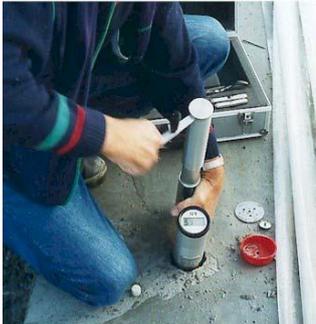
Industrial Floor, UK  
Strength before loading

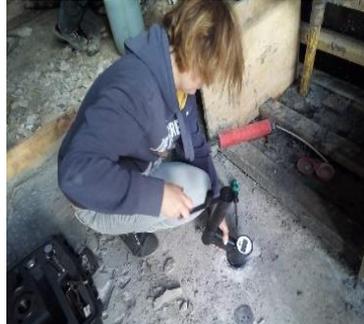
Tunnel Base, Denmark  
Strength before loading

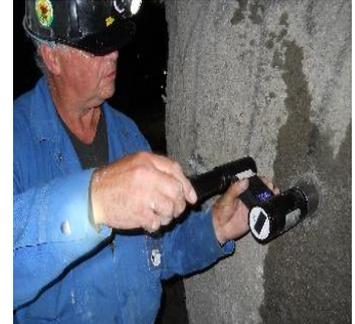
Shotcrete, Canada  
Strength

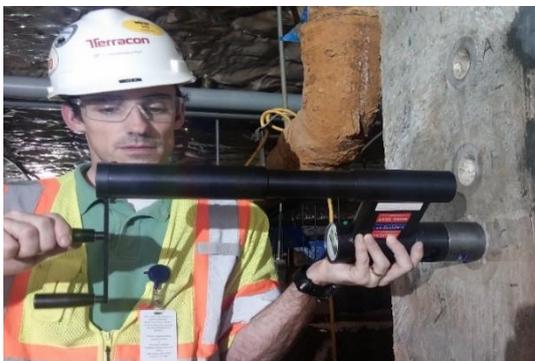
Columns, Houston  
Strength before further loading

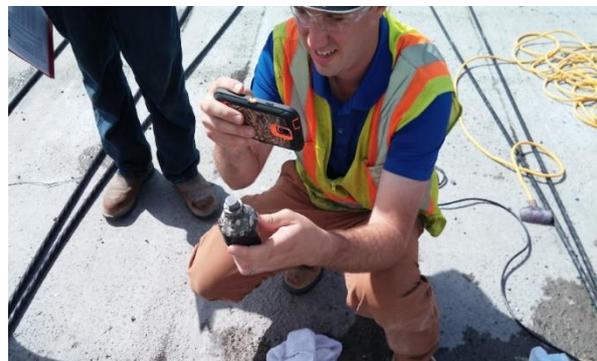
Bridge joints, Kentucky  
Strength before loading

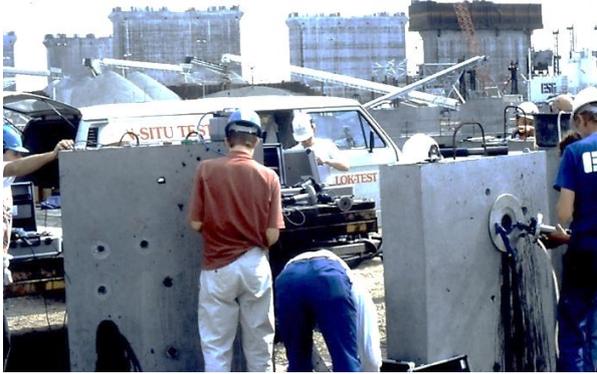
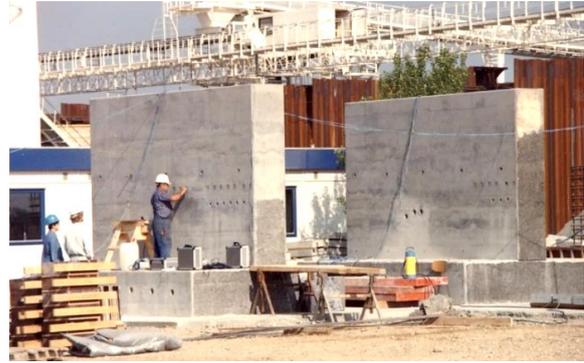
Great Belt Link, Denmark  
 LOK-TEST and CAPO-TEST training for checking cover layer quality, curing

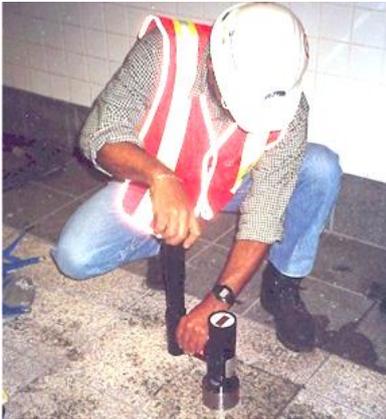
New York Metro  
 Tile adhesion

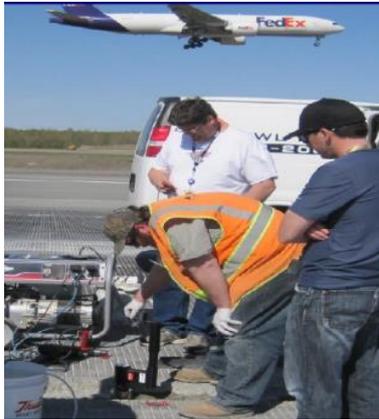
Joint testing at Anchorage Airport runway, Alaska  
 Testing of substrate before applying the joint overlay
