LOK and CAPO Tests

The experience of pull-out test during
The Great Belt Link (Storebælt) project in Denmark

Extractions of the Storebælt Technical Publication:

Concrete Technology

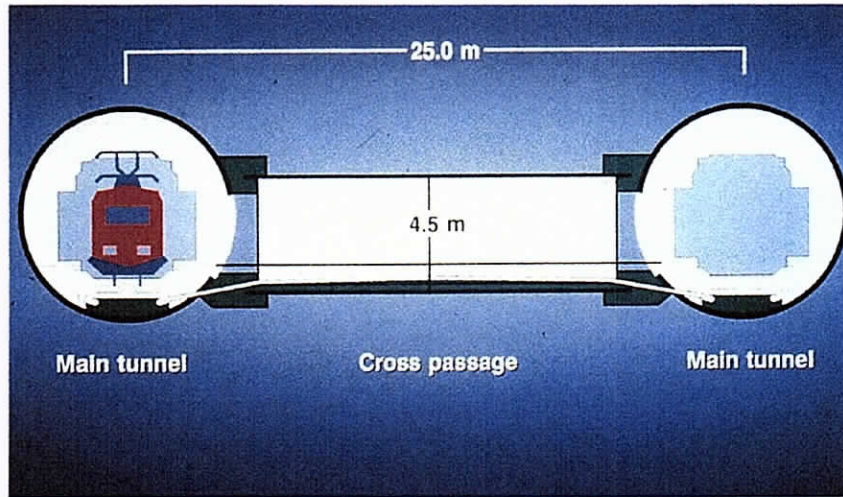
Fig. 2. Cross section of the East Tunnel.

The options for the East Tunnel were for it to be either bored or submerged. The chosen design was a bored tunnel with segmental concrete lining in the two main tunnels and cast iron segments in the cross-passages.

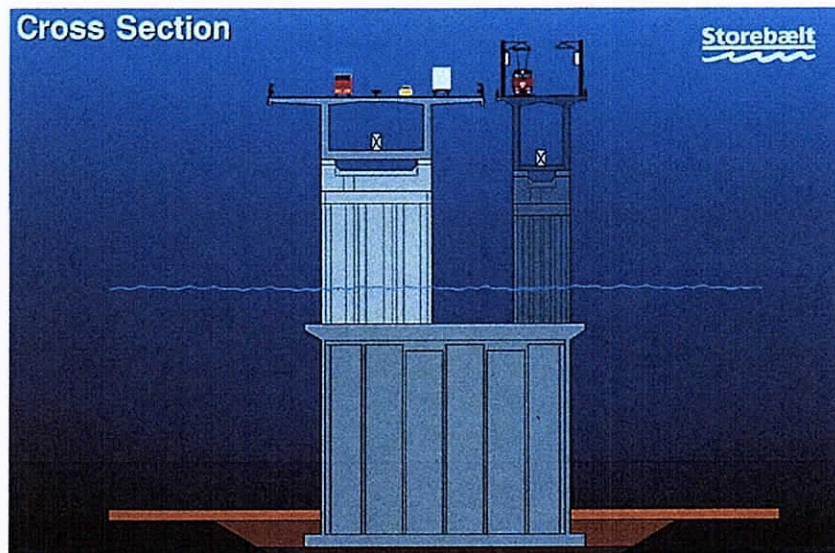
Fig. 3. Cross section of the West Bridge.

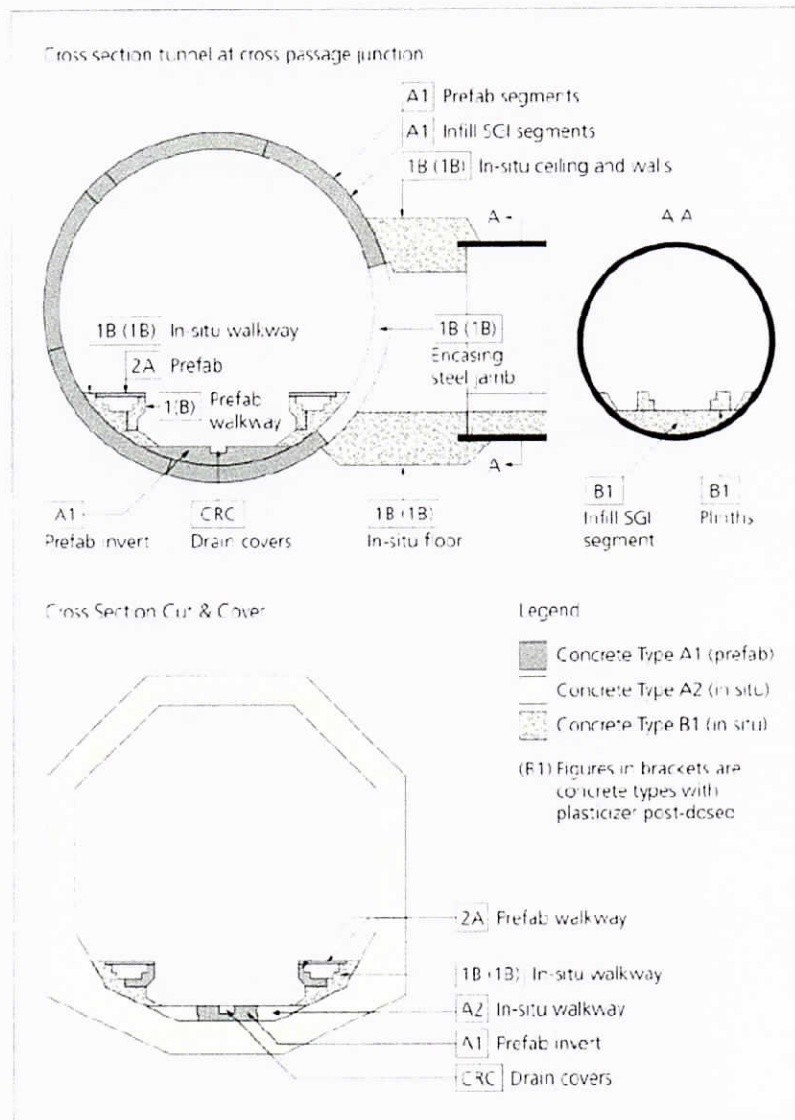
Fig. 5. Summary of the use of main concrete types in the East Tunnel. The A2 type was also used for portal buildings.

The East Tunnel SAB defined the requirement for three main types of concrete, two A-types and one B-type. Type A1, for segment production, was a 50 MPa concrete with a maximum water content of 135 kg/m³ and a maximum equivalent water/cement ratio of 0.35. Type A2, for in situ castings, was a 40 MPa concrete, with requirements for water content and water/cement ratio identical to those for type A1. Type B1 was a 35 MPa concrete with a maximum water content of 140 kg/m³ and a maximum equivalent water/cement ratio of 0.45. The specification also included requirements for the grout.

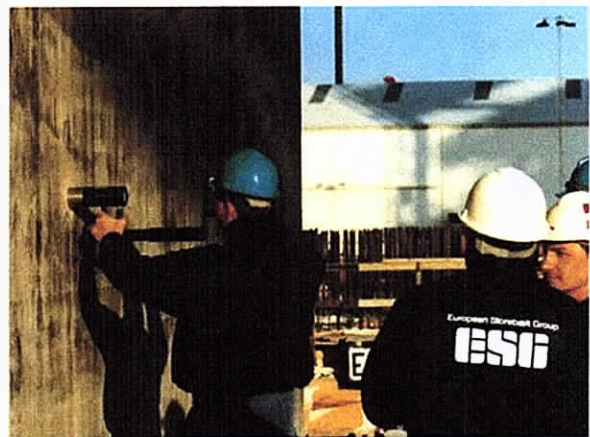
Fig. 7. LOK-test for in-situ strength assessment.

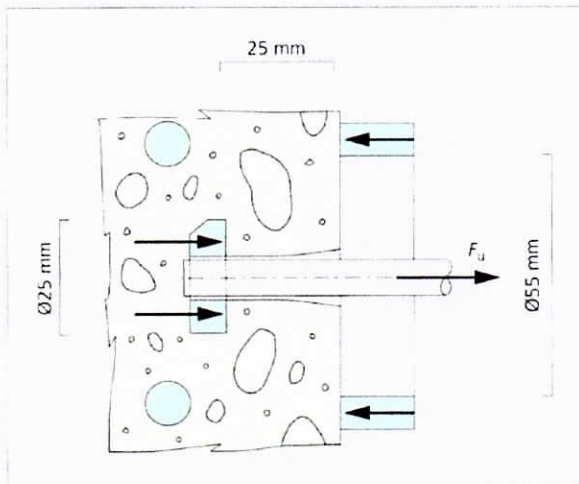
Fig. 8. The LOK-test principle. A steel disc 25 mm in diameter is embedded in the fresh concrete at a depth of 25 mm. After hardening of the concrete the disc is pulled against a steel backstop, 55 mm inner diameter, on the surface.

The first method (see Figure 8) is called LOK-test ('LOK' is the Danish designation for 'punch') and is used where it is possible to place a steel disc in the fresh concrete. For hardened concrete, the second method (see Figure 9) is used instead. In this CAPO-test ('CAPO' stands for 'cut and pull-out'), a steel ring is inserted into the concrete and expanded to fit a specially drilled hole and routed recess in the concrete. The diameter of both disc and ring is 25 mm, the distance to the concrete surface is 25 mm and the inner diameter of the backstop 55mm.

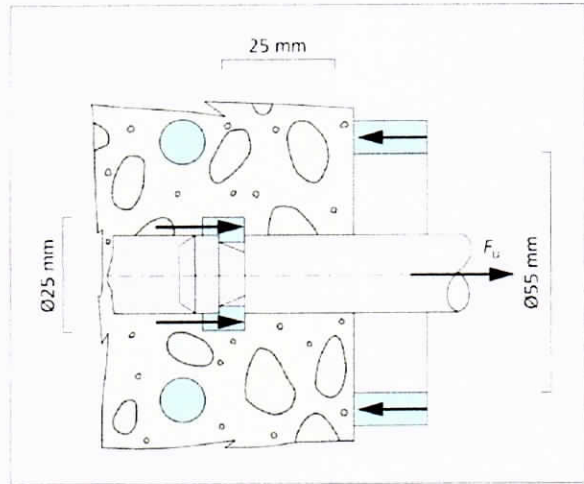
Fig. 9. CAPO-test principle. In a drilled and recessed hole, 25 mm below the surface, an expandable ring is inserted and expanded to fill the 25 mm diameter recess. In the test, the ring is pulled against a steel backstop, 55 mm inner diameter, placed on the surface.

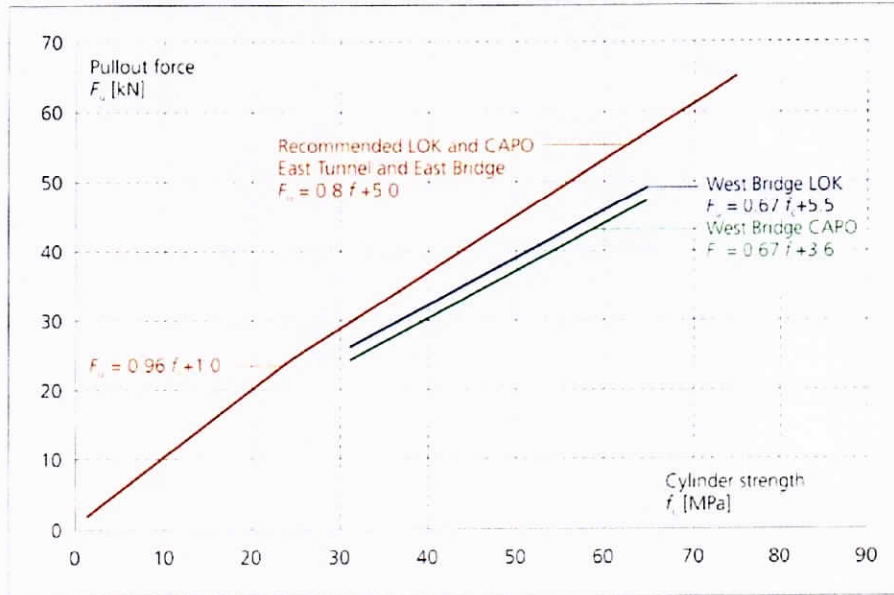
Fig. 10. Recommended correlation (red) between LOK-test and CAPO-test pull-out forces and 150 mm diameter x 300 mm long standard test cylinder compressive strength. This correlation was used for the East Tunnel and East Bridge whereas separate correlation relationships (blue and green) were established for the West Bridge.

The recommended correlation (see Figure 10) was used for the East Tunnel and East Bridge. During pretesting and full-scale trial castings for the West Bridge it was realized that the CAPO strength level determined on the basis of the recommended correlation was significantly lower than the LOK strength level. The obtained values also indicated a potential risk for rejections, so it was decided to carry out a correlation test for the actual West Bridge concrete. For this purpose, several test blocks were prepared, each 400 mm x 200 mm x 200mm and fitted with four LOK-test bolts. After 4 maturity days, 6 blocks were LOK- and CAPO-tested and at the same time, 18 cylinders were strength-tested. The tests were repeated after 7, 28 and 56 maturity days and the average pull-out forces plotted against the cylinder strength. It was found that the West Bridge correlations (see Figure 10) for LOK- and CAPO-tests were not identical with the recommended correlation.

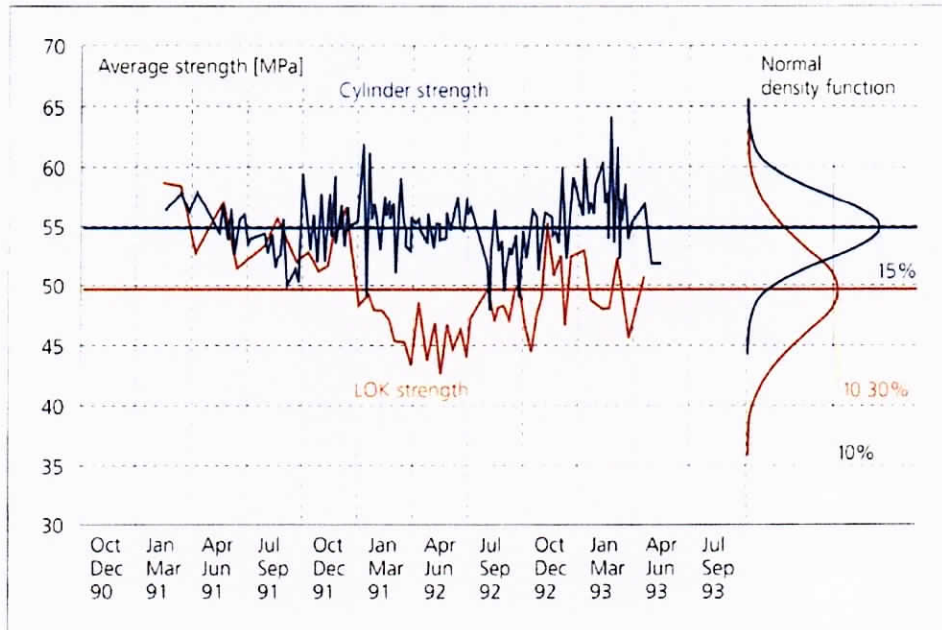
Fig. 11. West Bridge, rail girder inspection sections mix type B. Average strength results per inspection section of LOK-test and cylinder strength after 28 days. The average LOK-test strength for the entire production was 90% of the average cylinder strength. The coefficients of variation for the average LOK-test strength and average cylinder strength were 0.079 and 0.049 respectively.

During production, the coefficient of variation for each element type was computed from the previous 100 test results. For example, for the rail girder production was found to vary from 0.08 - 0.14. For the rail girder inspection sections n was 84 (see Table 3).

$$f_{ck} = \frac{42.5}{\exp \left[\left(2.28 + \frac{1}{\sqrt{84}} \right) 0.14 - 0.1875 \right]} = 36.7 \text{ MPa}$$

which was just above the required limit of 36 MPa, and the quality was therefore acceptable.

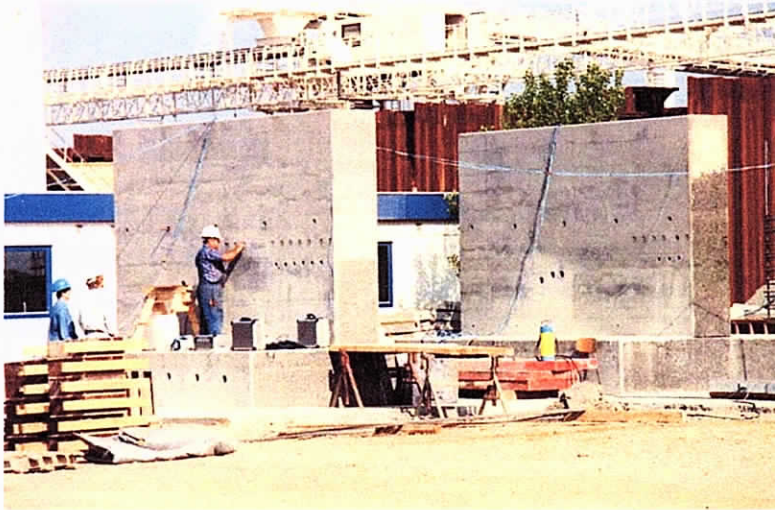
Fig.12. Trial casting, tested for chloride diffusion, strength and LOK-Test / CAPO-Test of the cover layer in relation to maturity to establish acceptable intervals.

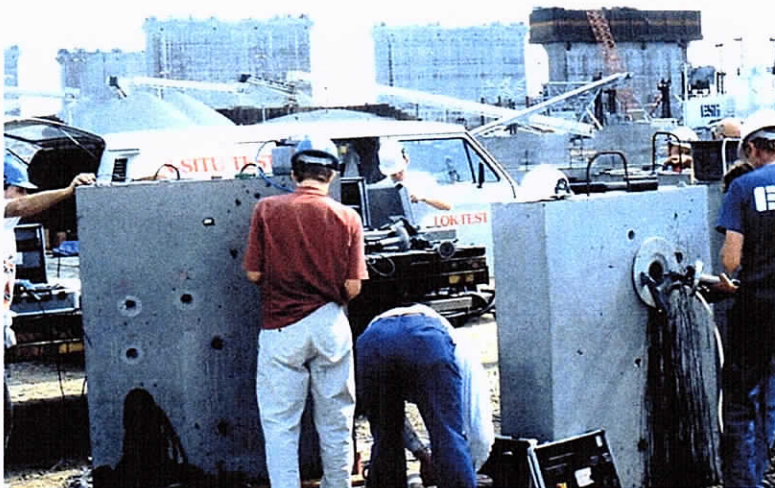
Fig.13. Training of the contractor's technicians on performing LOK-TEST and CAPO-TEST. The training course was completed with an examination and issuing of a diploma.

Regarding the use of pull-out testing (LOK and CAPO tests), it is a primary recommendation for production testing, provided that problems relating to training test operators, placing test bolts, and statistical evaluation of results are solved.

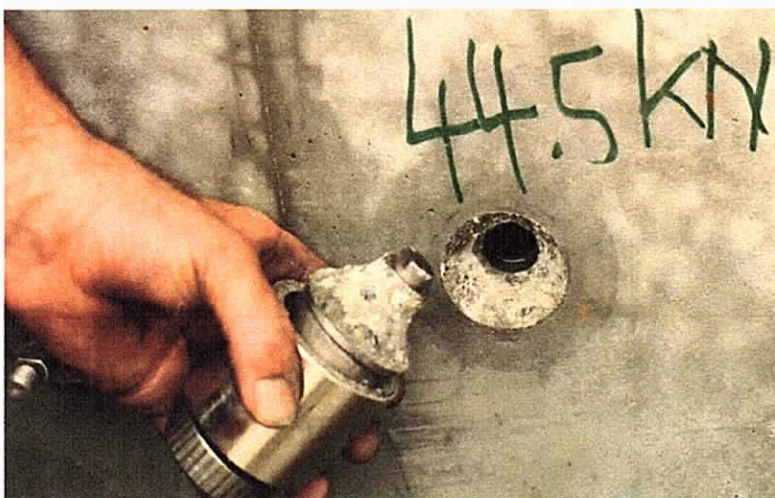
Fig.14. Successfully completed CAPO/LOK-Test of the cover layer of an element.

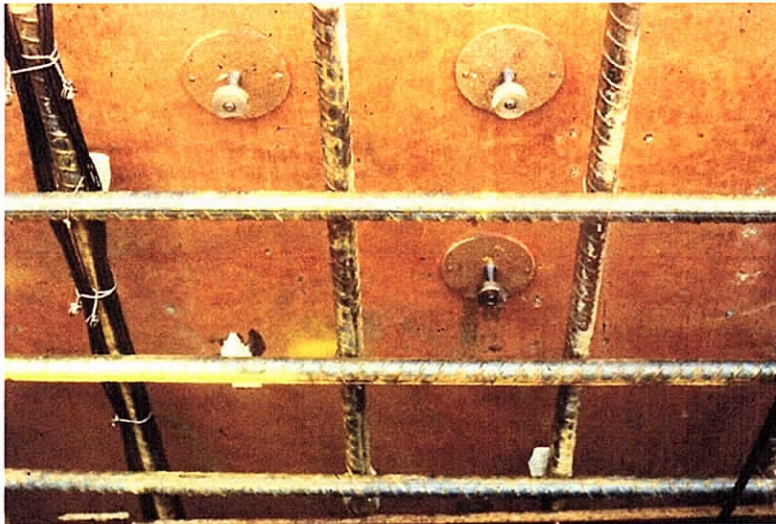
Fig.15. LOK-Test inserts installed in wooden formwork before concrete casting.

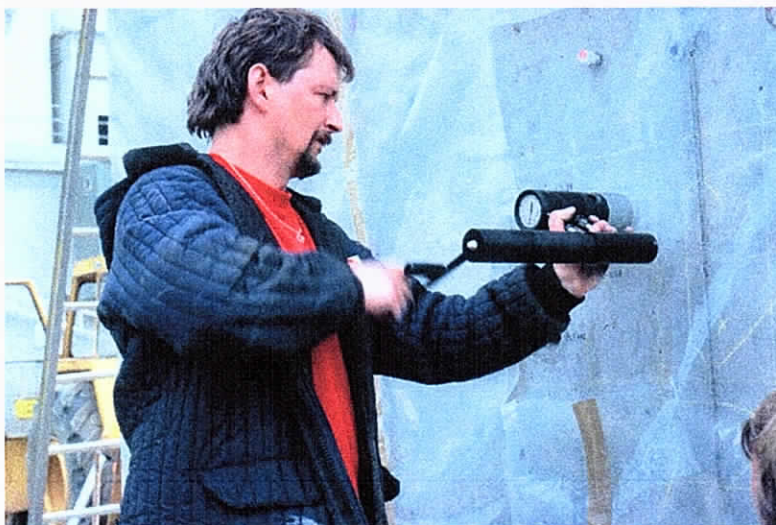
Fig.16. LOK/CAPO-Test in progress.
