# **LOK-TEST and CAPO-TEST pullout testing, twenty years experience**

By:  
Claus Germann Petersen  
B.Sc., M.Sc.

## **Synopsis:**

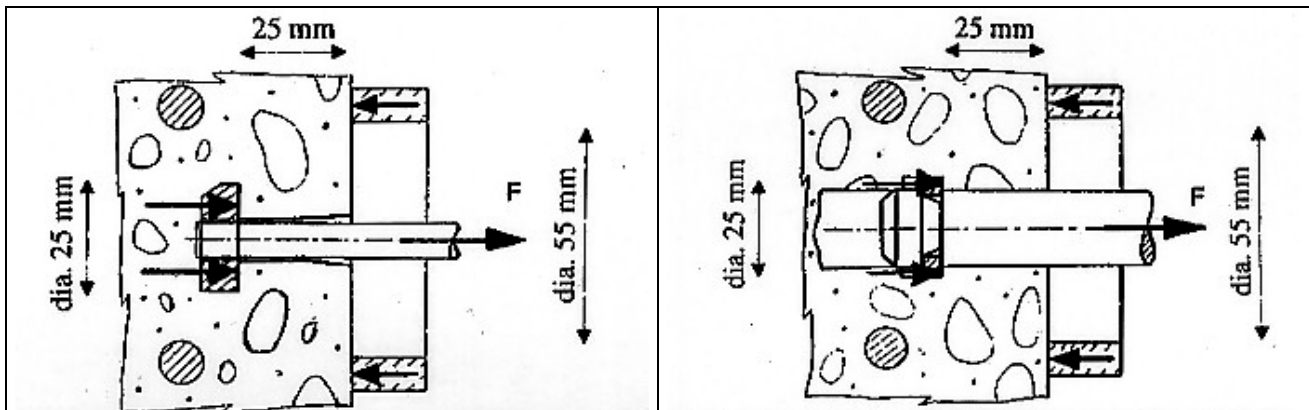
Figure 1. The Lok-Test (left) and the Capo-Test (right) testing shown schematically. With both systems a 25 mm in diameter disc/ring is pulled against a 55 mm inner diameter counterpressure placed on the surface until failure of the concrete occurs. The pull force is measured and related to compressive strength by a calibration curve.

'With Lok-Test (figure 1, left figure) a 25mm in diameter steel disc is embedded in the fresh concrete at a depth of 25 mm from the testing surface. At the time of testing, the disc is pulled against a counterpressure, 55 mm inner diameter, placed concentric with the disc on the surface, until rupture of the concrete occurs.

Similarly, for testing of existing structures, the Capo-Test (figure 1, right figure) utilizes a 25 mm ring, inserted and expanded into a recessed groove at a depth of 25 mm and pulled against a counterpressure as with Lok-Test.

Apart from the centerhole in the concrete, through which the pullbolt is attached to tile disc/ring, the test configuration for the two tests is identical. The centerhole in the Lok-Test disc is 11 mm in diameter. The same centerhole for Capo-Test is 18 mm.

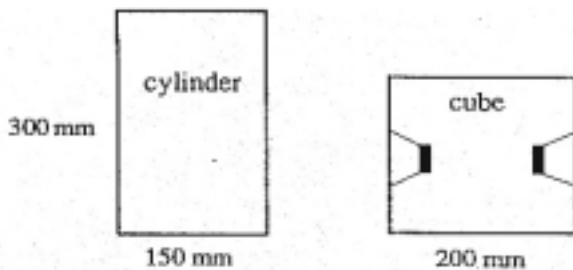
#### 1. Cylinder correlation procedure (Danish):

Compression tests made on 150 mm x 300 mm cylinders. Lok-Test's made on 200 mm cubes on opposite cylinder vertical faces, centrally placed.  
 Note: Same compaction and curing of the specimens is required as well as identical maturity at the time of testing.  
 Typically, 20-30 sets of specimens are made and comparative testing performed at 1, 2, 5, 14 and 28 days at 20 degree Celsius.

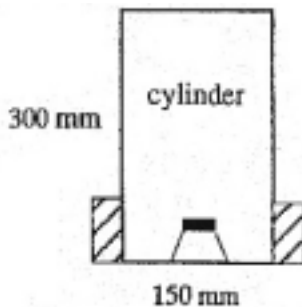
#### 2. Cylinder correlation procedure (North-American):

Lok-Test made exactly to failure followed by crushing of the cylinder.  
 Note: At higher strength levels a steel retaining ring is fitted around the bottom to prevent the cylinder to crack radially during pullout test. Accompanying cylinders without inserts are optionally used to make sure the pullout is not affecting the compressive strength.  
 Typically, 20-30 cylinders are made and comparative testing performed at 1, 2, 5, 14 and 28 days at 20 degree Celsius.

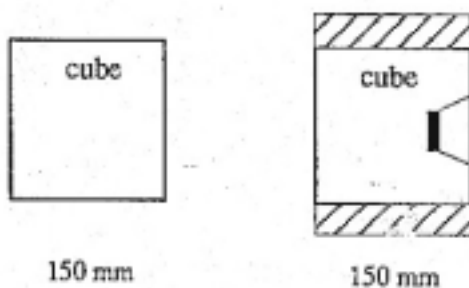
#### 3. Cube correlation procedure (Swedish/Dutch / English):

Compressive tests made on 150 mm cubes. Lok-Test's made on separate 150 mm cubes, at higher strength levels on 200 mm cubes.  
 Note: Same compaction and curing of the specimens is required as well as identical maturity at the time of testing. A steel retaining frame, as indicated, may be used to prevent the cube used for pullout to crack radially at higher strength levels for 150 mm cubes.  
 Typically, 20-30 sets of specimens are made and comparative testing performed at 1, 2, 5, 14 and 28 days at 30 degree Celsius.

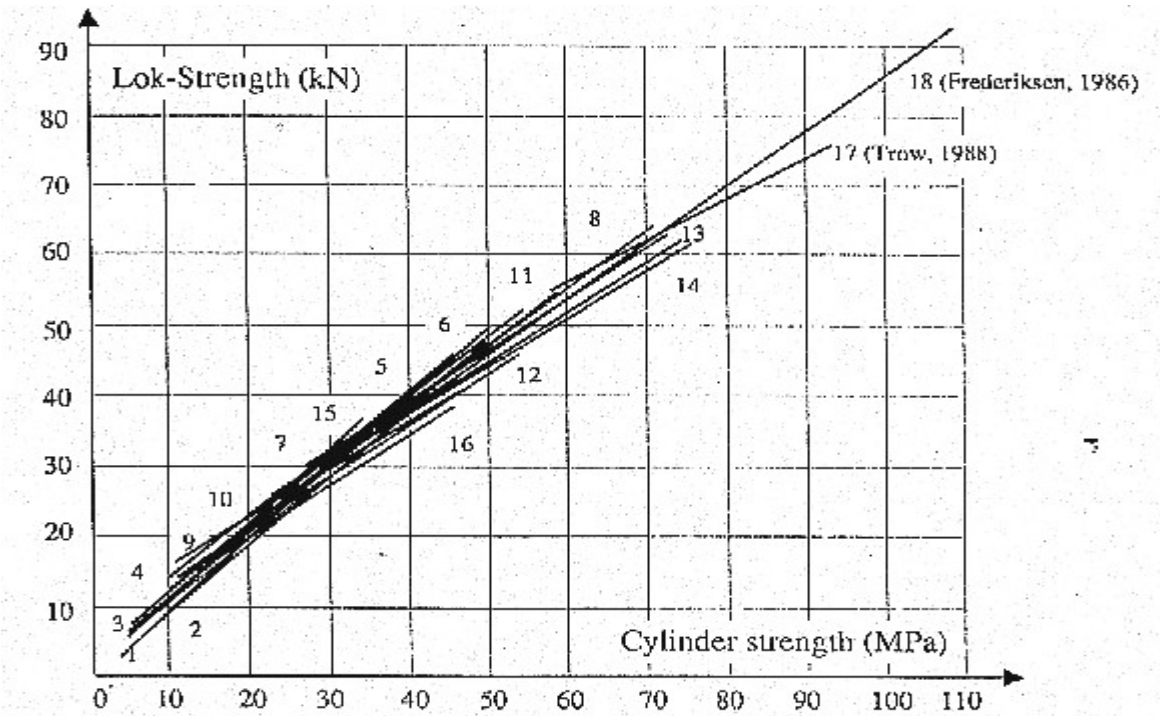
Figure 2. Eighteen correlations between Lok-Test pullout force and standard 150 mm x 300 mm cylinder compressive strength from Denmark, USA and Canada for normal types of concrete.

The coefficient of correlation ranged from 0.91 to 0.99, typically 0.96.

As shown in figure 2, the illustrated correlations show great stability for normal concrete. The following mean-correlation is suggested as the general one:

Correlations in figure 2 are on a 95% confidence level within plus/minus 5% from the suggested general correlation.

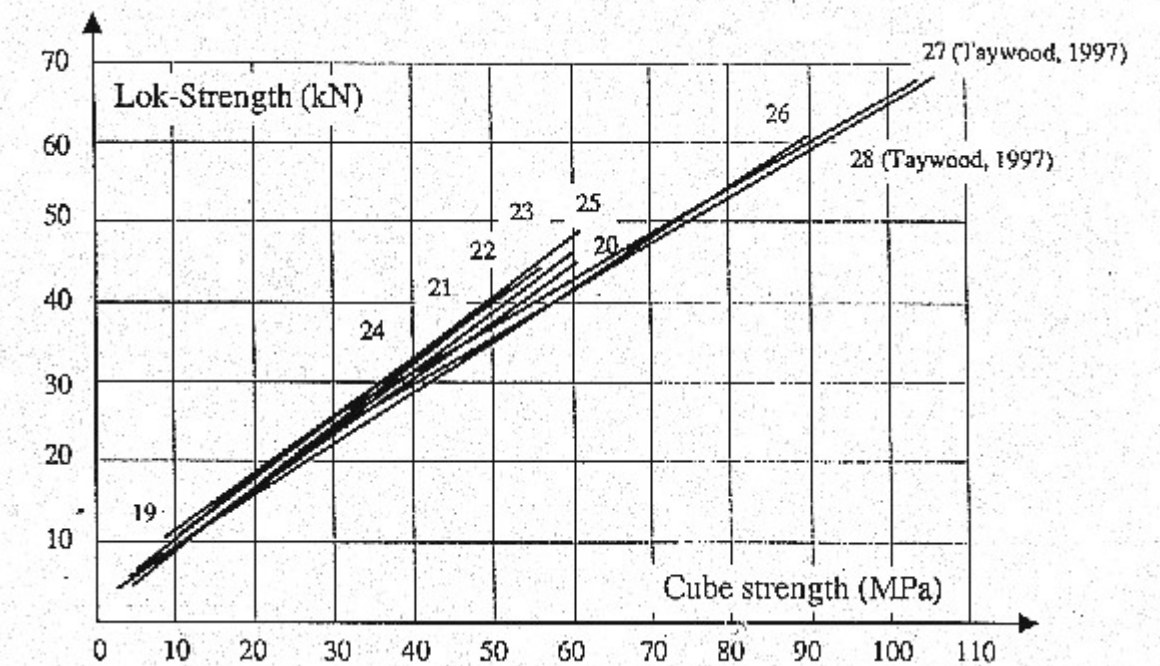
Figure 3. Ten correlations between Lok-Test pullout force and standard 150 mm cubes compressive strength from Sweden, England, Norway and The Netherlands for normal types of concrete.

As for cylinders, the correlations between pullout force and 150 mm cube compressive strength exhibit stability for normal concrete as illustrated in figure 3. Obviously, the relationship is slightly non-linear, as with the cylinder correlation.

Figure16, following page, illustrates the mean-correlation, which on a 95% confidence limit is plus/minus 6% apart from the correlations in figure 3.

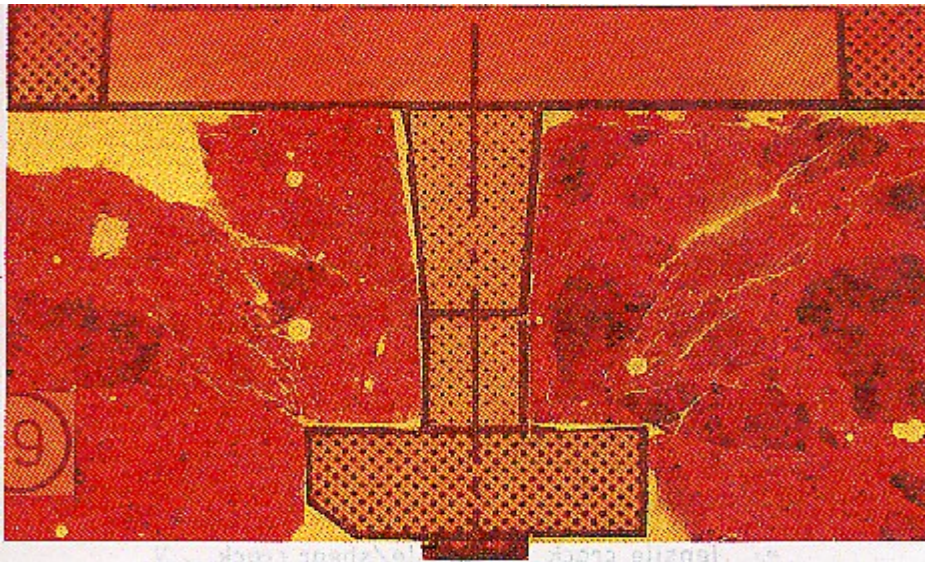
Figure 6. Crack analysis of Lok-Test de-loaded from the peak (#6) of the load-displacement curve shown in figure 8. The tensile cracking, stage no.1, has been formed as well as the multiple parallel microcracking, stage no.2. Stage no.3, the sliding crack, has not yet been formed.

The failure mechanism was further investigated experimentally by Herbert Krenchel in 1985. He loaded Lok-Test to different levels on the load-displacement curve. Afterwards, the samples were saw-cut through their axis, the surfaces were ground smooth and impregnated with epoxy containing a fluorescence dye to reveal cracks under ultraviolet light. The findings are given on the following page figure 6, 7 and 8, (Krenchel, & Bickley, 1985).

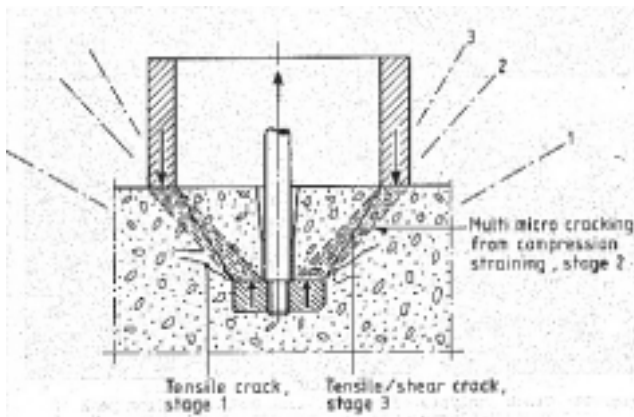
Figure 7. The three different stages of internal cracking during a Lok-Test.

"The internal rupture during this type of test is a multistage process where three different stages, each with different fracture mechanisms, can be clearly separated. In the first stage, at a level of about 30-40% of the ultimate load, tensile cracking begins, starting from the notch formed by the upper edge of the pullout disc. This crack runs out in the concrete at a pronounced open angle (cone angle between 100 degrees and 135 degrees). The total length of this first crack is typically 15-20 mm from the edge of the disc. In the second stage of internal rupture, a multitude of stable microcracks are formed in the above mentioned truncated zone. The main direction of these cracks, running from the top of the disc to the bottom of the counterpressure, forms a cone angle of approximately 84 degrees. The formation of this second crack pattern is parallel to the formation of increasing vertical microcracks inside a concrete cylinder or cube during ordinary uniaxial compressive tests. Development of the acoustic emission activity during this second stage of the test also follow a function quite parallel to the AE-development of ordinary uniaxial compressive tests. If more and more oil is pumped into the pull-out machine, even after the load has stabilized at the peak point, the third stage of internal rupture occur. This forms a tensile/shear crack running all the way around from the outside edge of the disc to the inside edge of the counterpressure ring. The final--pull-out cone angle, which -can be seen when the cone is pulled out, is about 52 -degrees."

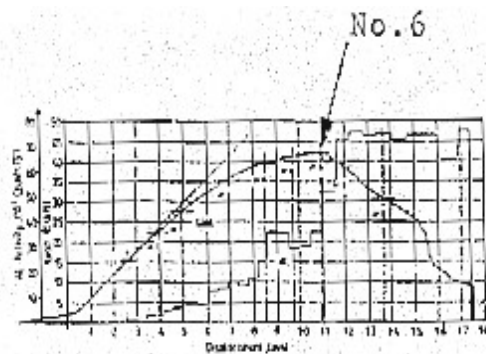
Figure 8. Complete load/displacement curve with AE-registration. Figure 6 illustrate the cracking at load level #6.

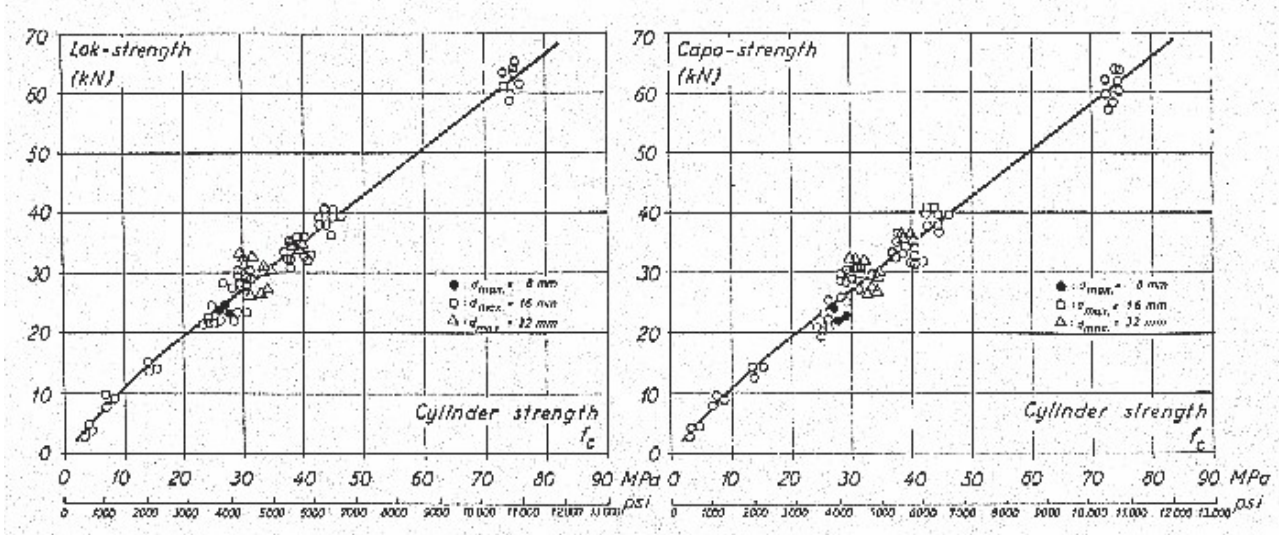
Figure 9. Danish comparative investigation made between Lok-Test / cylinder strength and Capo-Test / cylinder strength, cylinders being 150 mm x 300 mm standard cylinders (Krenchel, 1982)

The Danish one (Krenchel, 1982) is reproduced in figure 9. Lok-Test and Capo-Test were made on 200 mm cubes, two of each tests centrally placed in opposite vertical faces, and compared to cylinder strength as outlined in the Danish procedure, section 2.1. Each point in figure 9 represent an average value of 2 cylinder results and 2 Lok-Test, respectively 2 Capo-Test. The correlation coefficient of both methods was found to be 0.95, and the coefficient of variation on the cylinders 3.6%, for Lok-Test 7.9% and for Capo-Test 7.8%, on average.

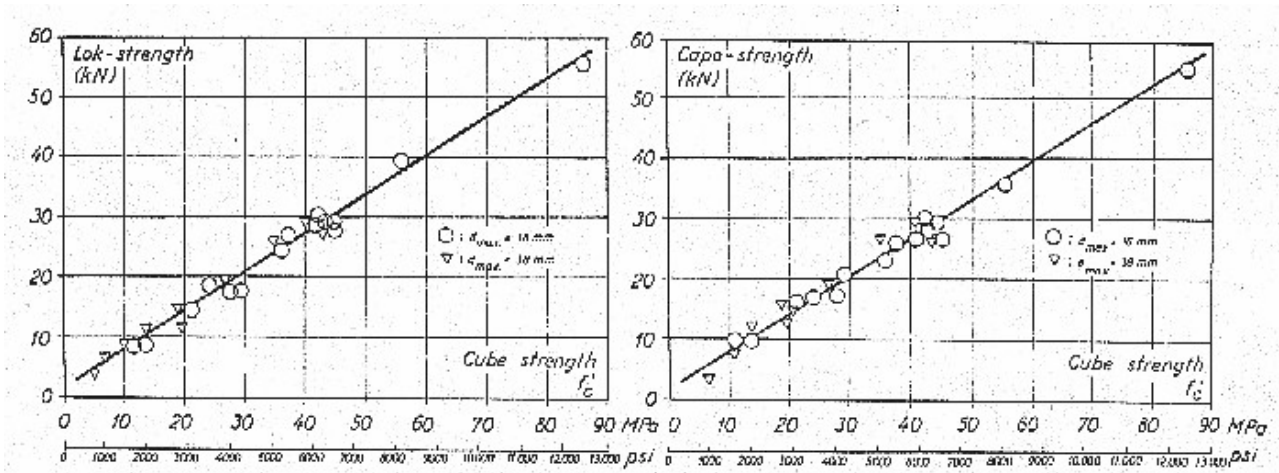
Figure 10. Swedish comparative investigation made between Lok-Test / cube strength and Capo-Test / cube strength, cubes being 150 mm x 150 mm x 150 mm standard cubes (Bellander, 1983)

The Swedish one (Bellander, 1983) is shown in figure 10. Lok-Test and Capo-Test were made on 150 mm cubes as shown in the Swedish/Dutch/English procedure, section 2.1. At higher strength level a steel retaining frame was fitted to the 150 mm cube to prevent radial cracking during pullout. Each point is an average of 3 cube tests and 3 Lok-Tests, respectively 3 Capo-Tests. The correlation coefficient of Lok-Test / cubes was 0.98, of Capo-Test / cubes 0.97 and the residual standard deviation 2.0 MPa on both recession lines.

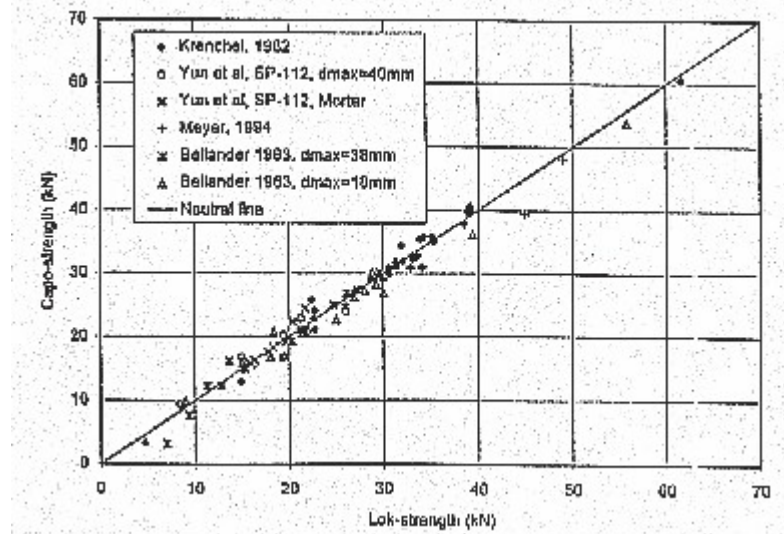
Figure 11. Capo-Test compared to Lok-Test (Krenchel, 1982), (Bellander, 1983), (Yun et al, 1990) and (Meyer, 1994)

As will be seen, the Capo-Test correlations resemble the Lok-Test's, almost identically, and the Capo-Test pullout forces are the same as the Lok-Test's.

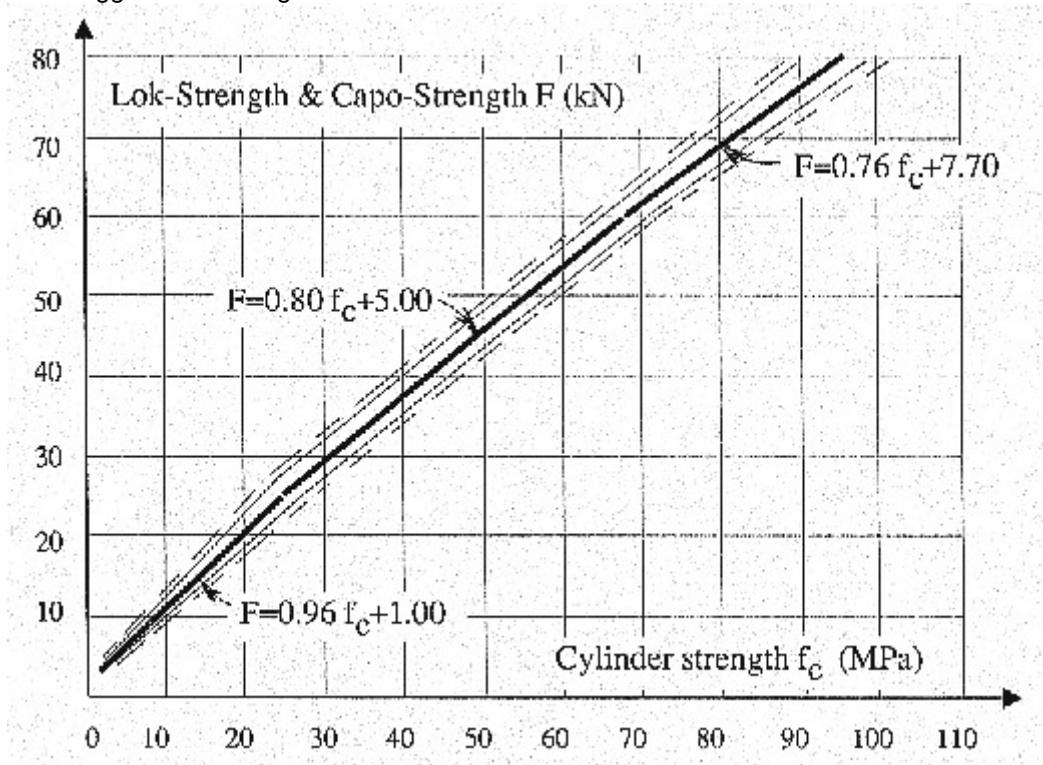
Figure 13. The suggested, general correlation between pullout strength measured by Lok-Test or Capo-Test and 150 mm x 300 mm standard cylinder compressive strength. The confidence limits are 95% limits for 16 mm (-) and 32mm (--) maximum aggregate size (Krenchel, 1970) for an average of 2 reference tests and 4 pullout tests.

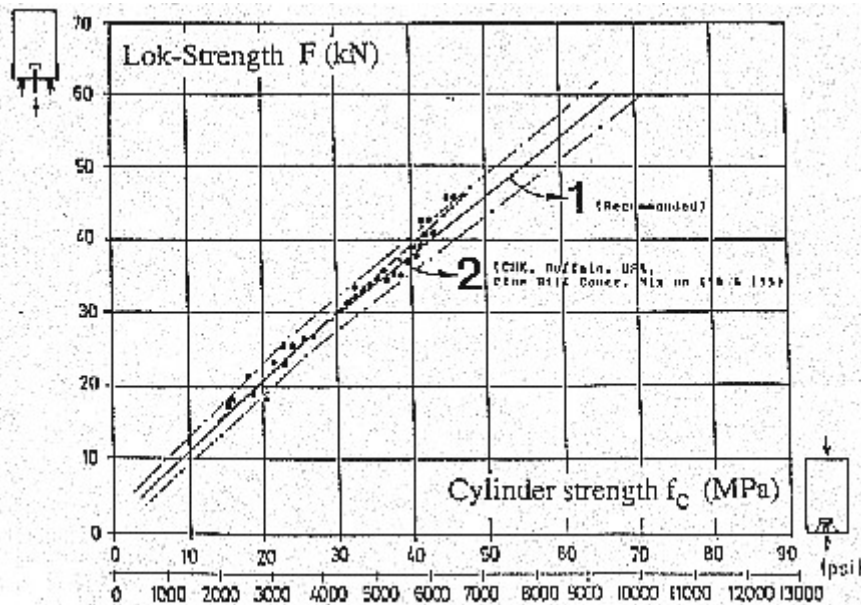
Figure 14. Comparison between the recommended correlation (figure 13) and comparative measurements made by CME, Buffalo, USA, between Lok-Test and standard cylinder strength made for two different mixes. Each point represents one Lok-Test result compared with one cylinder result.

The North American one utilized the second procedure shown section 2.1 with Lok-Test inserts cast into the bottom of cylinders. Lok-Test's were pulled exactly to failure, and the cylinders were crushed in compression. A total of 32 cylinders were cast, moist-cured and tested at varying maturity. Maximum aggregate size was 32 mm. The measurements are plotted in figure 14 along with the regression line, and compared to the recommended correlation exhibited in figure 13.

The correlation was found to be:  $F \text{ (kN)} = 0.94 f_c \text{ (MPa)} + 1.20$  with a coefficient of correlation of 0.96. The within-variation on the Lok-Test was  $S_F = 1.77 \text{ kN}$  ( $V_F = 7.6\%$ ) and on the cylinders  $S_C = 1.45 \text{ MPa}$  ( $V_C = 7.3\%$ ). Had the general correlation been used, the deviation in the strength estimates would have been 1.1% different, on average.

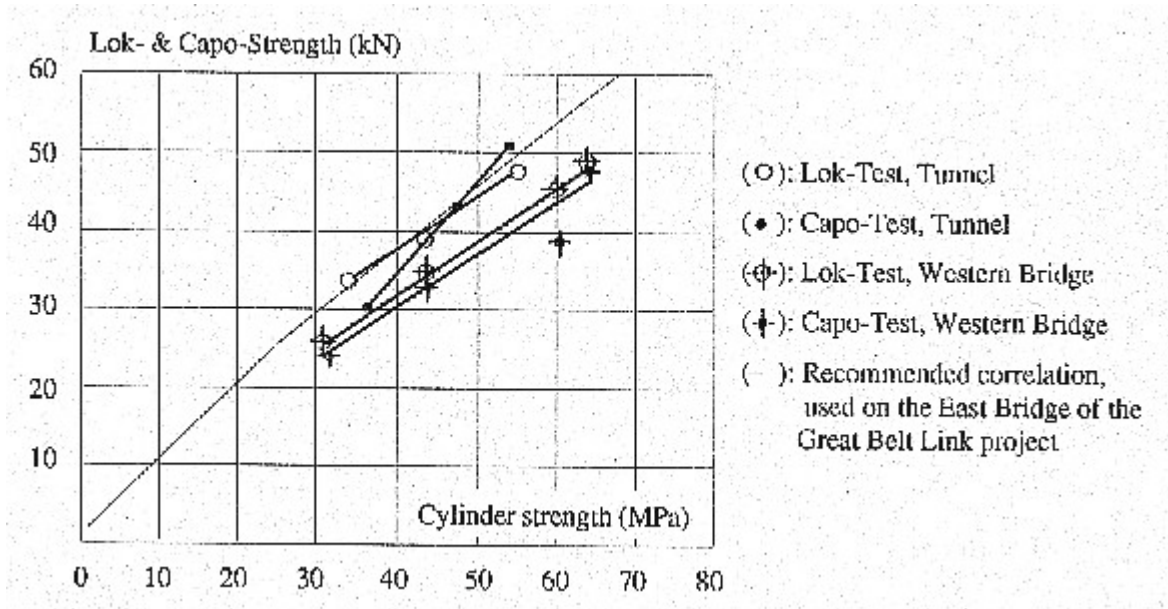
Figure 15. Correlations between Lok-Test/Capo-test and cylinder strength used on the Great Belt Link's Western Bridge, the Tunnel and the East Bridge

The correlations obtained are shown in figure 15 along with the recommended correlation. The same type of concrete (type B concrete) was used for all correlations.

As will be seen, the Western Bridge's correlations deviate on average 20% from the recommended one, while the Tunnel's are not significantly different from the recommended.

As far as the Western Bridges correlations are concerned, Meyer believed the difference to be caused by a relatively high content of powder in the concrete and its low w/c-ratio, (Meyer, 1994). This explanation is, however, not substantiated by the tunnel contractor's correlation, where the same concrete mix was used. Furthermore, correlations made by Krenchel in 1970 also covered concrete with a w/c-ratio of 0.35, and he found no deviation from the recommended one for low w/c-ratios (Krenchel, 1970).

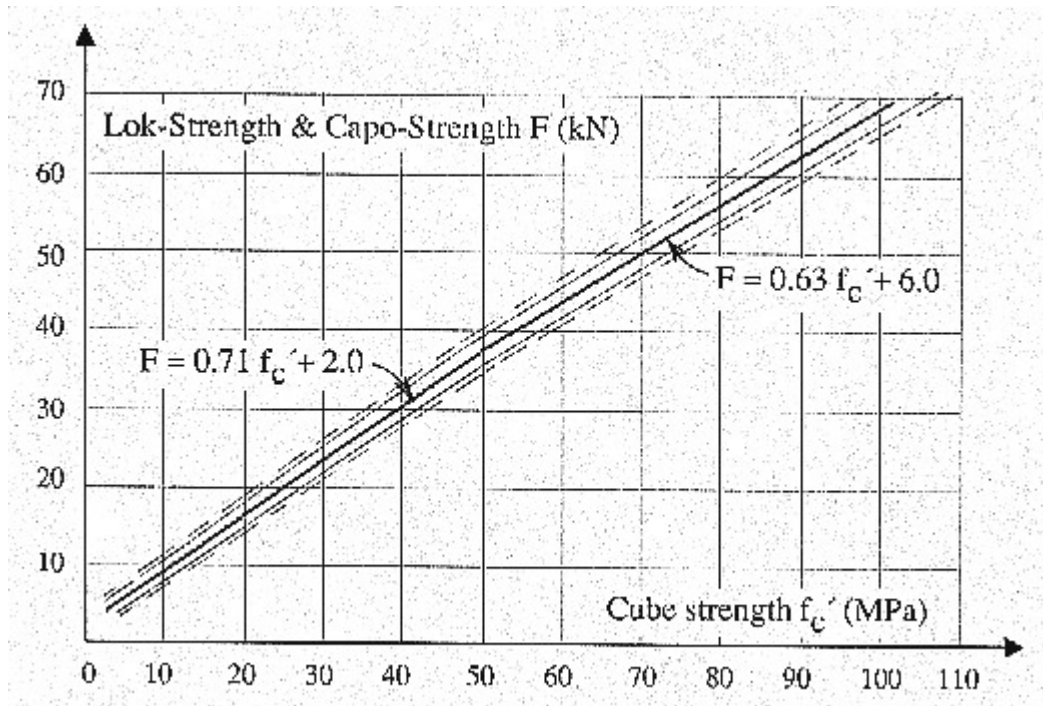
Figure 16. The suggested, general correlation between pullout strength measured by Lok-Test or Capo-Test and 150 mm standard cube compressive strength. The confidence limits are 95% limits for 16 mm (-) and 32 mm (-) maximum aggregates size (Krenchel, 1970) for an average of 2 reference tests and 4 pullouts.

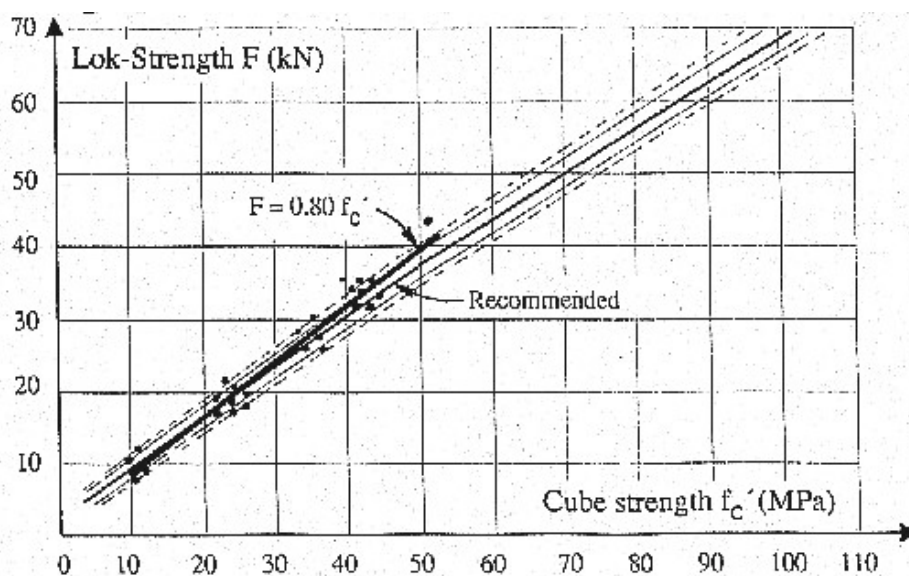
Figure 17. comparison between the recommended-correlation (figure 16) and measurements made by Pont et Chaussées, Luxembourg, between Lok-Test and standard cube compressive strength. Each point represents an average of two Lok-Test's and one cube result.

In the calibration from Luxembourg the 3rd procedure in section 2.1 was utilized with Lok-Test's embedded in 200 mm cubes, two Lok-Test's in each cube for comparison to cube strength. A total of 26 sets of specimens were manufactured on vibration table, water-cured and tested at varying maturity. The maximum aggregate size was 32 mm. The findings are illustrated in figure 17.

The correlation is  $F = 0.8 f_c'$ , and the coefficient of correlation 0.95. The within-test variation on the Lok-Test was  $S_F = 2.9 \text{ kN}$  ( $V_F = 9.9\%$ ) and on the cubes  $2.3 \text{ MPa}$  ( $V = 7.1\%$ ), on average.

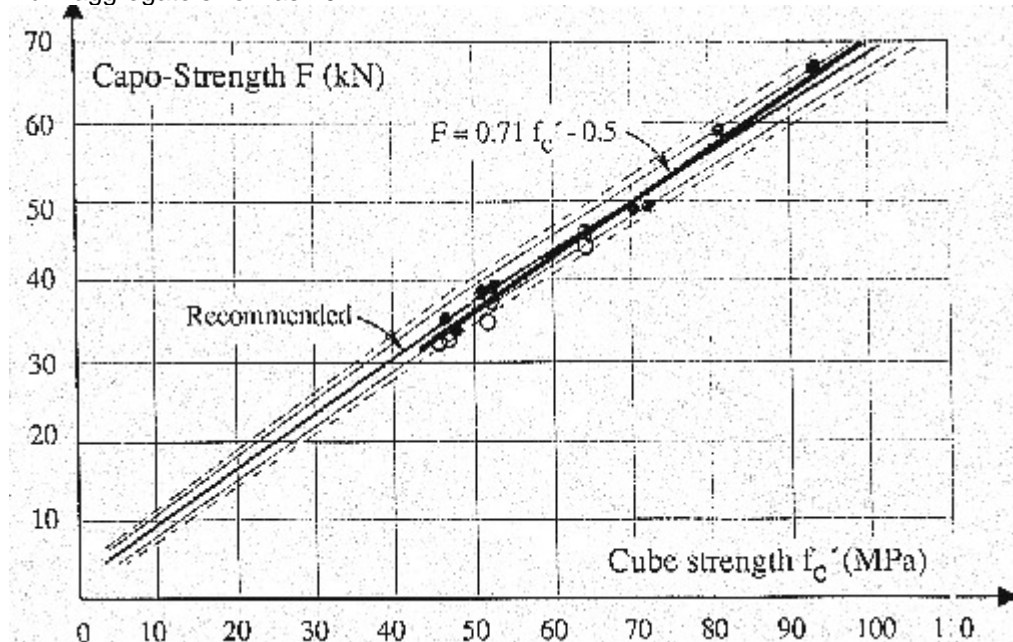
Figure 18. Comparison between the recommended correlation (figure 16) and comparative measurements made at the TML site in U.K. between Capo-Test on cubes compared to standard cube strength (●) and Capo-Test on elements compared to production cured cubes (o).

The correlation was performed according to the 3rd procedure outlined in section 2.1. Eight sets of cubes were produced, each set consisting of 4 cubes. Compaction was made on vibration table and curing in water at 20 degree Celsius. Of each set, two of the cubes were tested with Capo-Test while the cubes were still in their steel moulds (to prevent radial cracking), and the other two were tested in compression. Testing was performed at 4, 7, 28, 154 and 329 maturity days. Two sets were tested at the first three maturity ages, while one set was tested at the last two maturity ages. In figure 18 each comparative measurement (●) represents in this manner an average of two Capo-Test's and two cubes, 8 points in total.

Additionally, segments with 4, 7 and 28 maturity days were tested with Capo-Test (4 Capo-Test in each) and compared to two production cured cubes. Two segments were tested at each maturity age. In figure 18 the 6 points labeled (o) represents an average of 4 Capo-Test's and two cubes (Worters, 1990).

The correlation was found to be  $F = 0.71 f_c' - 0.5$  and the coefficient of correlation 0.98. The residual deviation is 1.9 MPa. Had the recommended correlation been used instead of the produced one, an average deviation on the strength estimate of 0.8% would have been achieved.

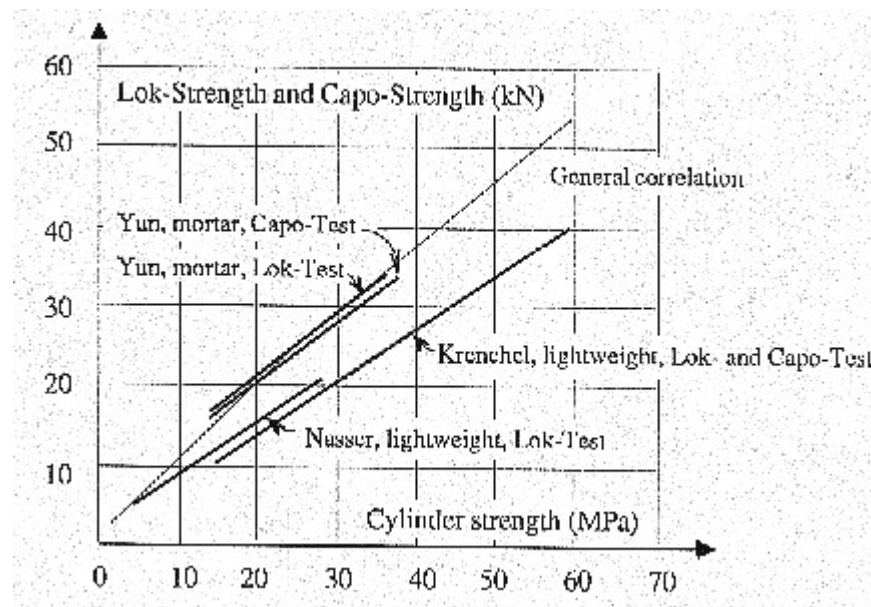
Figure 19. Lightweight concrete correlations by (Krenchel, 1982) and (Nasser, 1988) compared to mortar correlations by (Yun et al, 1988) and the general correlation for cylinder strength

Calibrations have shown no effect from varying type, shape and size of maximum aggregate size, only the variation increase on the pullout test result as the maximum aggregate size increases. Even for mortar, the correlations performed (to 150 mm x 300 mm cores) by (Yun et al, 1988) show no significant deviation from the general one as indicated in figure 19.

However, for lightweight aggregate another correlation has been found, reported in a supplementary investigation by (Krenchel, 1982) and by (Nasser, 1988).

The variation on the mortar was for Lok-Test 4.5 % and on the Capo-Test 7.1 %.

On the lightweight concrete the variation on the Lok-Test was found to be 5.1% and on the Capo-Test 5.5%.

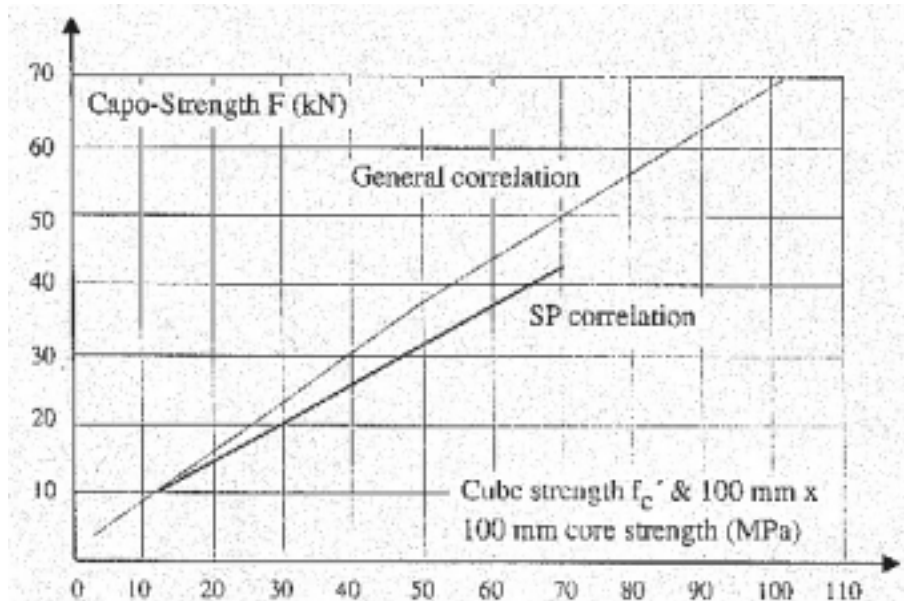
Figure 20. The correlation between Capo-Test and 100 mm x 100 mm cores, trimmed and air cured 3 days before testing, made by the National Swedish Testing Institute (SP) on 13 old Swedish bridges. The correlation is compared to the general correlation for standard cubes (figure 6).

The correlation obtained (Rockström and Molin, 1989) is shown in figure 20 together with the general correlation for standard cubes for comparison.

The correlation by the National Swedish Testing Institute (SP) was found to be  $F = 0.55 f_{cc} + 3.16$ . The residual standard deviation measured was 4.1 MPa.
