#### In-Situ Strength by CAPO-TEST

NATO Workshop on load carrying capacity of bridges 01-03 june, 2015 Høveltegård, Birkerød, Denmark

Claus Germann Petersen
GERMANN INSTRUMENTS, Inc.

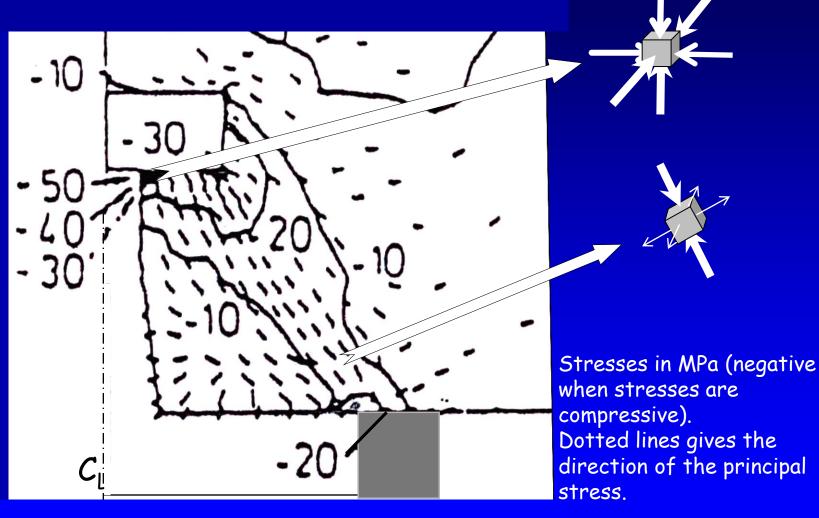
Stress curves at 70% loading

Calculations are made for a uniaxial compressive strength of 31.8 MPa. Note the much higher stresses (up to 50 MPa) are present right below the disc due to concentrated tri-axial loading in this area.

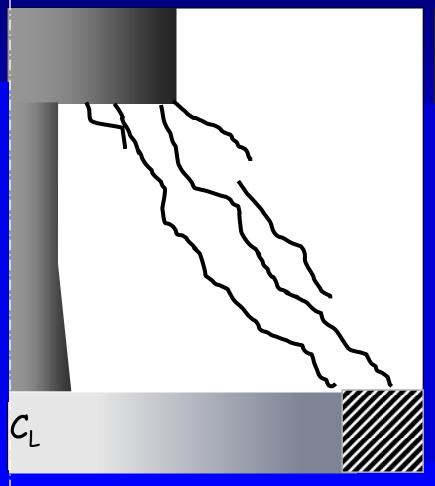
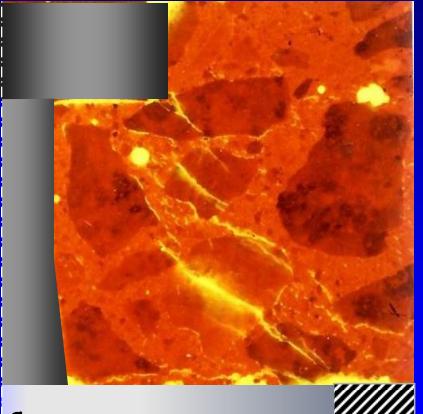
### Compressive cracking, 98% loading, Finite element analysis and experimental analysis

"It has been shown that large compressive forces run from the disc in a rather narrow band towards the support, and this constitutes the load-carrying mechanism. Moreover, the failure in a LOK-TEST is caused by crushing of the concrete and not by cracking. Therefore, the force required to extract the embedded steel disc is directly dependent on the compressive strength of the concrete".

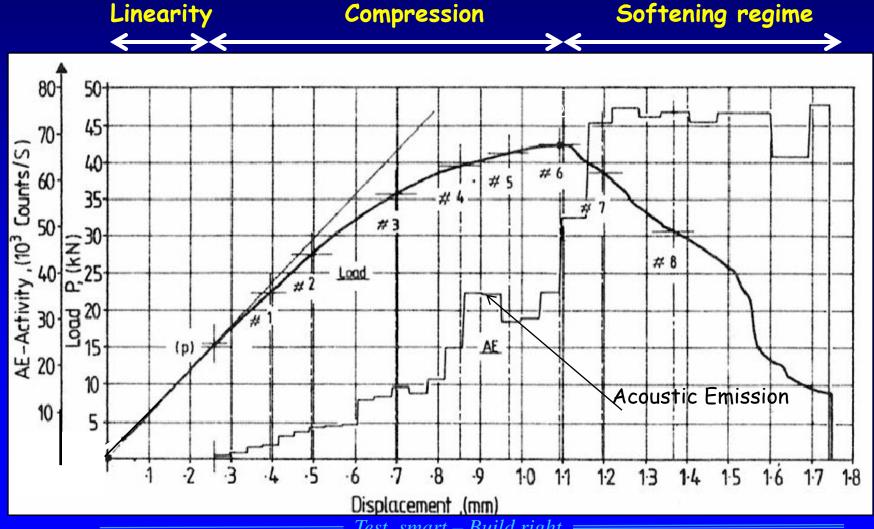
# Load displacement curve for pullout test

- 1. At about 30% of the load a circumferential crack is developed at a open angle running from the outer edge of the disc. This is where the liniarity is lost.
- 2. From thereon multiple microcracks are developed in a compression band between the disc and the counterpressure
- 3. A collaps happens into the softening regime at increased loading, forming the final pullout cone

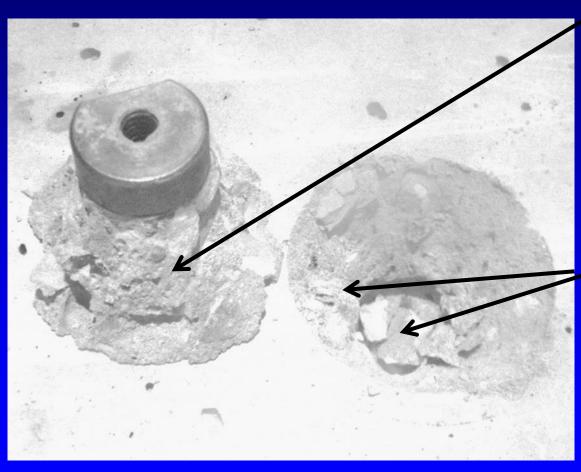
#### LOK-TEST pullout failure

"Leave" from the second crack pattern with the concrete in compession being intersected in the softening regime

Crushed material in the compression zone

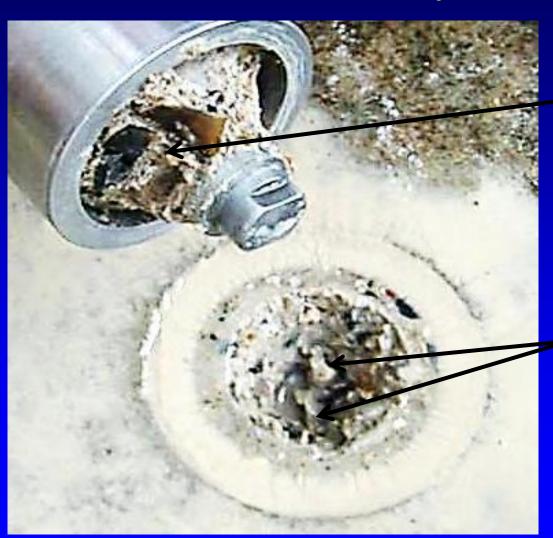
#### **CAPO-TEST** pullout failure

"Leave" from the second crack pattern with the concrete in compession being intersected in the softening regime

Crushed material in the compression zone

- LOK-TEST and CAPO-TEST measure the compressive strength of concrete (2nd crack pattern). This constitute the load-carrying mechanism
- The tests are NOT testing the tensile, NOR the shear strength, only the compressive strength
- The tensile crack develops at about 30% of the ultimate load. This crack release stesses in the pullout area. Therefore, pullout values are not affected by inherent stresses in the structure (ref.: Jehrbo Jensen, J.K.: "Influences of Stresses in a Structure on the LOK-TEST Pullout Force", AUC, Deptm. of Building Technology and Structural Engineering, Aalborg, Denmark, 1990)

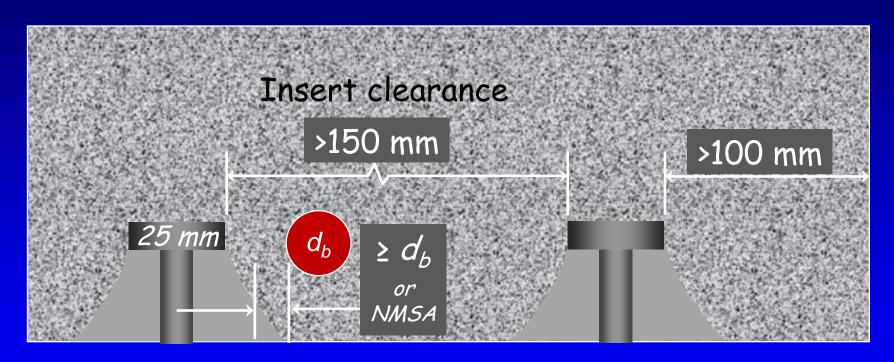
# Clearance Requirements ASTM C900

Reinforcement clearance

Edge distance

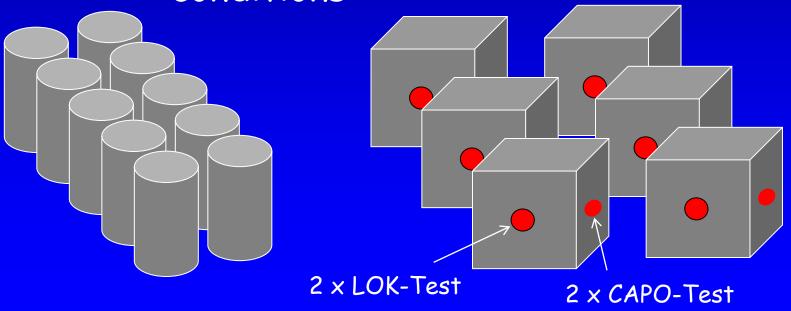
#### **Correlation Testing**

- Prepare cylinders (or cubes)
- Prepare 200 mm cubes with inserts
- Compact and cure under same conditions

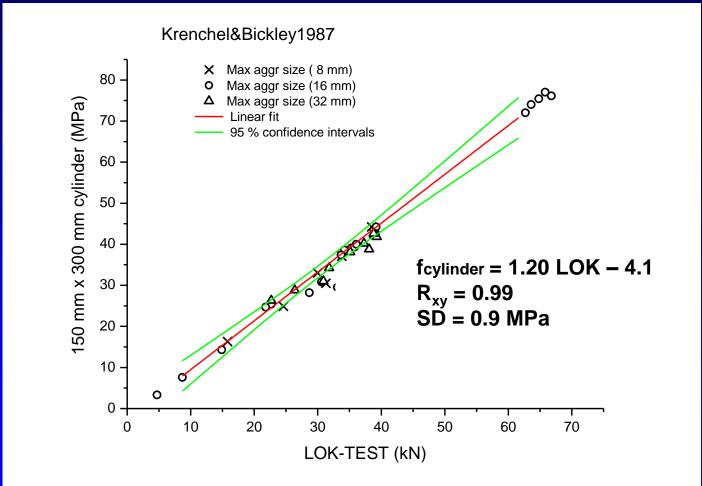
#### LOK-TEST to cylinder strength, 1st major correlation 1987

Aggregate type: Sea Gravel and Granite (for strength > 70 MPa)

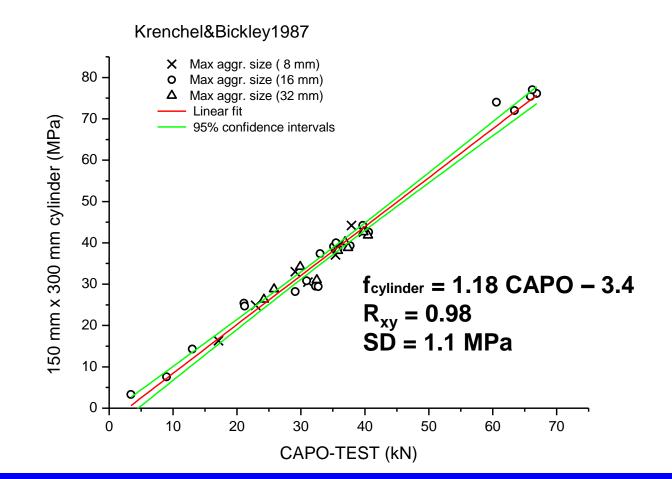
## CAPO-TEST to cylinder strength, 1st major correlation 1987

Aggregate type: Sea Gravel and Granite (for strength > 70 MPa)

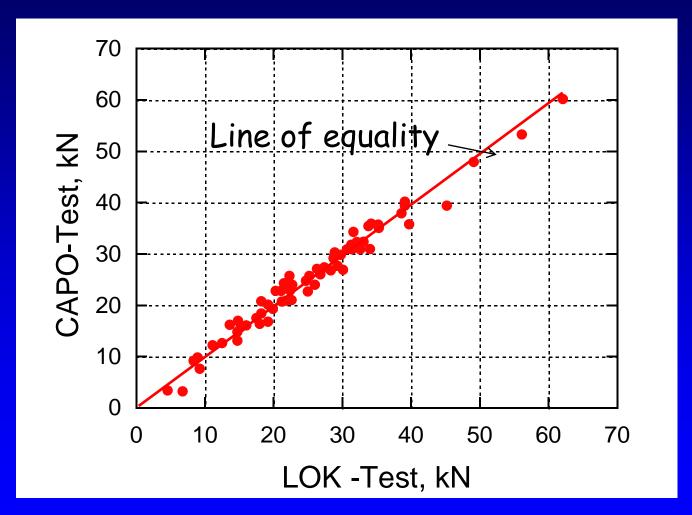
#### **CAPO-TEST to LOK-TEST**

Refs: Krenchel (1982), Bellander (1983), Yun (1990), & Meyer (1994)

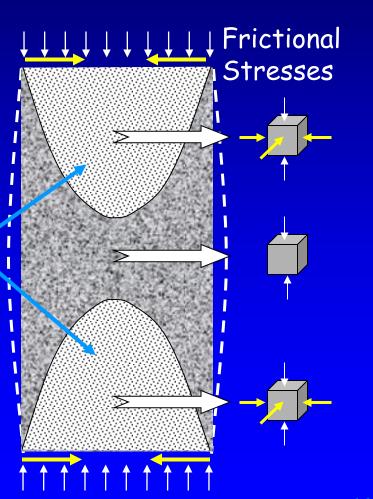
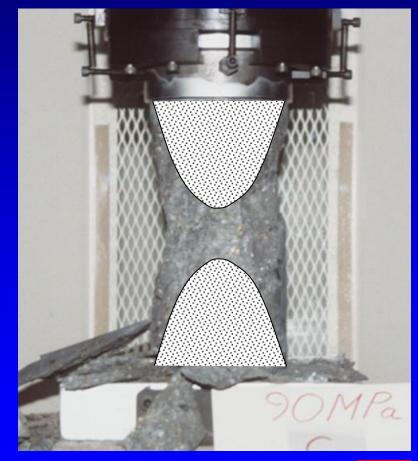
## Effect of End Friction – Triaxial Compression

Zones of triaxial compress ion

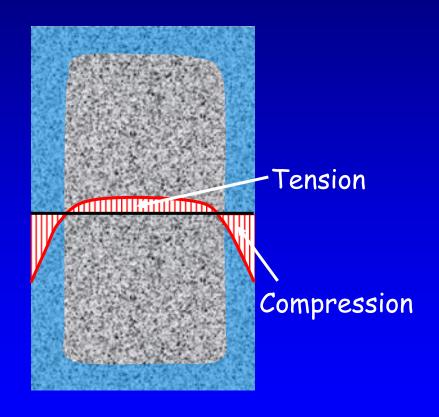
## Moisture Gradients Immediately After Wet Drilling

- Moistened concrete tends to swell
- Swelling is restrained by dry interior
- Results in internal stresses; outer region in compression
- Measured strength is reduced

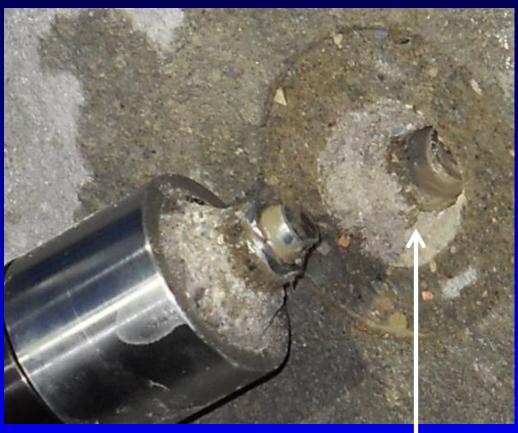
Capo-Test on shotcrete,

Note the failure zone is unaffected by water

needed during coring / recessing

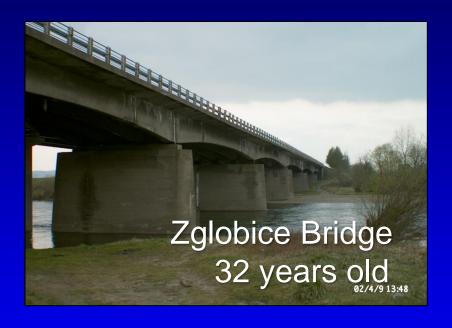
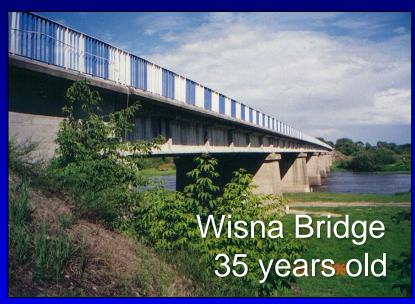
## Comparative Strength Estimates from Polish Bridges, summary

Cores		CAPO-TEST		Schmidt on Structure		Schmidt on Cores	
Average	(MPa)	V (%)	(MPa)	V (%)	(MPa)	V (%)	(MPa)	V (%)
Strength	32.8	9.5	33.5	11.7	55.9	16.4	44.5	15.1

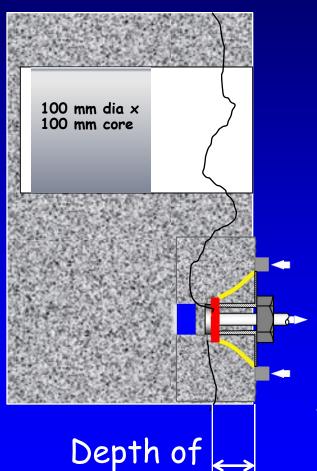
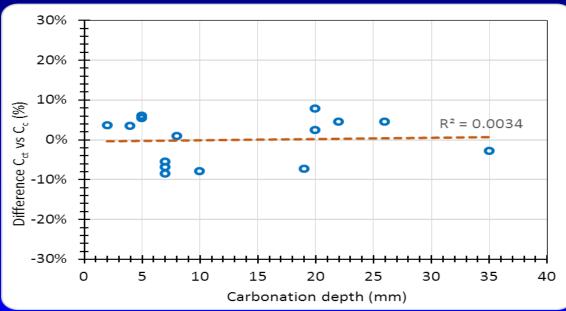
#### **Effect of carbonation**

Avg. Core 33.9 MPa, Avg.CAPO 33.7 MPa, Diff -0.6% Avg. Carbonation Depth 13.1 mm

- Capo-Test depth is 25 mm, samples for coring is taken deeper in the structure
- Relationships have not been investigated for max. aggregate size > 40 mm
- Capo-Test seems to be unaffected by depth of carbonation (Polish data)
- Minimum distance to edges and corners of 100 mm has to be observed
- Minimum distance from the "strut" to reinforcement ~ 10 mm

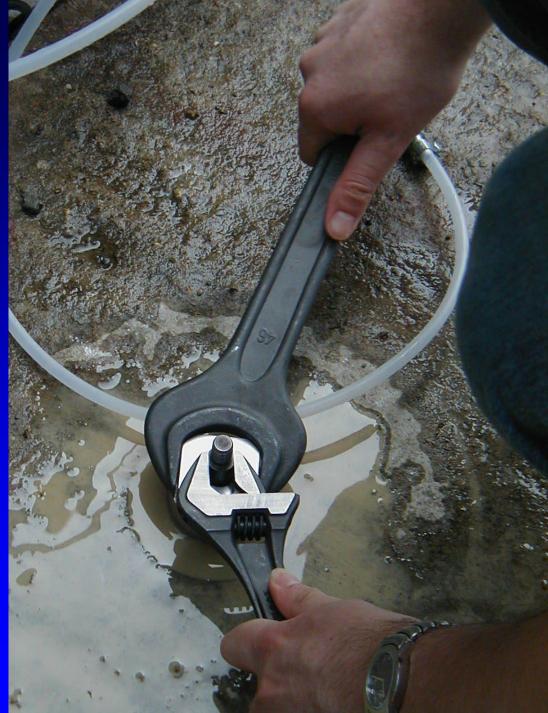
#### **Expand Ring**

## Pullout the Expanded Ring against a 55 mm counterpressure

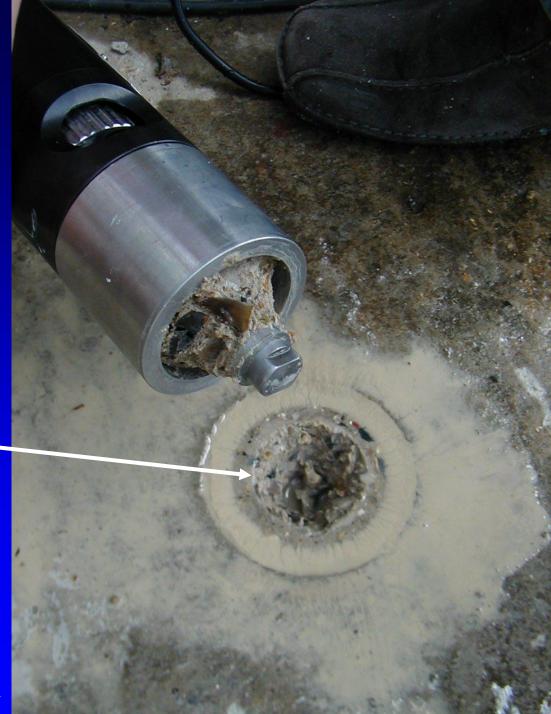
### Acceptable Test

Sharp 55 mm diameter edge from counterpressure

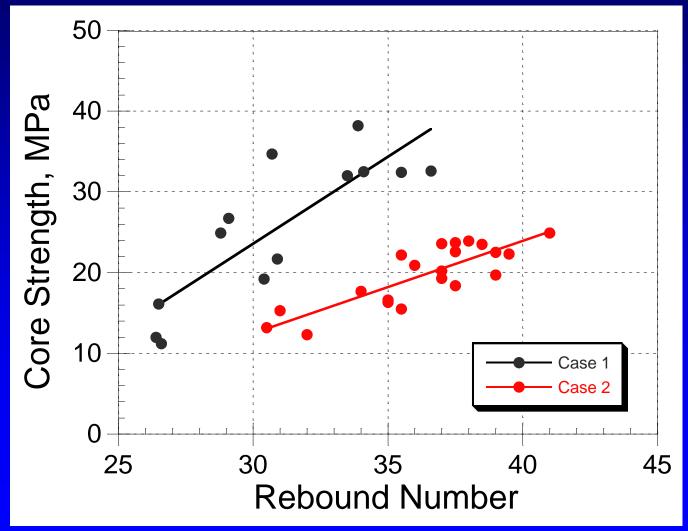
#### **Comparison of Relationships**

### Rebound Hammer related to cube strength

Average relationships shown for granite and limestone aggregates and curing conditions (water and air)

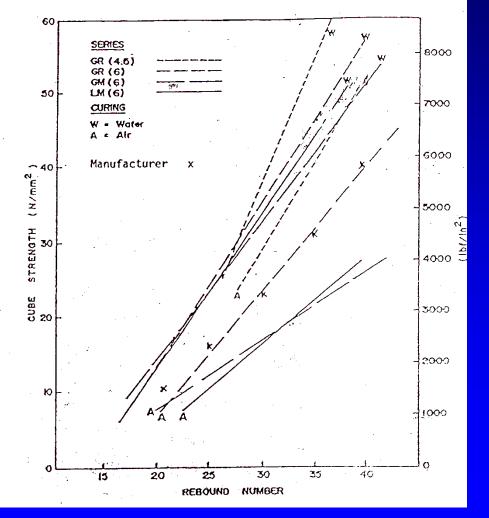
Series	Aggregate		Aggregate-cement
	contre	fine	ratio
GR(4.5)	granite	river sand	4.5
GR(6)	granite	river sand	6.0
GM(6)	granite	mining sand	6.0
LM(6)	limestone	mining sand	6.0

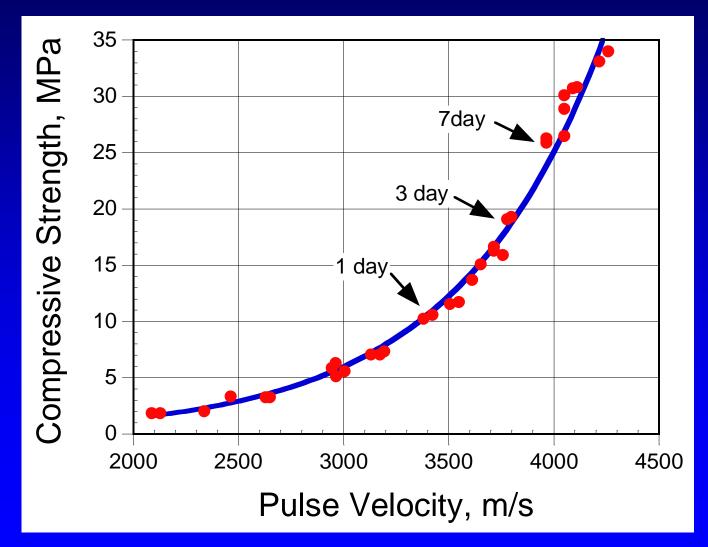
#### Relationship for a specific mix

For mature concrete, large increase in strength is accompanied by small increase in velocity, mix specific.

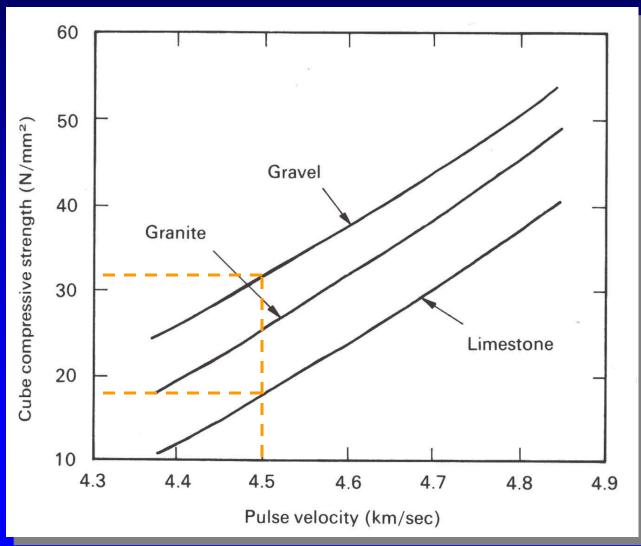
### **Example**Aggregate Type

#### UPV (Ultrasound Pulse Velocity) related to cube strength

Average relationships shown for granite and limestone aggregates and curing conditions (water and air)
